RE: LORAIN COUNTY
CITY OF AVON
LOR-90-22.26
CONSTRUCTION STORM WATER
3GC05376*AG

On May 31, 2012, Dan Bogoevski and I performed a compliance inspection for storm water best management practices (BMPs) at the above referenced site. We were accompanied by Rob Knopf, Engineer for the City of Avon. While on site, we met with Luke Wysocki, Project Engineer for ODOT District 3. Our records indicate that the City of Avon Sanitary and Water Line Addition has obtained coverage under the Ohio EPA General Storm Water National Pollutant Discharge Elimination System (NPDES) Permit for Construction Activities #3GC05376*AG.

INSPECTION PHOTOS

LOR-90-22.26

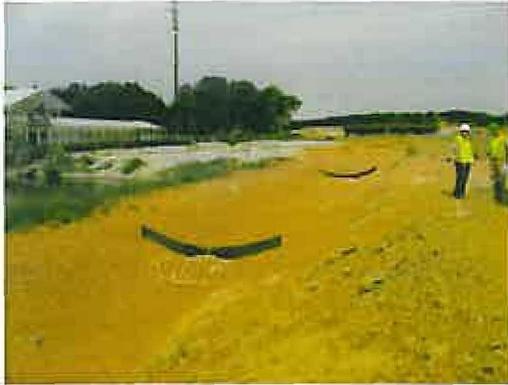
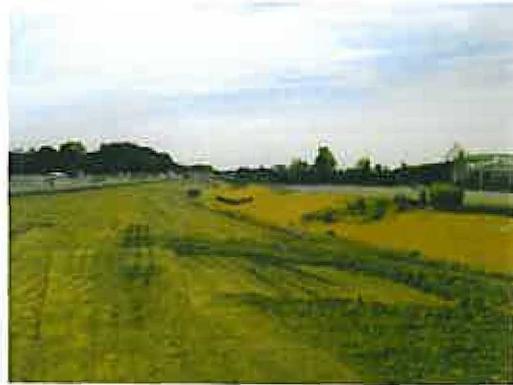
Figure 1 & 2: Ramp 1, Heider Ditch Drainage Area

1. Sediment ponds need to be installed within the drainage channels along Ramp 1 at their outlets to Heider Ditch at both the east and west sides of Heider Ditch. The drainage area is too large for just a silt fence and rock check dam.

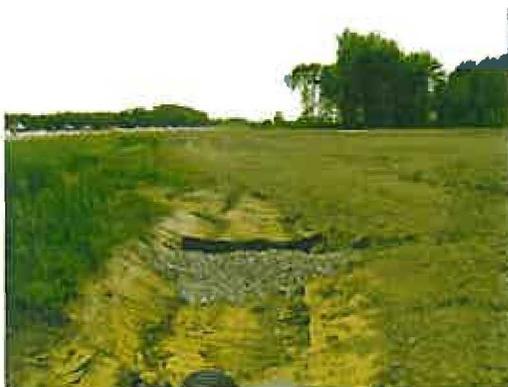
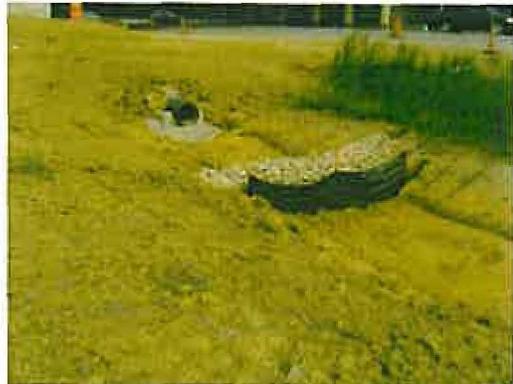
Figure 3 & 4: Ramp 1, east end at Nagle Road Structure

- a. Ramp 1 at the Nagle Road bridge abutment.
 - b. At the end of Ramp 2 at Heider Ditch.
 - c. At the ends of Ramp 3 and Nagle Road ditch before the culvert.

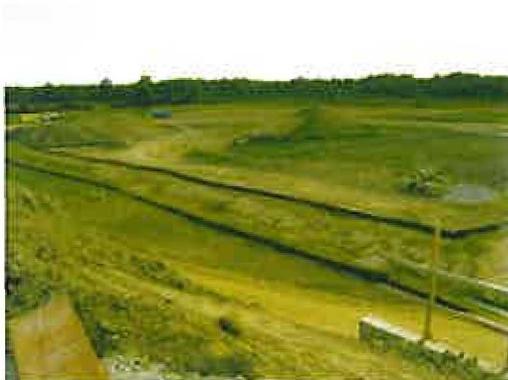
Figure 5: Ramp 3

- d. At the east end of Ramp 3 at the end of the acceleration lane at the culvert prior to the jurisdictional stream.
 - e. On each side of the jurisdictional stream on Avon Road

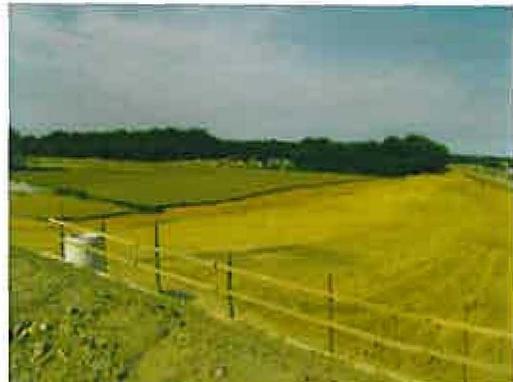
Figure 6: Ramp 4

2. Ramp 4 at Nagle Road Bridge needs a sediment pond. The drainage area is too large for existing silt fence. Drainage from the north side of the ramp breaks toward a drainage channel. Silt fence needs to be installed along the length of the drainage channel on the north side of the ramp.

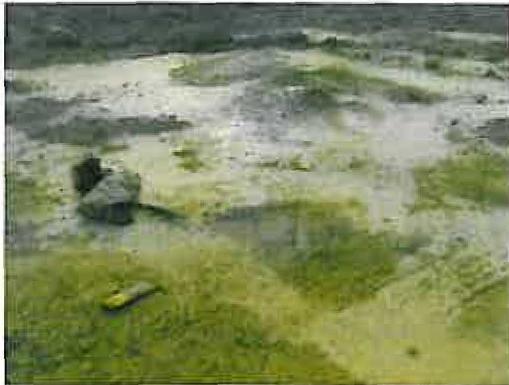
Figure 7: Current concrete washout pit, north side of Chester, west side of Nagle

- f. At DC-27, instead of the ditch check currently in place.
4. A concrete washout pit is needed. The trucks are just being washed out onto the ground right now.

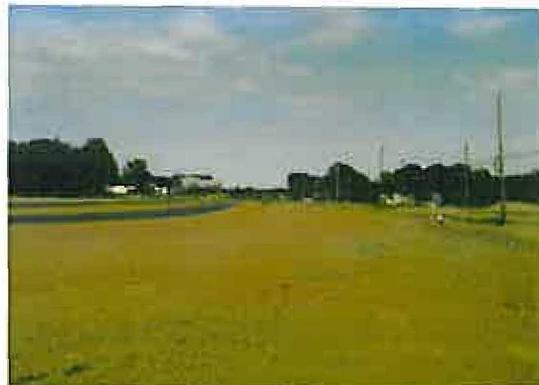
Figure 8: Temporary Road, looking East

9. A silt fence is needed at the northeast corner of Nagle Road and Just Imagine Drive along the temporary road.
10. Exfiltration trenches have been installed on Nagle Road north of the Cleveland Clinic Building for post-construction control. But, the top layer of permeable concrete does not appear to meet specifications. The concrete is not flush with the roadway surface and the aggregate is loose and not bound. These exfiltration trenches may need to be rebuilt before the project is accepted.

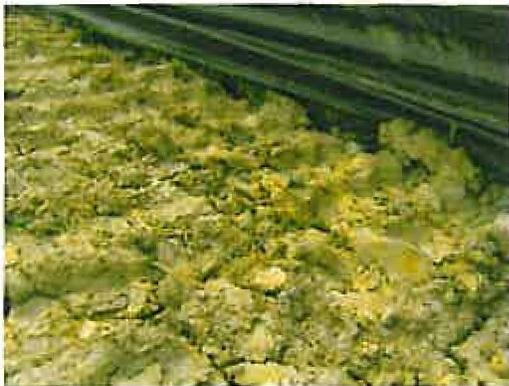
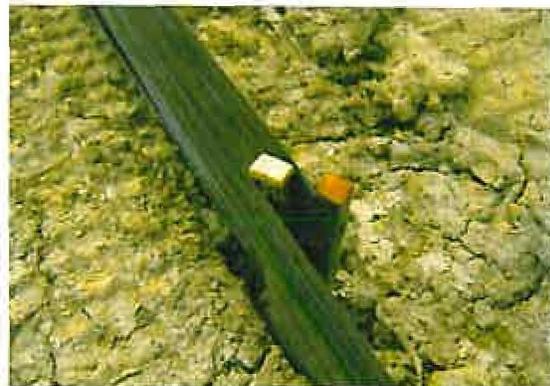
Figure 9 & 10: FF-1; gap underneath fence, gap between stakes

7. FF-1 on sheet 5 of the Storm Water Pollution Prevention Plan (SWP3) needs to be trenched and backfilled, since currently water can flow right under it. The stakes at the joints need to be twisted together as well.

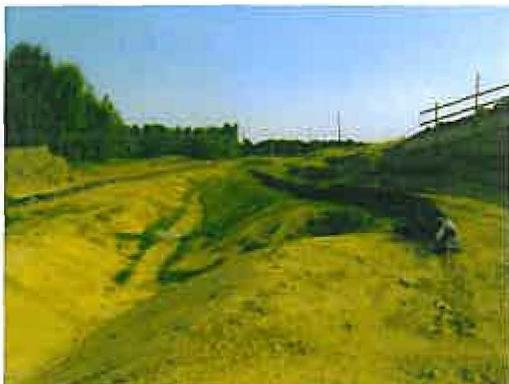
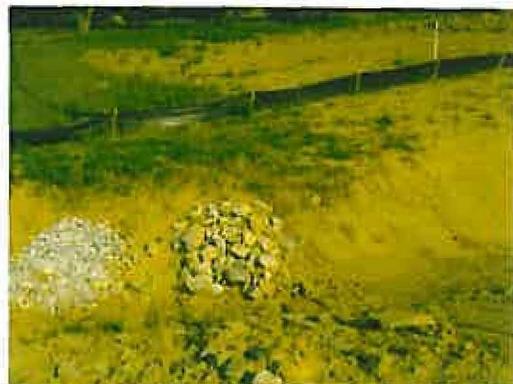
Figure 11 & 12: Ramp 1, east end at Nagle Road Structure

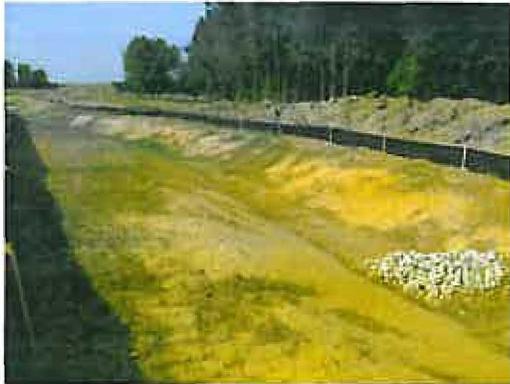
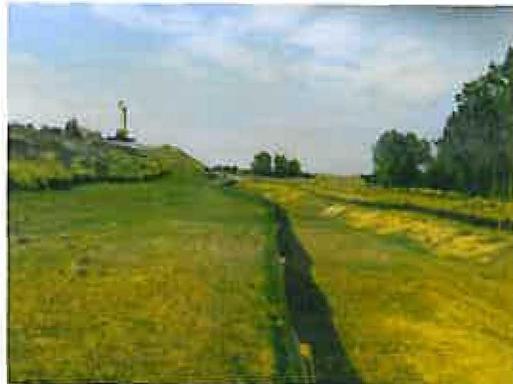
Figure 13 & 14: Ramp 1, east end at Nagle Road Structure

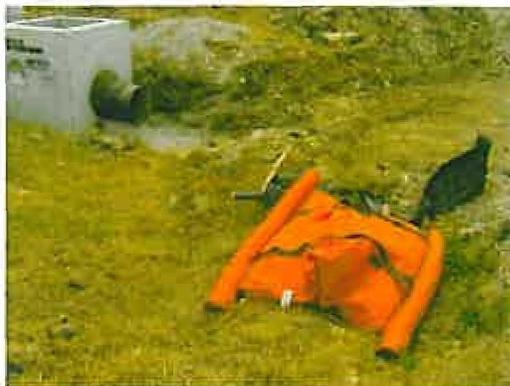
Figure 7: Two curb Beaver Dam inlet protections on IP-32

5. There needs to be inlet protection on IP-27, 29, 30, and 31 before they are in service. Dandy Bags have been used inappropriately to construct IP-32. Please replace with an appropriately constructed inlet protection.

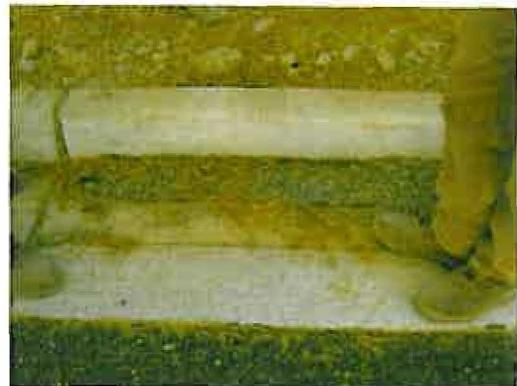
Figure 8: Exfiltration trench
