RE: CUYAHOGA COUNTY  
CITY OF CLEVELAND  
CLEVELAND STATE UNIVERSITY-  
NORTH CAMPUS DEVELOP  
CONSTRUCTION STORM WATER  
PERMIT NO: 3GC05695

**INSPECTION PHOTOS**

**Cleveland State University – North Campus Develop**

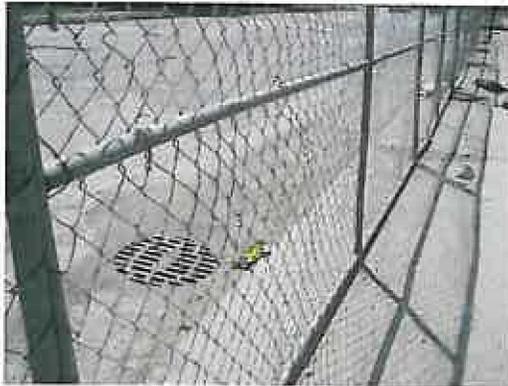
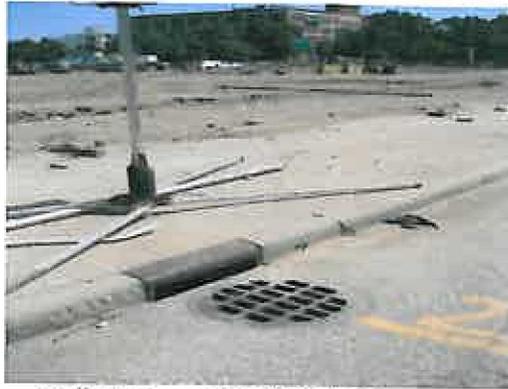
**Figures 1 & 2:** Offsite catch basins that have sediment running into them.

1. Soil should be kept on your site. A filter sock or other perimeter sediment control is suggested along sections of pavement near offsite catch basins.
2. This silt fence along the perimeter of the site should be maintained to avoid soils from running into the streets.
3. Clean up the dirt on sidewalk.
4. The concrete washout pit has a few holes. Consider replacing this liner. Also, the concrete was missing the pit when being dumped. Ensure all the concrete is making it into the pit at the time of washout.
