RE: CUYAHOGA COUNTY  
CITY OF MIDDLEBURG HEIGHTS  
SOUTHWEST GENERAL HEALTH CENTER  
CONSTRUCTION STORM WATER  
PERMIT NO: 3GC05873

On June 18, 2012, I performed a compliance inspection for storm water best management practices (BMPs) at the above referenced site. While on site, I met with the following representatives of The Albert M. Higley Co.: Don Cairns, Superintendent of the site, Eric Dey, Sr. Project Engineer, and Cameron Carris, Project Engineer. Our records indicate that Southwest General Health Center has obtained coverage under the Ohio EPA General Storm Water National Pollutant Discharge Elimination System (NPDES) Permit for Construction Activities #3GC05873\*AG.

**INSPECTION PHOTOS**

**Southwest General Health Center**

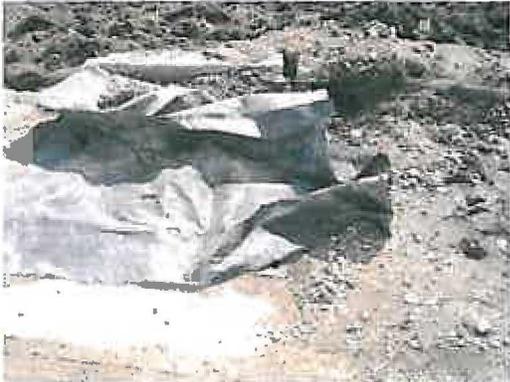
1. The catch basin in the southeast corner of the site has no inlet protection. This drains goes directly into the storm sewer. A dandy bag needs to be installed per SWP3.

**Figure 1:** Southeast corner catch basin with filter fabric covering it

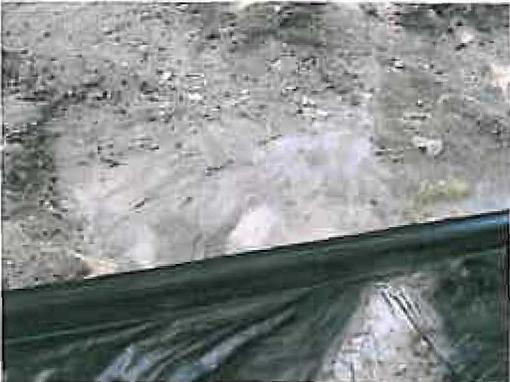
2. There are several holes in the silt fence, and places where runoff has cut underneath it. The fence needs to be maintained by repairing holes, twisting the joint stakes together prior to staking, and correctly trenching and backfilling.

**Figure 2:** Hole in the northeast silt fence

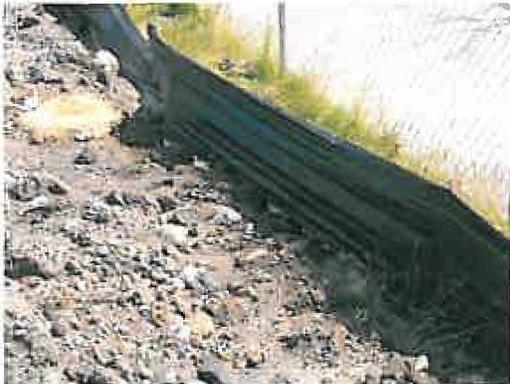
**Figure 3:** Silt fence not trenched and backfilled. Holes underneath

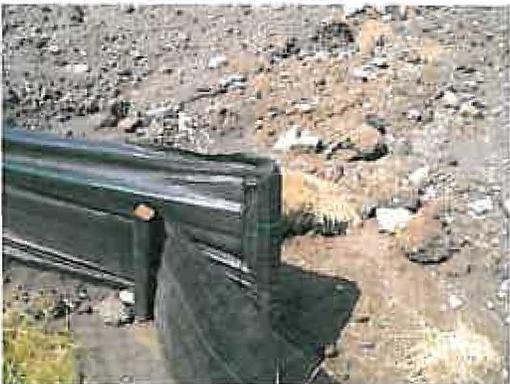
**Figure 4:** Joint stakes not twisted together

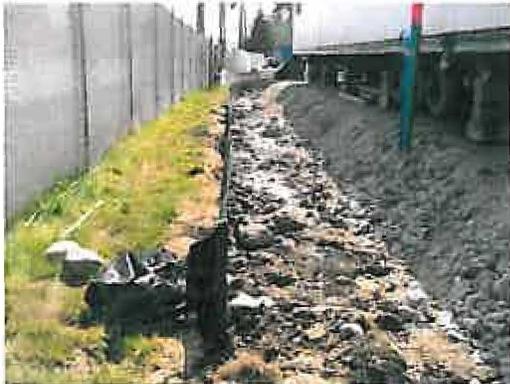
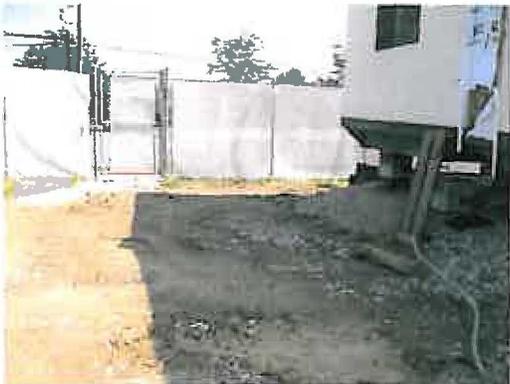
3. Silt fence was being used on the northeast side of the site, as well as on the north side along Bagley Road. The SWP3 showed a filter sock was going to be installed on the east side of the site. Although silt fence is an acceptable substitute for filter socks, the SWP3 needs to be amended to show the silt fence placement instead of the filter sock. The north side silt fence needs to be extended to the gravel to the west.

**Figures 5 & 6:** North silt fence. Needs to be extended to the gate/gravel to the west

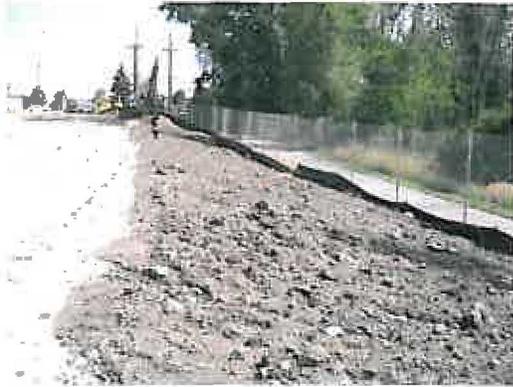
4. The east slope of the site has remained untouched for approximately a week, according to Eric Dey. Any disturbed soil that lies untouched for more than 21 days must be temporarily stabilized within seven days of last disturbance. The east slope is likely to meet these criteria. This slope needs to be seeded and mulched.

**Figure 7:** East side slope needs temporary stabilization  
**Figure 8:** Construction entrance needs redressing

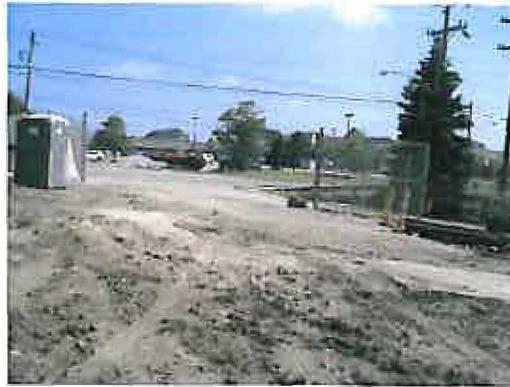
5. The rock construction entrance and on-site access road needs to be redressed with stone. The entrance in the southeast corner of the property is not shown on the SWP3 and must be added to the plan. The areas directly inside and outside of the entrances should be kept clean.
