RE: LAKE COUNTY  
CITY OF MENTOR  
DIAMOND BUSINESS PARK  
CONSTRUCTION STORM WATER  
PERMIT NO: 3GC05323

**NOTICE OF VIOLATION**

**INSPECTION PHOTOS**

**Diamond Business Park**

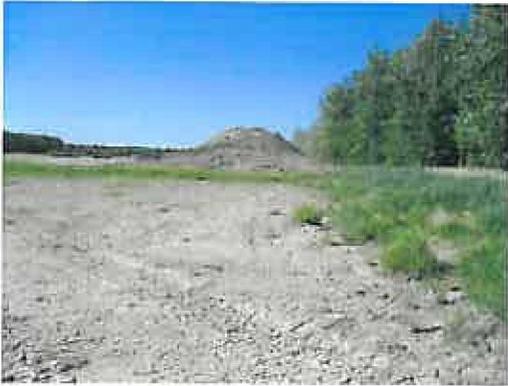
**Figure 1:** Sediment basin in the northwest corner of the property  
**Figure 2:** Outlet structure of the sediment basin

- 1. Failure to construct the sediment basin in compliance with required design standards.** This is a violation of Part III.G.2.d.ii of the NPDES permit and ORC 6111.04 and 6111.07. Since only one page of the SWP3 was on site, no calculations or details for the sediment basin were shown. Even without these, it was clear that this sediment pond was not designed or installed per the requirements of the NPDES permit. The outlet is out-of-date and was built incorrectly. Please note that the NPDES permit requires the outlet structure of sediment basins to provide a minimum 48-hour drain time for the dewatering volume. The rule-of-thumb design used on this site, i.e., a perforated riser pipe wrapped in geotextile, does not ensure the minimum drain time is met. Further, sediment ponds must provide an additional sediment storage volume equal to 1,000 cubic feet per acre of disturbed area below the invert of the dewatering structure. No sediment storage volume was evident in this basin. Please refer to the *Rainwater and Land Development* manual (Ohio Department of Natural Resources, 2006) for the required outlet designs and sediment pond calculations.

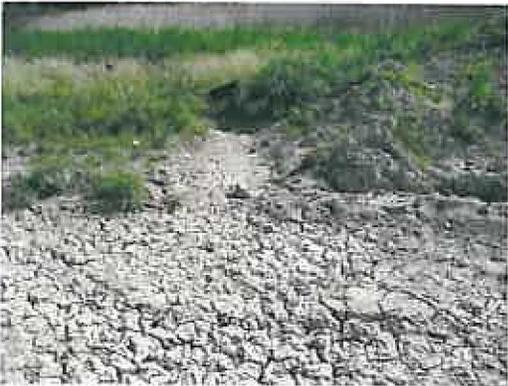
**Figure 3:** Northeast corner of the site. Water has been draining to this location  
**Figure 4:** Silt fence attempting to block the above flow to the wetlands

- 3. Failure to provide a sediment pond for concentrated flows of storm water runoff or where drainage areas exceed the design capacity of silt fence.** This is also a violation of Part III.G.2.d.ii of the NPDES permit and ORC 6111.04 and 6111.07. Water has been converging into the northeast corner of the property (Fig 3 & 4). Only a silt fence is there to pond the water. This silt fence is loose and water appears to flow over it. This flow goes directly into wetlands. A sediment trap is currently necessary in this location due to the size of the drainage area and concentrated nature of the runoff. Silt fence was also observed across several ditches where storm water flows concentrate (Fig 6 & 10).

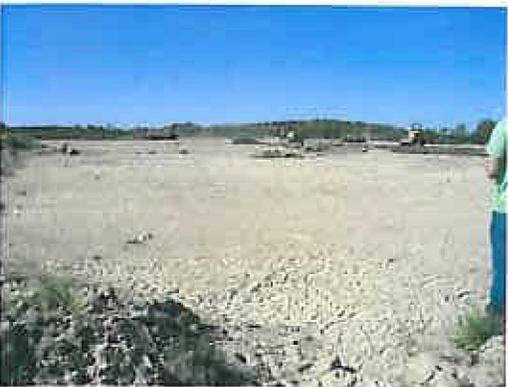
**Figure 5:** Northeast corner and drainage area to this location  
**Figure 6:** Southeast corner of Phase 1 site. Silt fence is falling down where water is flowing.

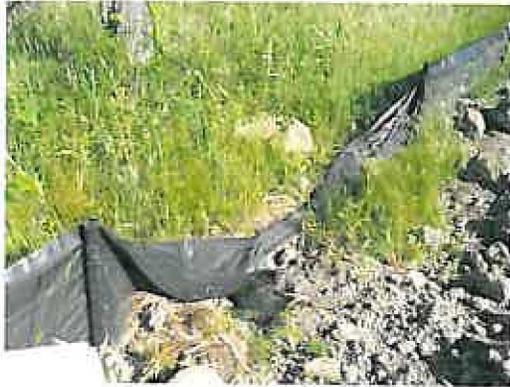
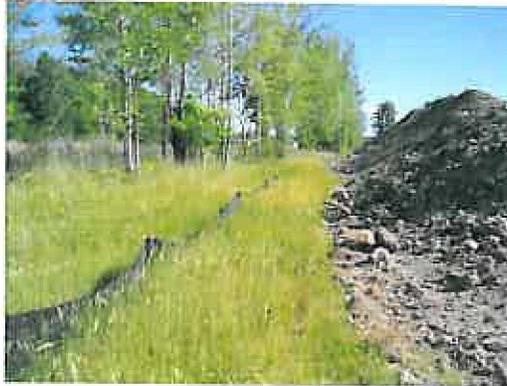
**Figures 7&8:** Silt fence has fallen down. Silt fence is loose.

- 4. Failure to maintain silt fence in a functional condition until the areas it controls have reached final stabilization.** This is a violation of Part III.G.2.h of the NPDES permit and ORC 6111.04 and 6111.07. The silt fence along the entire property has not been maintained. It sags and, in some places, it has fallen down. The joints where the two end stakes meet need to be twisted together prior to staking.

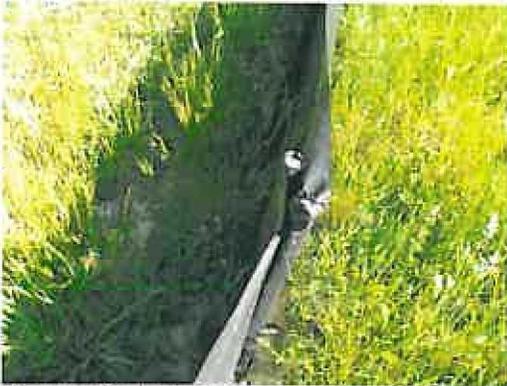
**Figure 9:** Joint stakes not twisted together

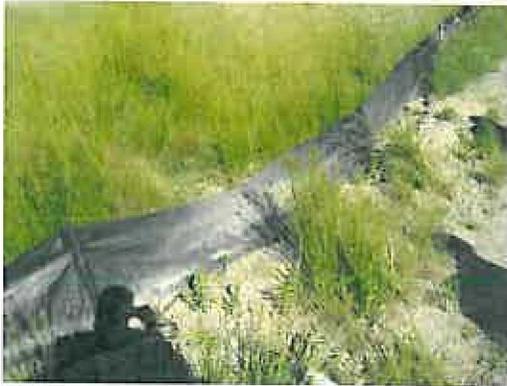
**Figure 10:** Silt fence trying to block a concentrated flow

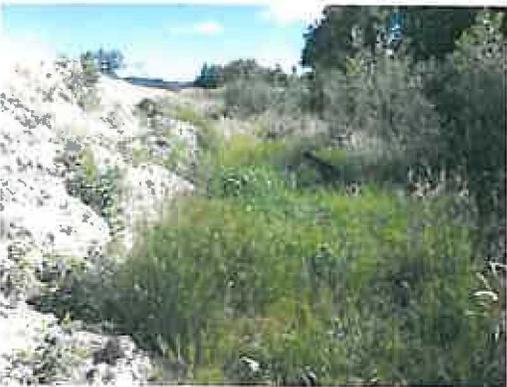
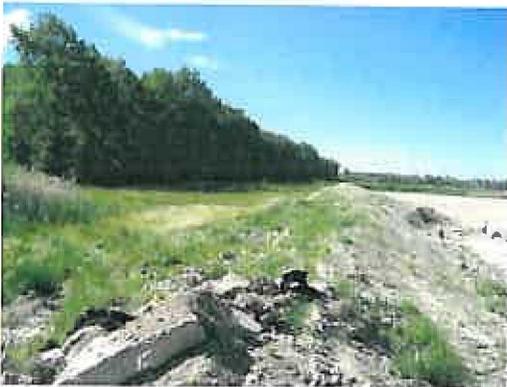
**Figures 11&12:** Overgrowth covering silt fence on east side of mound that has not been stabilized. Mound not shown in SWP3.

- 6. Failure to amend the SWP3 to reflect changes in design, construction, operation or maintenance.** This is a violation of Part III.D of the NPDES permit and ORC 6111.04 and 6111.07. The topsoil stockpile on the east side of the site and the BMPs for it are

not shown on the SWP3. An amendment to the plan needs to be made to accommodate the stockpile and control the runoff from it.

- 7. Failure to initiate temporary stabilization of disturbed areas within seven days of last disturbance if they are to remain idle for 21 days or longer.** This is a violation of Part III.G.2.b.i.Table 2 of the NPDES permit and ORC 6111.04 and 6111.07. The site should be reviewed on a weekly basis to determine which areas require temporary stabilization between construction operations. Areas requiring temporary stabilization must be seeded and mulched (or just mulched) to initiate stabilization. A log documenting grading and stabilization activities is required by Part III.G.1.m of the NPDES permit.

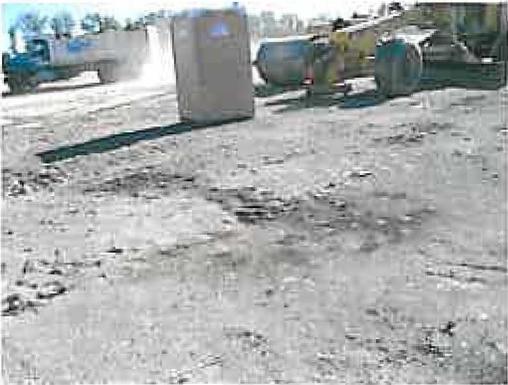
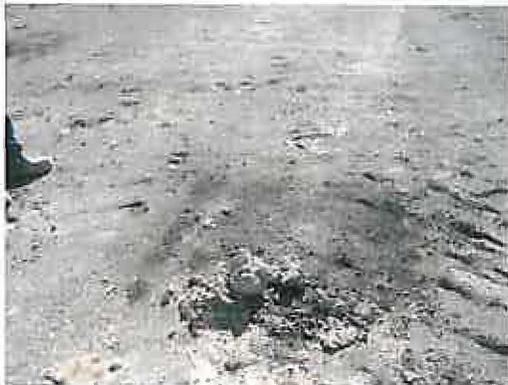
**Figures 13&14:** Contaminated soils near equipment parking.

- 5. Failure to implement non-sediment pollutant controls to control the discharge of hazardous materials.** This is a violation of Part III.G.2.g of the NPDES permit and ORC 6111.04 and 6111.07. Oil has spilled onto the ground. The contaminated soil needs to be excavated and disposed of properly. To prevent this from happening in the future, equipment should be repaired when needed and a drip pan should be placed under the leak to prevent soils from becoming contaminated.
