**Environmental
Protection Agency**

RE: CUYAHOGA COUNTY
CLEVELAND
INDUSTRIAL STORM WATER
WEST 3RD AGGREGATE FACILITY
PERMIT NO: 3GR01468

On July 10, 2012, this writer conducted an inspection of your facility, located at 2615 West 3rd Street, Cleveland, Ohio, to determine compliance with the Ohio EPA General Storm Water National Pollutant Discharge Elimination System (NPDES) permit for Industrial Activity. As a representative of West 3rd Aggregate Facility, Eric Sherrill, the plant manager, was present during the inspection. Along with my observations from the inspection, I have provided comments concerning your permit below:

INSPECTION PHOTOS
July 10, 2012
Cuyahoga County

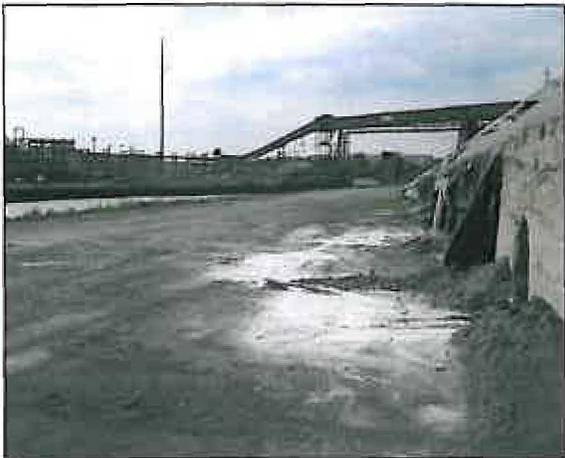
1. The rock salt stockpile, on the southeast of the property, is covered. There is evidence that salt is still seeping out and flowing east through a hole in the adjacent concrete wall and towards the river (Figure 1). Provide a berm, around the opening in the concrete wall, east of the wall. A berm will allow the water to pond and the sediment and other pollutants can settle. The salt will be contained inside the berm. Implement routine inspections of the berm and periodically clean out the pollutants inside the berm and properly dispose of the waste.

Figure 1
Salt tracking out of opening in concrete wall.

- Berm the aforementioned area so to contain salt seepage.
- Cover dumpsters with lids or tarps.
- Cover small salt pile on northeast corner of property.
- Install silt fence along the Cuyahoga River for sediment control.
- Make aforementioned improvements to SWPPP.

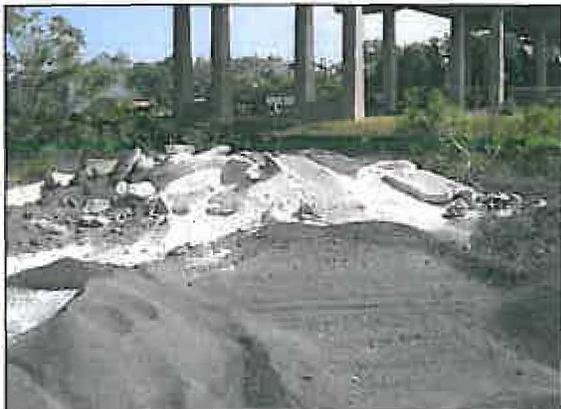
2. The waste dumpster was left uncovered. The dumpster must be covered to prevent the collection of storm water and the formation of leachates.
3. A small salt pile on the northeast corner of the property is uncovered (Figure 2). The salt pile must be covered to prevent exposure to storm water.

Figure 2
Uncovered Salt Pile

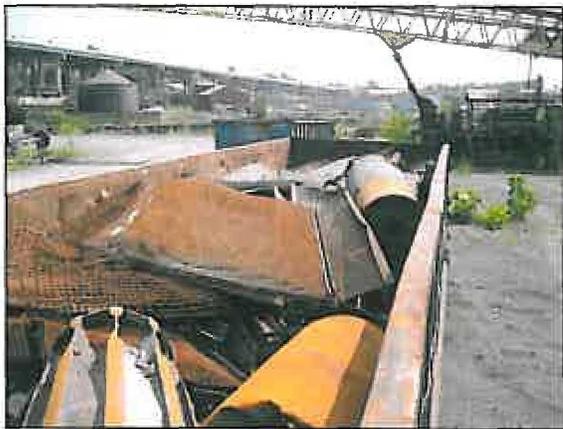
4. The metal scrap dumpster was uncovered (Figure 3). There was a few old oil drums inside that may still have oil in them. The dumpster must be covered with a lid or tarp to prevent the collection of storm water and the formation of leachates.

Figure 3
Uncovered Scrap Dumpster

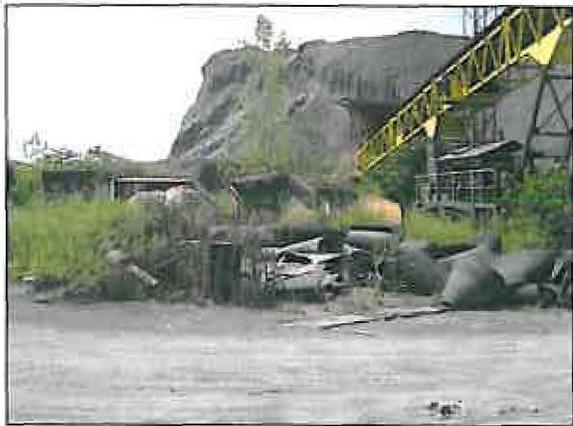
5. In the area around the scrap dumpster, various material is being stored outside (Figure 4). For good housekeeping purposes, if the facility does not plan on using any of this material, properly dispose of the material as soon as possible.

Figure 4
Material being stored outside

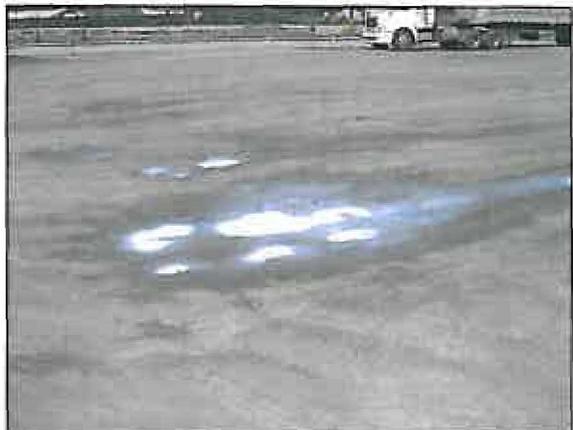
6. There is a lot of loose dust and sediment throughout the facility. When it rains, the sheet flow will pick up loose sediment and flow into the river. Install a silt fence along the river so to protect the river from sediment pollution.
7. The facility sprays a milky white liquid for dust control (Figure 5). We ask that you specify exactly what kind of material you are spraying for dust control, from what company you are purchasing this material, and any test data that has been recorded on this material.

Figure 5 Liquid material for dust control.
