RE: LORAIN COUNTY
CITY OF AVON
RICHARD E JACOBS FAMILY HEALTH CENTER
CONSTRUCTION STORM WATER
PERMIT NO: 3GC04676

On July 2, 2012, I performed a compliance inspection for storm water best management practices (BMPs) at the above referenced site. I was accompanied by Rob Knopf, Engineer for the City of Avon; and Tom Hardwick, Inspector with Bramhall Engineering and Surveying Company. Our records indicate that the Cleveland Clinic Office of Construction has obtained coverage under the Ohio EPA General Storm Water National Pollutant Discharge Elimination System (NPDES) Permit for Construction Activities #3GC04676*AG.

INSPECTION PHOTOS
Richard E Jacobs Family Health Center

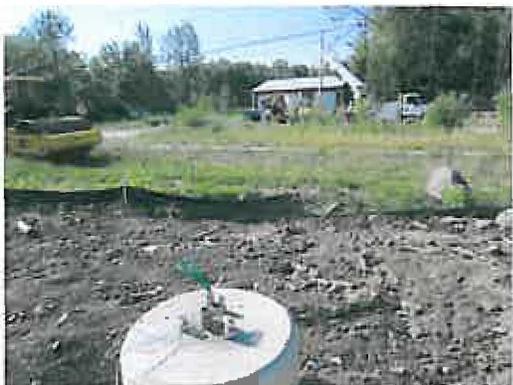
Figure 1: Silt fence has fallen down

1. Silt fence must be maintained throughout construction. There are several locations where the silt fence has fallen down. Also, the joint stakes of the fence must be twisted together prior to staking. Dirt must be kept away from the silt fence to create a buffer where water can pond. Please retighten the silt fence, fix the joints, and pull the dirt away from the fence.

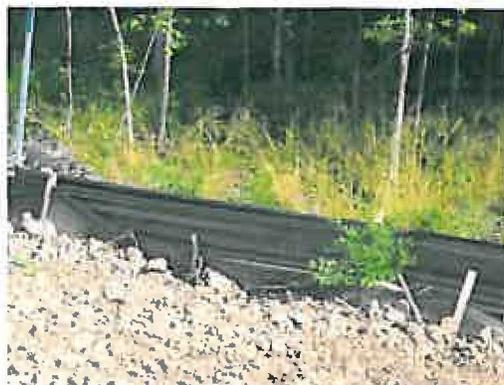
Figure 2: Joint stakes not twisted together prior to staking

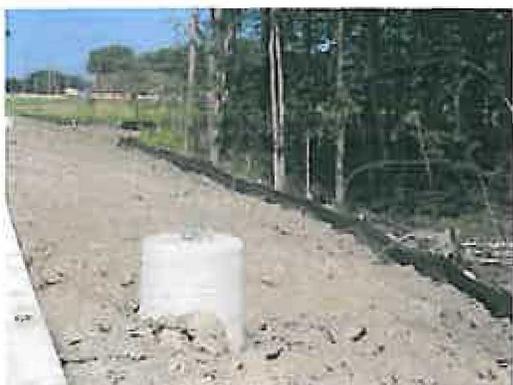
Figure 3: Dirt pushed up against silt fence. Area where temporary stabilization may need to occur

2. If areas disturbed by construction activity will not be reworked within 21 days of the last date they were disturbed, the NPDES permit requires temporary stabilization to be initiated within 7 days of last disturbance. There appear to be areas of the site where temporary stabilization is appropriate; where dirt is up against the silt fence is one location where it may be necessary.

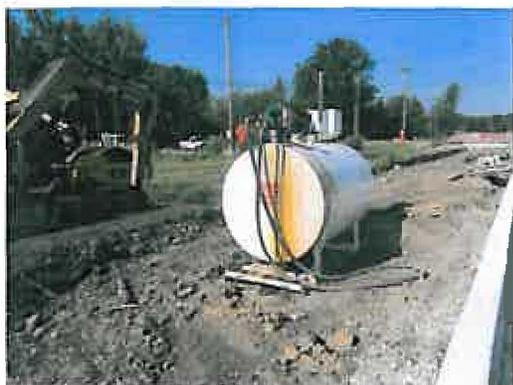
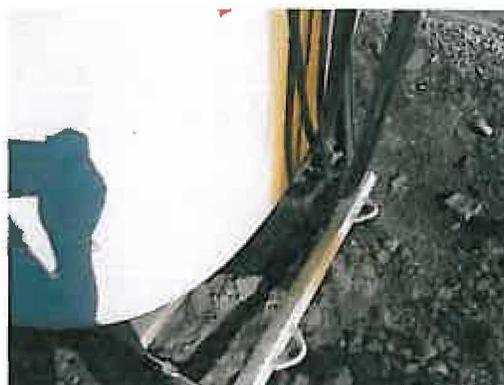
3. There is a fuel storage tank on site that is double walled. There was spilled oil on the ground where the nozzle is located. Contaminated soil must be disposed of immediately

Figures 4&5: Fuel containment with an oil spill under the hose nozzle.

into a solid waste dumpster. If the leaking continues, a drip pan should be placed underneath this area, or repairs to the container need to occur.

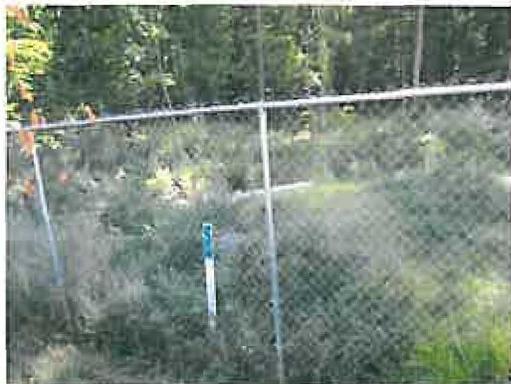
Figure 6: Fence blocking access to outlet of retention pond.

4. The retention basin is installed and is functioning properly. However, access to the point of discharge to the stream was not apparent. As part of the NPDES permit, post-construction BMPs must be up-kept throughout its lifetime. Access to this point of discharge is necessary to comply with the obligations of the NPDES permit.
5. There is trash in the retention basin. This area, as well as the area of construction, should be kept clean and free of debris. Please dispose of this trash properly.

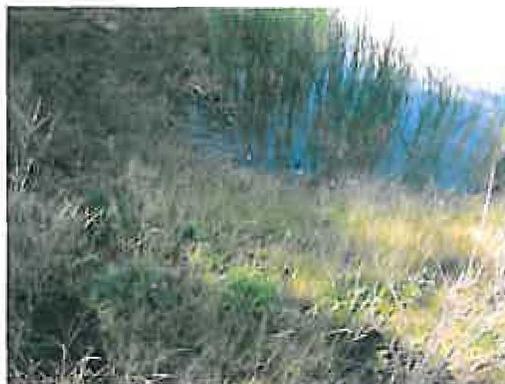
Figure 7: Trash in retention pond.
