RE: LORAIN COUNTY
CITY OF AVON
JUST IMAGINE DRIVE
CONSTRUCTION STORM WATER
PERMIT No: 3GC05742

INSPECTION PHOTOS
Just Imagine Drive

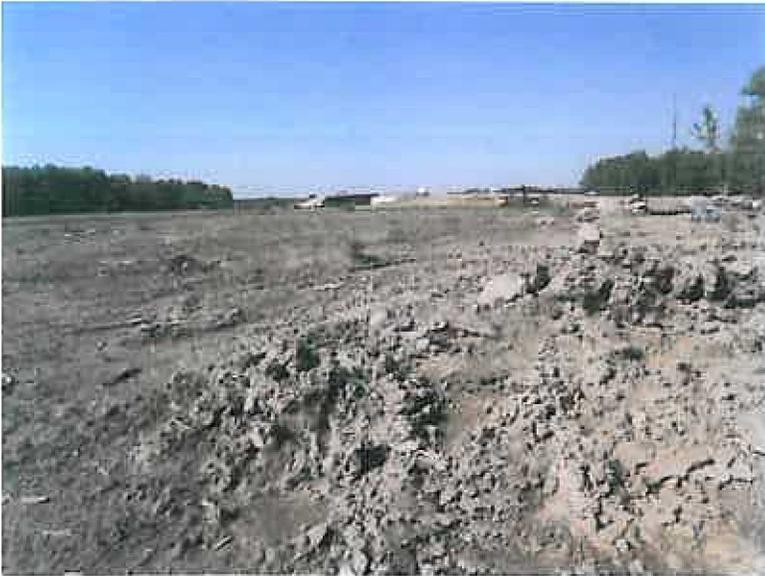
1. Most of the area has reached 70% growth density, but there are several locations where seeding and mulching needs to take place. This site has not been disturbed for more than 21 days. The NPDES permit requires temporary stabilization to be initiated within seven days of last disturbance.
2. There is a pile of trash and debris on the site. This needs to be cleaned up and disposed of properly.

Figure 1: Bare soil that needs to be seeded and mulched

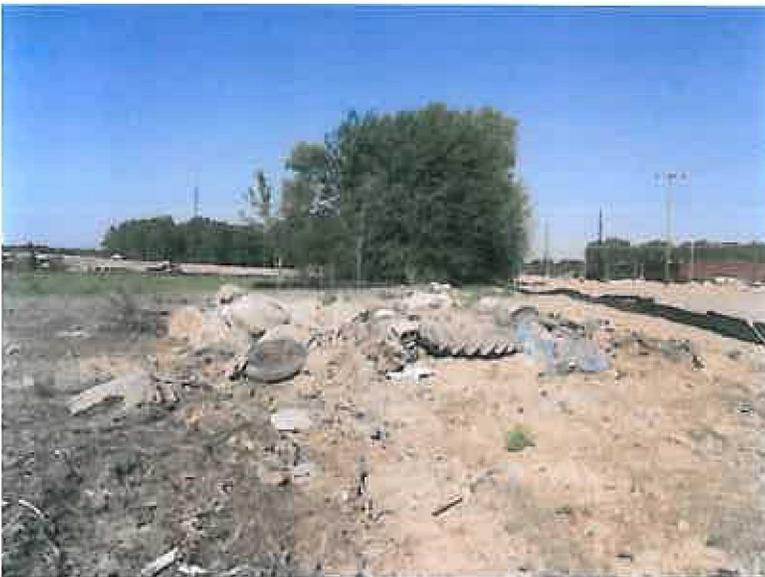
Figure 2: Trash and debris pile
