RE: CUYAHOGA COUNTY  
VILLAGE OF HUNTING VALLEY  
UNIVERSITY SCHOOL -  
THE HUNTING VALLEY CAMPUS  
CONSTRUCTION STORM WATER  
PERMIT NO: 3GC05346

**INSPECTION PHOTOS**

**University School – The Hunting Valley Campus**

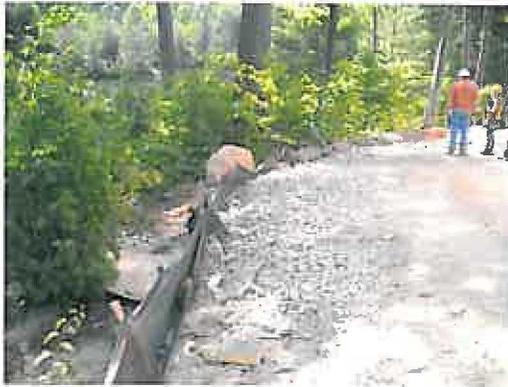
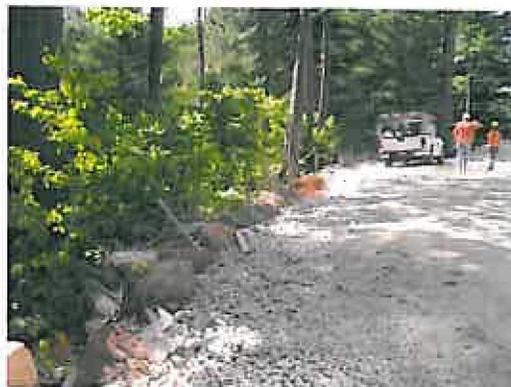
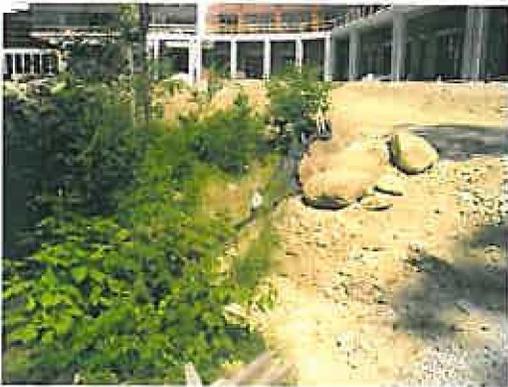
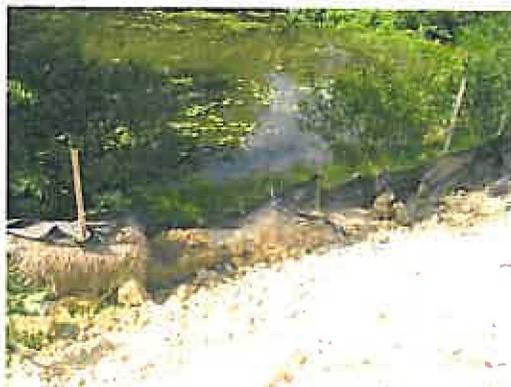
**Figures 1-4: Silt fence in disrepair. Covered in dirt or rocks.**

1. Areas of silt fence have fallen down and been covered in soil. I noted that the soil was being pulled back away from the fence during my visit, but the fence needs to be repaired and replaced where it has been knocked down. In addition, the joint stakes of the silt fence must be twisted together prior to staking.

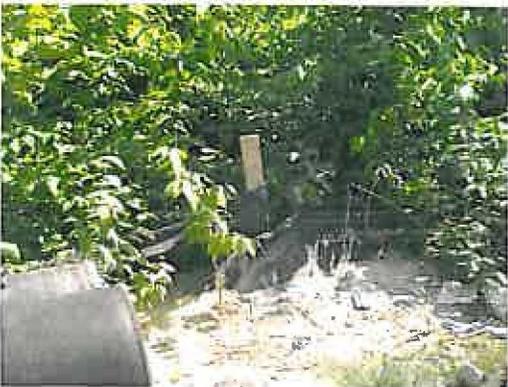
**Figure 5: Joint stakes of the silt fence not twisted together.**

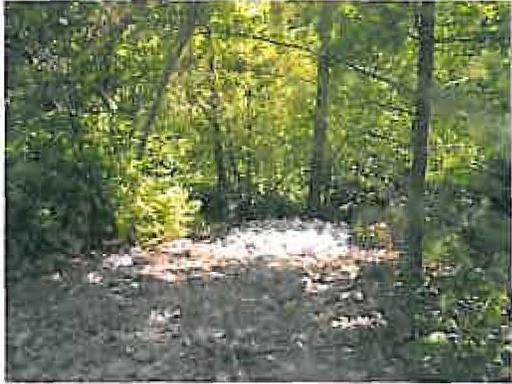
**Figure 6:** Rock outlet protection for the bioretention swale.

2. The outfall from the basin does not appear to be long enough. The rock outfall may need to be extended. See the enclosed specification for rock outlet protection from *Rainwater and Land Development, Ohio's Standards for Stormwater Management, Land Development and Urban Stream Protection* (Ohio Department of Natural Resources, 2006, for proper construction of inlet protection within paved areas).

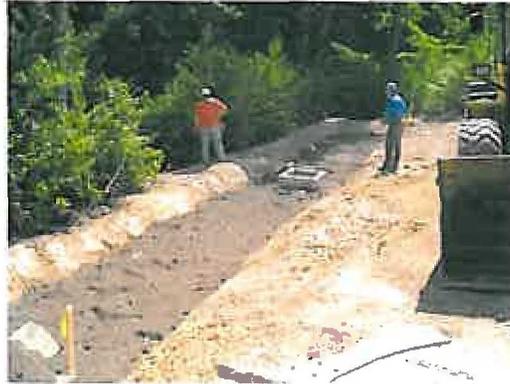
**Figure 7:** Location where temporary or permanent stabilization should take place.

3. If areas disturbed by construction activity will not be reworked within 21 days of the last date they were disturbed, the NPDES permit requires temporary stabilization to be initiated within seven days of last disturbance. The outfall sides of the bioretention swales should either be temporarily or permanently seeded within seven days; if it is within 50 feet of the lake on site, it must be stabilized within two days.

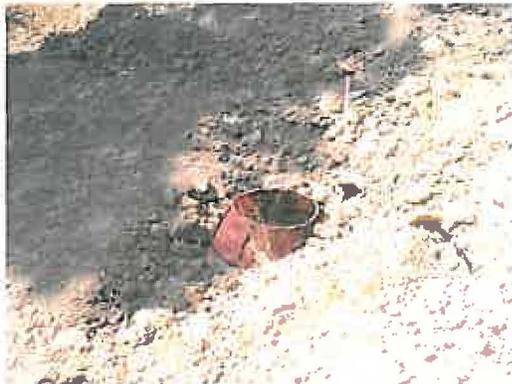
**Figure 8:** Catch basin inlet protection

4. The type of inlet protection being used on the catch basins is not shown in the Storm Water Pollution Prevention Plan (SWP3). Anything on the site must be shown on the SWP3, just as anything in the SWP3 must be found on the site. The SWP3 is a living document and should be amended as need. Please add the specific type of inlet protection to the SWP3 and delete items not being used.
