RE: LAKE COUNTY  
EASTLAKE  
INDUSTRIAL STORM WATER  
SIMA MARINE SALES INC  
PERMIT NO: 3GRM00002

**NOTICE OF VIOLATION**

INSPECTION PHOTOS  
July 24, 2012  
Lake County

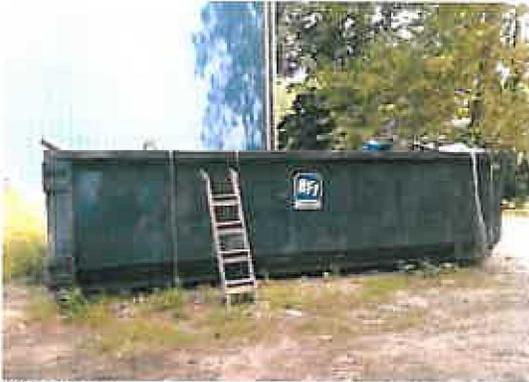
- b. From the 2011 inspection, Sima Marine was directed to cover the general trash dumpster located behind Building 3. During the follow-up inspection, the

dumpster was uncovered (Figure 1). This dumpster must be kept covered with a lid or tarp to prevent the collection of storm water and the formation of leachates.

Figure 1  
General trash dumpster uncovered

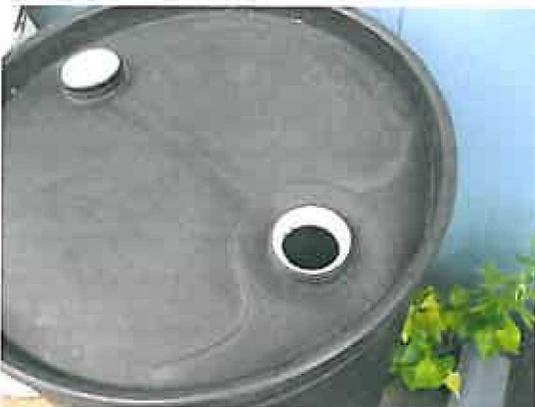
- c. In the oil area, drums containing antifreeze were lined along Building 2. Two of the drums were uncapped (Figure 2). The drums must be capped at all times, unless in the process of being loaded or unloaded. If you are loading or unloading antifreeze into these drums, they must be held under secondary containment or inside a building with no storm water floor drains.

Figure 2  
Uncapped antifreeze drum.

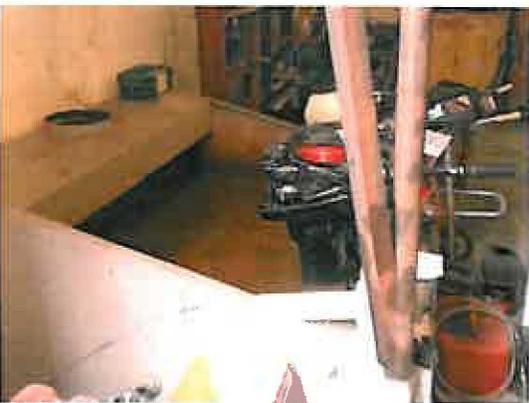
4. **Failure to eliminate all unauthorized discharges.** This is a violation of Part I.C.4 of the NPDES permit and ORC 6111.04 and 6111.07. The outboard test tank, located in Building 3, contains water along with oils from boat motors and floating rust particulate from the rusting steel tank (Figure 3). Sima Marine indicated that when the tank is cleaned out, the floating solids are filtered out and the rest of the water is discharged outside of the building. There may still be pollutants, such as motor oil, gasoline and antifreeze, in the water. This discharge is not authorized under this permit and must be covered under a different NPDES permit or eliminated. This discharge can be eliminated by disposing it into a holding tank.

Figure 3  
Outboard Test Tank

Please contact Marie Underwood, of the Ohio EPA Division of Surface Water, for further information on how to properly dispose of the contaminated water. You can contact Marie by phone at (330) 963-1185 or by email at [marie.underwood@epa.state.oh.us](mailto:marie.underwood@epa.state.oh.us).

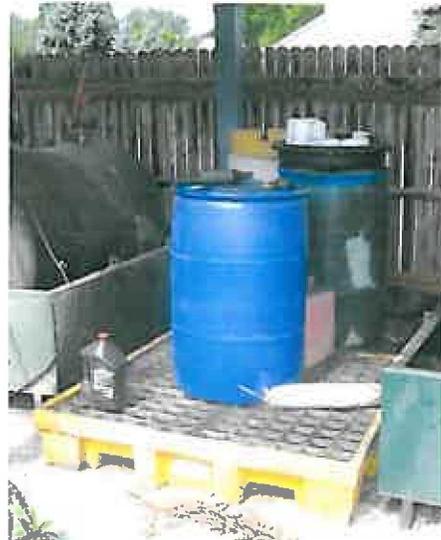
1. In the oil area, next to Building 2, a blue used oil drum is held under secondary containment (Figure 4). The drum must be correctly labeled "Used Oil".
2. Fill has been placed at the base of the wooded area, downhill from the showroom (Figure 5). Vegetation must be planted on the loose soil as soon as possible to prevent erosion and sedimentation.
3. Spill kits should be available in the Showroom and in Building 1. A few oil leaks were spotted leaking from boat motors. Frequently check for motor leaks. When discovered, place a drip pan under the leak and properly clean and dispose of the leaked oil.
4. The fork lift vehicle in Building 1 was leaking oil. The oil must be properly cleaned up and disposed of immediately. A drip pan must be provided as soon as the leak is discovered. The vehicle must be repaired as soon as possible to stop it leaking.

Figure 4  
Unlabeled used oil drum.

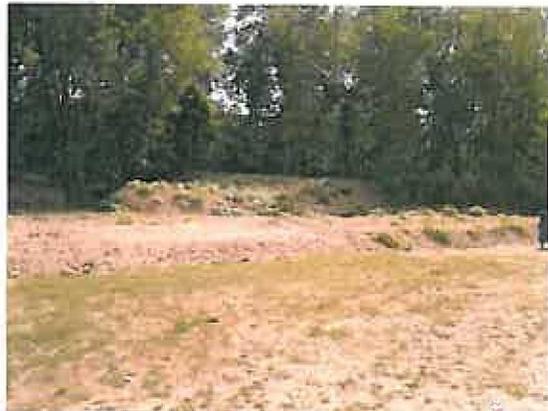
Figure 5  
Area filled with soil.
