RE: CUYAHOGA COUNTY
MAYFIELD VILLAGE
MAYFIELD HIGH SCHOOL
CONSTRUCTION STORM WATER
PERMIT NO: 3GC05697

NOTICE OF VIOLATION

INSPECTION PHOTOS

Mayfield High School

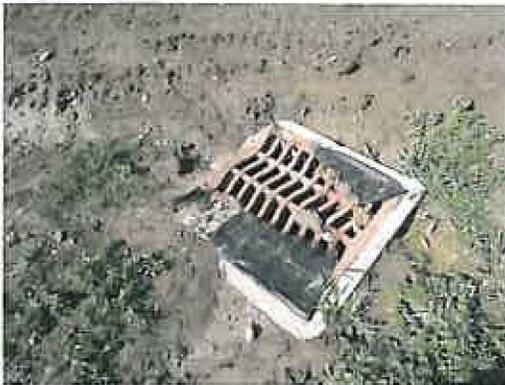
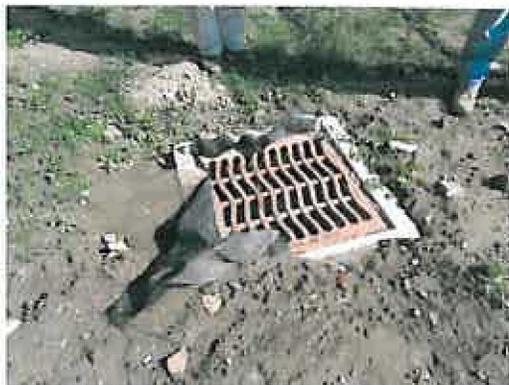
Figures 1&2: Catch basins around baseball field

1. **Failure to maintain or install a sediment control as noted in a previous inspection.**
This is a violation of Part III.G.2.i.i of the NPDES permit. The catch basins around the baseball field have failing inlet protection. The inlet protection is not the type specified in the SWP3. Please install proper inlet protection.
2. If areas disturbed by construction activity will not be reworked within 21 days of the last date they were disturbed, the NPDES permit requires temporary stabilization to be initiated within seven days of last disturbance. There appear to be areas of the site where temporary stabilization is appropriate.

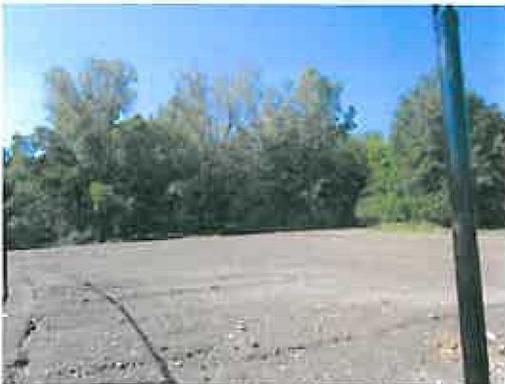
Figure 3: Area to the right of the home bleachers of the football stadium
