RE: PORTAGE COUNTY
BRIMFIELD TWP.
CONSTRUCTION STORM WATER
DISTRIBUTION WAREHOUSE FACILITY
PERMIT NO: 3GC05848

NOTICE OF VIOLATION

DISTRIBUTION WAREHOUSE FACILITY
Brimfield Twp. Portage County
Insite Real Estate Investment Properties LLC

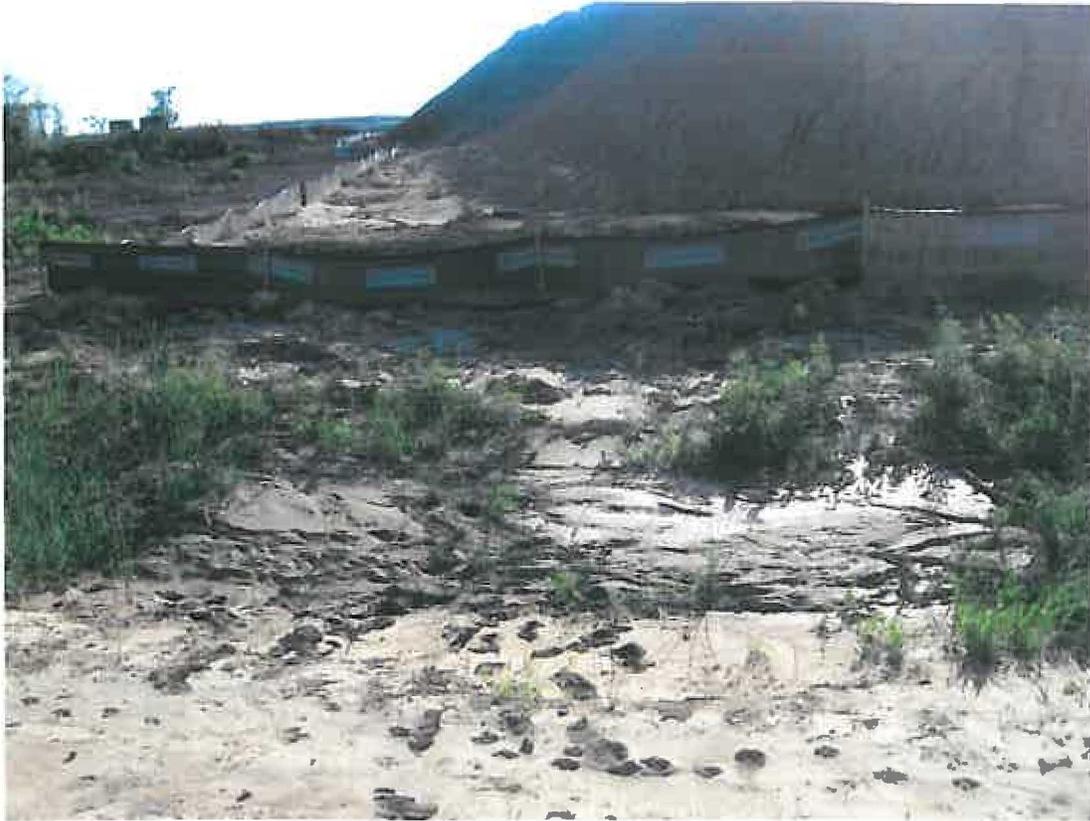
Fig 1. A significant soil stockpile has been established in the NE corner of the site. Runoff from this stockpile has filled the ditch along Crystal Parkway with sediment.

- **Failure to amend the SWP3 to reflect changes in design, construction, operation or maintenance which have a significant effect on the potential for the discharge of pollutants to surface waters of the State.** This is a violation of Part III.D of the NPDES permit and ORC 6111.04 and 6111.07. A significant soil stockpile area has been created on the NE corner of the property, yet it is not reflected on the SWP3. In addition, the mound in the SW corner of the site has been extended beyond what is

indicated on the SWP3. The SWP3 must be amended to show the location of the stockpile and the BMPs required to adequately control it.

- **Soil Stockpile Area.** Although silt fence was installed near the base of the stockpile, the municipal separate storm sewer system (drainage ditch) along Crystal Parkway was filled with sediment. Storm water runoff from the stockpile must be collected and diverted through a sediment trap or sediment basin prior to discharge from the site.

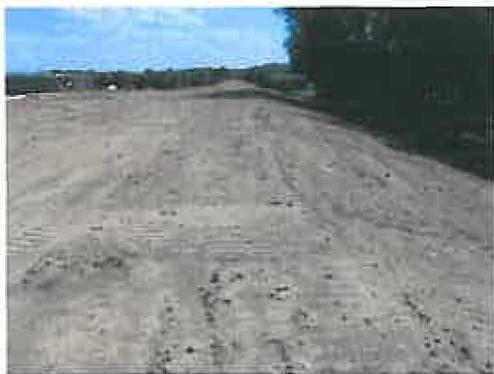
Fig 2 (LEFT). West perimeter of site. Disturbed areas that will lie dormant for 21 days or longer must be temporarily stabilized between construction operations.

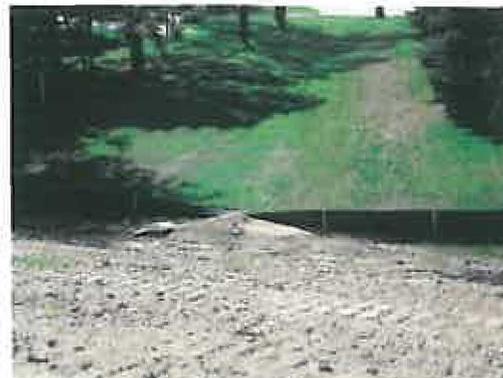
Fig 3 (RIGHT). Sediment overtops silt fence along the west perimeter with evidence of off-site deposition beyond.

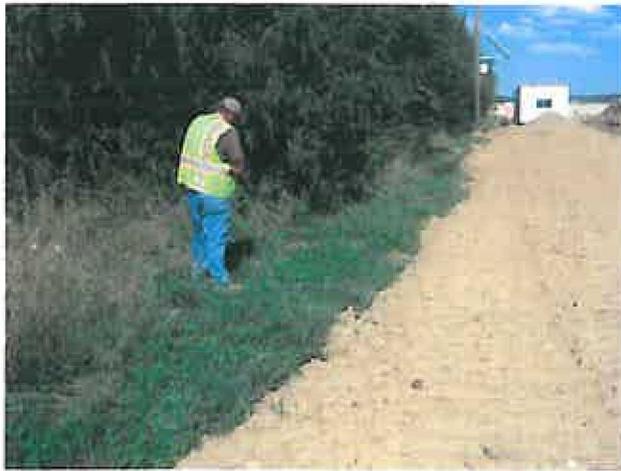
Fig 4 (LEFT). There are no perimeter sediment controls in place to address the north site perimeter west of the construction trailer. This area is sloped off site onto adjacent properties. Silt fence, filter socks or filter berms must be installed.

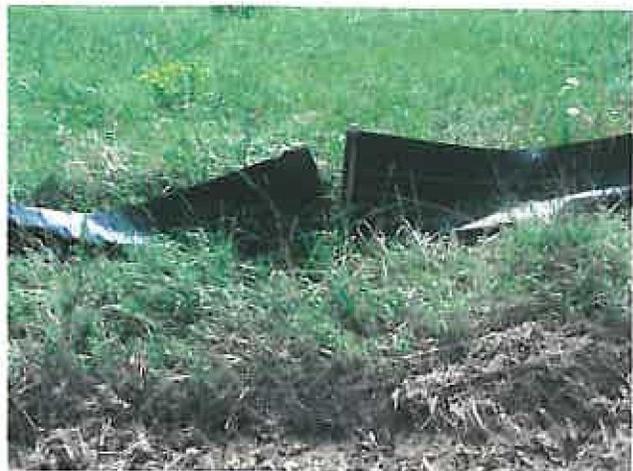
Fig 5 (RIGHT). Silt fence has not been installed correctly. Where two pieces of the silt fence come together, the end stakes must be twisted together prior to staking to ensure a watertight connection.

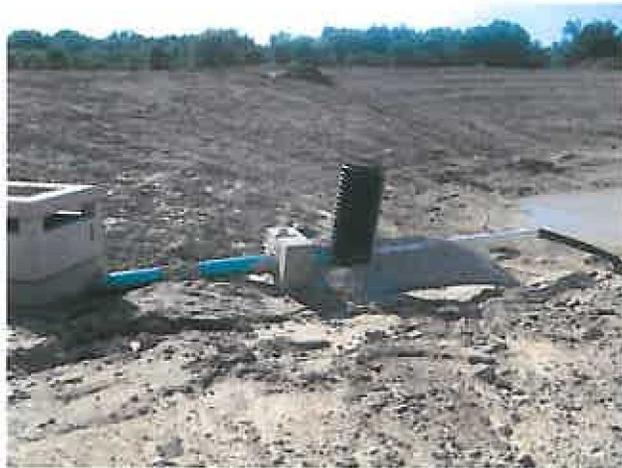
Fig 6 (LEFT). The temporary outlet structure of the West Basin may not be providing sufficient dewatering volume. The elevation difference between the skimmer invert and side window of the permanent outlet structure is less than 4.5 feet. Further, the basin embankments have not been seeded and mulched.

- **West Basin.** Although installed, this sediment basin has not been installed per the approved SWP3. Please review elevations and the construction of the temporary outlet structure to ensure that you are providing the required dewatering volume and minimum dewatering time. The approved SWP3 indicates that there should be 4.5 feet of elevation difference between the invert of the skimmer stub and the next higher point of discharge from the pond to store the dewatering volume. It appears that only three feet has been provided. In addition, the 3-inch dewatering orifice has not been installed on the skimmer device. This orifice size is required to ensure a minimum dewatering time of 48 hours.

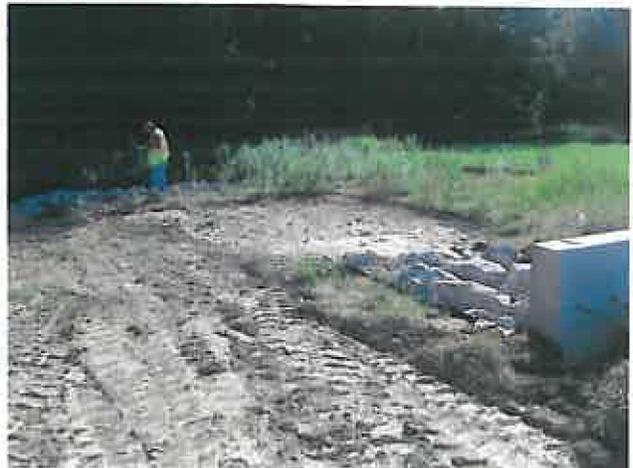
Fig 7 (RIGHT). The level spreader at the discharge of the West Basin has not been installed per the approved plan.

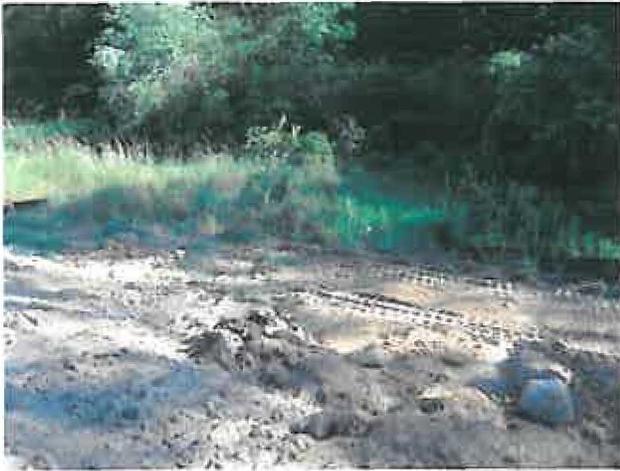
Fig 8 (LEFT). There is a gap in the silt fence along the south perimeter that allows untreated runoff to discharge off-site. Silt fence must be installed across this gap to close it.

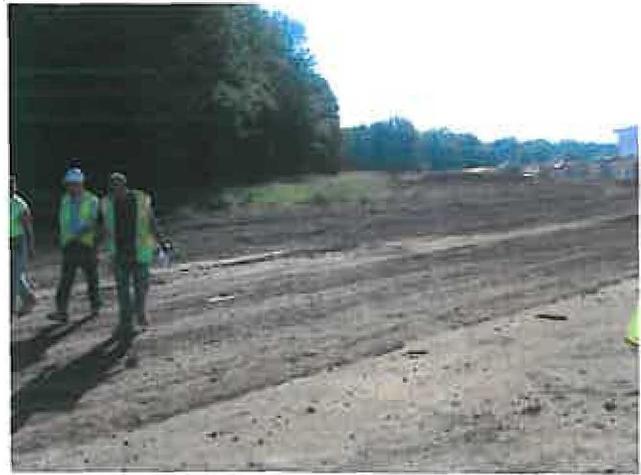
Fig 9 (RIGHT). Silt fence must be extended to the east along the area disturbed to extend Progress Blvd.

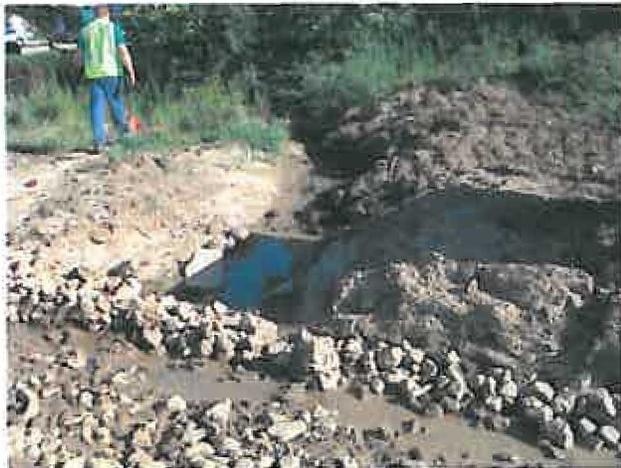
Fig 10 (LEFT). Swale near the Progress Blvd entrance drains sediment-laden runoff off site. There is no sediment control in place.

- **Site Entrance off Progress Blvd.** Storm water from the area disturbed to extend Progress Blvd flows toward the site entrance off Progress Blvd. A swale has been cut to drain runoff off-site. No sediment control has been provided. A sediment trap should be established to control runoff before it discharges from the site.

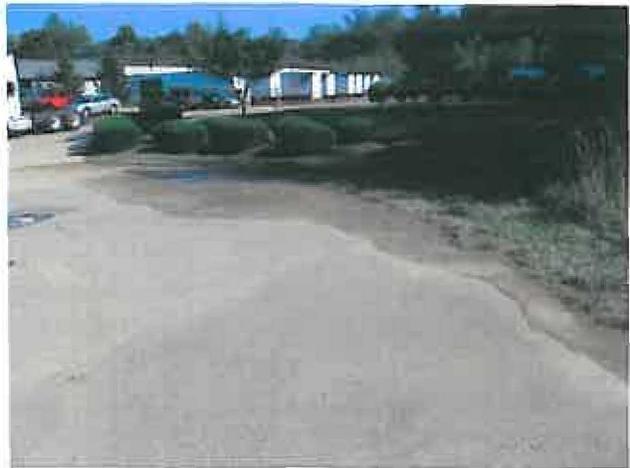
Fig 11 (RIGHT). Sediment has deposited on existing Progress Blvd at the construction site entrance.

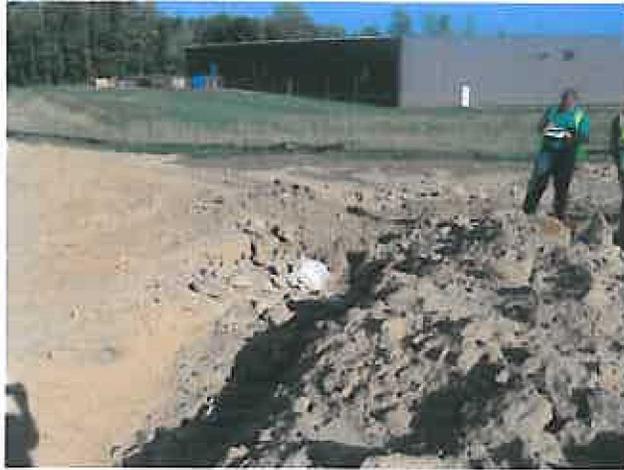
Fig 12 (LEFT). A diversion near Reduction Engineering is directing concentrated runoff toward the silt fence. Silt fence cannot control concentrated flows of runoff.

- **East Side of Site north and near Reduction Engineering.** Although silt fence has been installed along the perimeter of the disturbed area per the SWP3, site grading is such that the drainage area directed to the silt fence exceeds the capacity of silt fence allowed by Part III.G.2.d.iii of the NPDES permit. Sediment was observed overtopping the silt fence west of Reduction Engineering. Either site grading should be amended to limit the area draining to the silt fence and maximize the area draining to the East Sediment Basin or additional sediment ponds must be installed to control runoff and protect adjacent wetlands. Eliminate the diversion cut to drain disturbed areas toward the silt fence near Reduction Engineering.

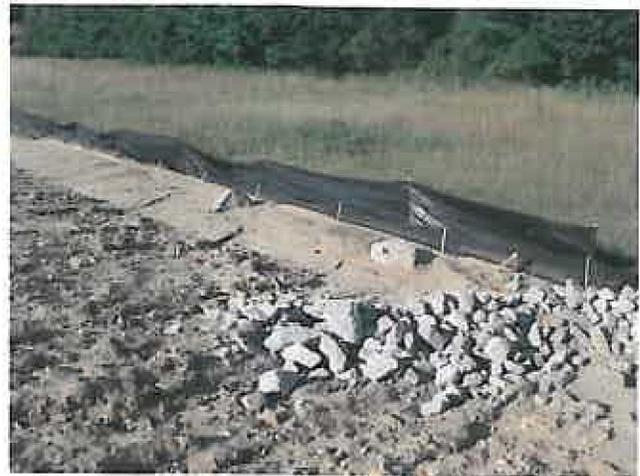
Fig 13 (RIGHT). A second line of silt fence has been erected to address the sediment build up on the existing silt fence along the eastern site perimeter. However, the second line of silt fence has not been trenched in and backfilled as required for proper installation. Further, additional sediment ponds should be considered as the drainage area directed to the silt fence appears to exceed the limits contained in the NPDES permit.

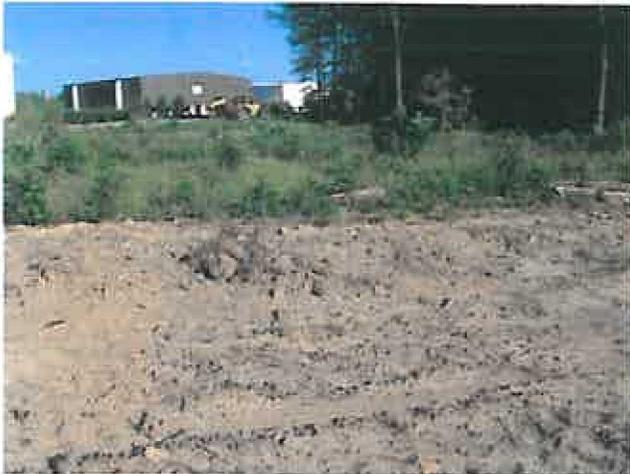
Fig 14 (LEFT). There is no silt fence in place to protect Wetland C from sediment-laden runoff.

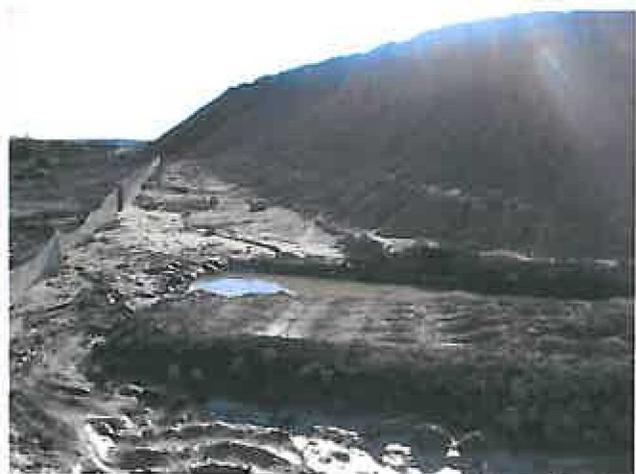
Fig 15 (RIGHT). Attempt at a sediment trap for the soil stockpile area is insufficient to comply with the NPDES permit. Please consult with the project engineer to determine an appropriate design. Further, the stockpile has not been temporarily stabilized.
