RE: LAKE COUNTY
CITY OF MENTOR
INDUSTRIAL STORM WATER
MT HEAT TREAT INC.

NOTICE OF VIOLATION

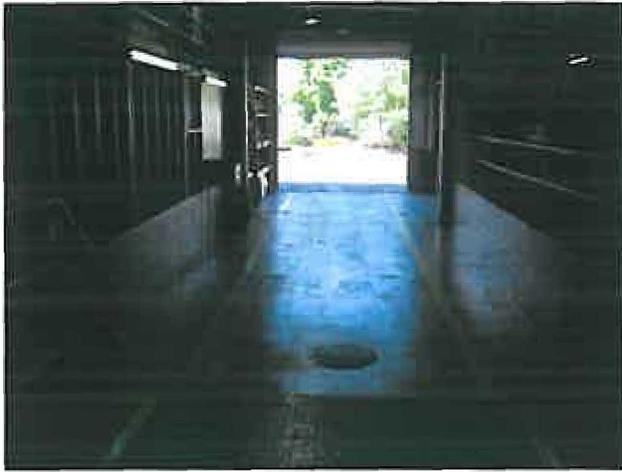
Fig 1 (LEFT). The Floor drain inside the covered loading dock connects to the storm sewer system. Furnaces are located adjacent to the loading dock to the right of the area pictured here.

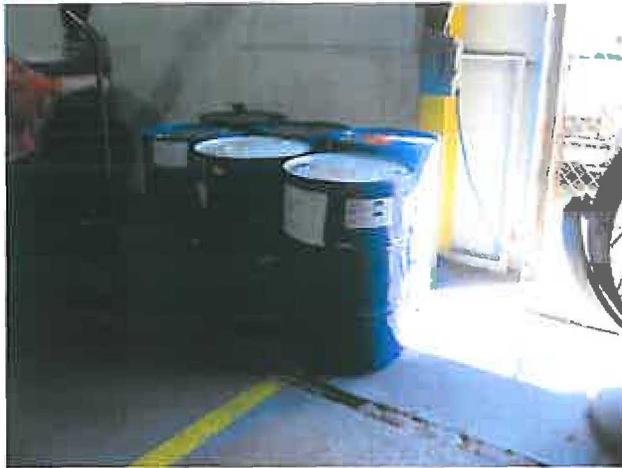
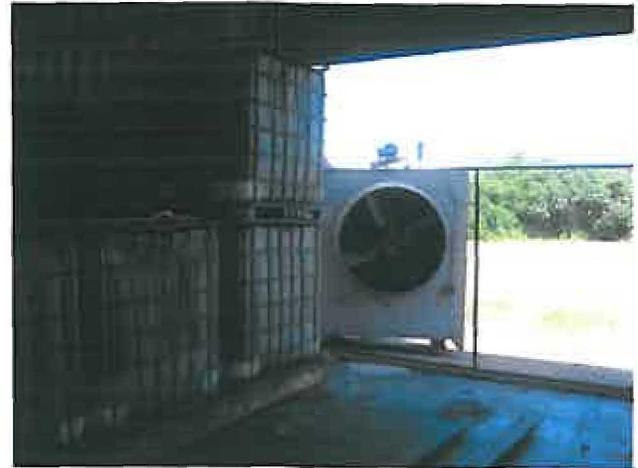
Fig 3 & 4. Although stored indoors, drums and totes containing used oil and a water/oil mixture are stored near doorways. These items should either be moved away from doorways or stored on containment trays or within secondary containment.

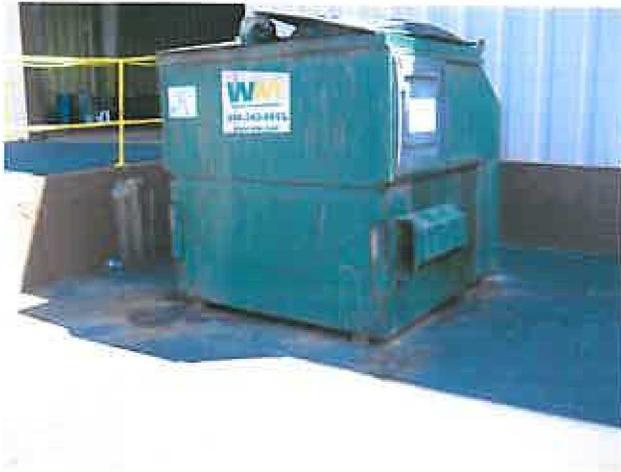
Fig 5 (LEFT). Stains on the pavement around the trash dumpster indicate leaks or spills have occurred. The dumpster lid is ajar.

Dumpsters should be inspected periodically to ensure they are in good condition and are not leaking.

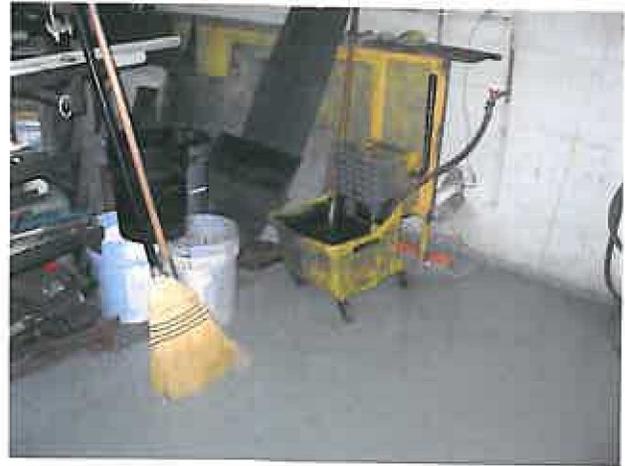
Fig 6 (RIGHT). The water in the mop bucket appears black. MT Heat Treat indicated that this water is disposed in a "recycle drum".

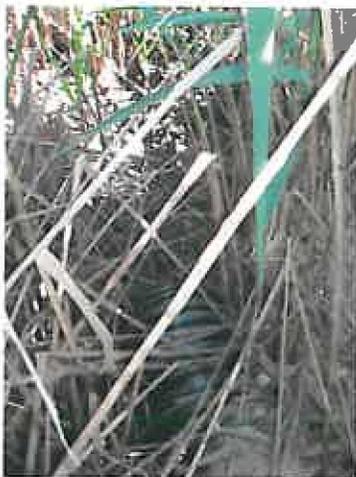
Fig 7. Because access to the storm sewer system outfall is difficult, MT Heat Treat may wish to consider taking samples for quarterly visual monitoring at the first manhole above the outfall (pictured here). There are no significant storm water pollutant inputs between that manhole and the outfall.

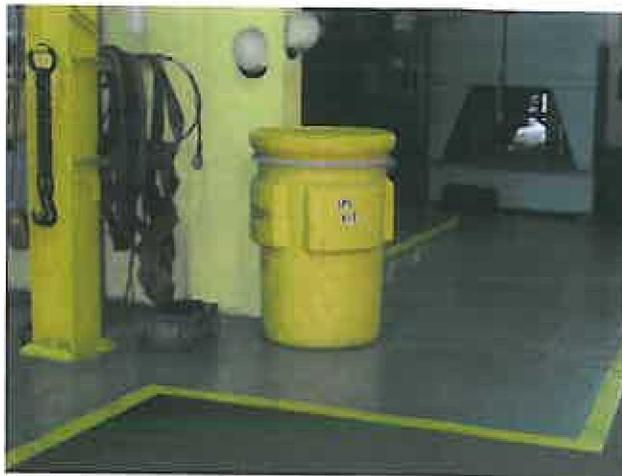
Fig 8. The label on the spill kit is starting to come off.
