**RE: MILACRON, LLC, MT. ORAB, ANNUAL INSPECTION
NOTICE OF VIOLATION**

Pretreatment Compliance Inspection Report

INDUSTRIAL USER INSPECTION CHECKLIST

**Cincinnati Milacron
Mt Orab Plant
Process Schematic**

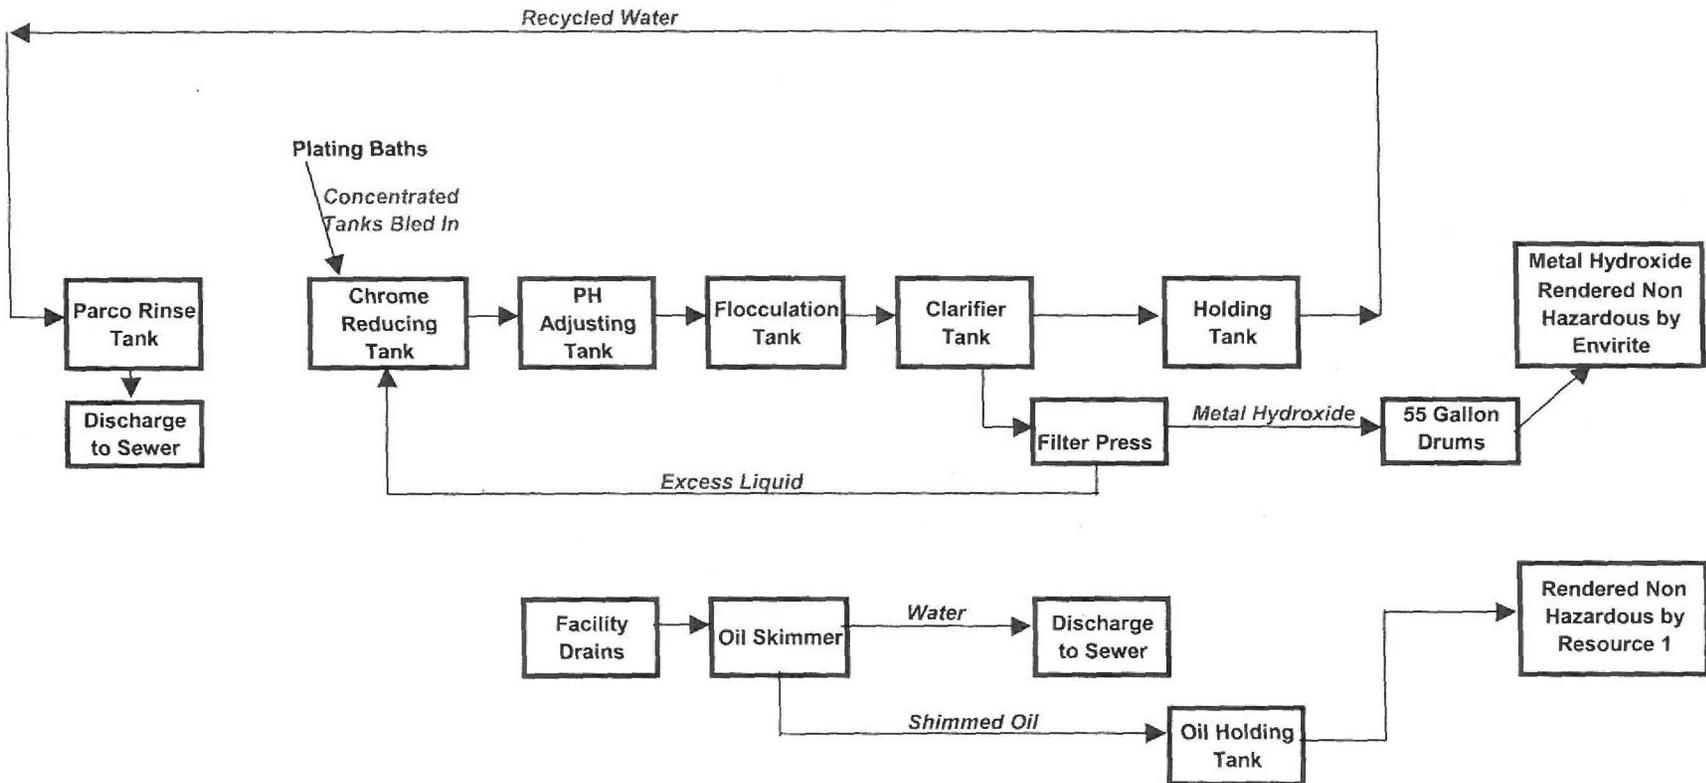
Pretreatment Schematic

The oil skimmer operates on a continuous basis. The wastewater treatment system operates on a batch basis, however, this is now being routed back to the process. It is no longer discharging to the sanitary sewer.
