RE: CUYAHOGA COUNTY
CITY OF BEACHWOOD
CONSTRUCTION STORM WATER
BEACHWOOD REHABILITATION HOSPITAL
PERMIT NO: 3GC05751

NOTICE OF VIOLATION

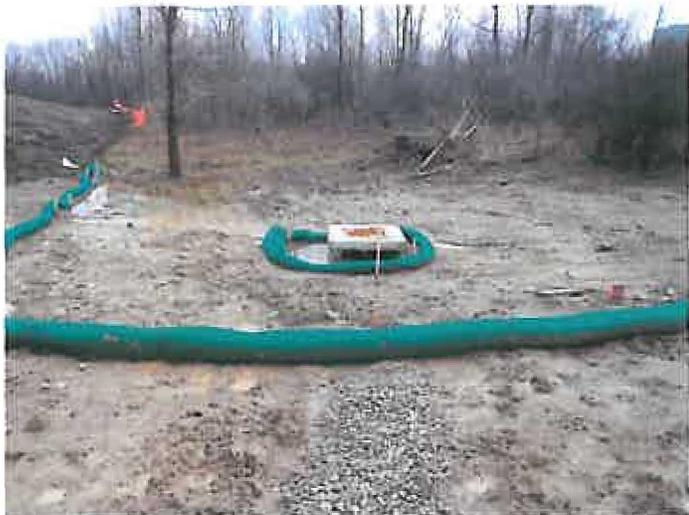
Figure 1: Improper use of filter socks for inlet protection;
Filter sock not pinned thru/ backfilled; Stockpile to be stabilized

- **Storm drain inlet protection has not been constructed properly.** Inlet protection was constructed simply by encircling drains with filter socks. Please note that geotextile is to be supported by a wooden frame and cross braces constructed of 2"x4"s as well as wire mesh. Please review the specifications contained in the enclosure titled Storm Drain Inlet Protection from *Rainwater and Land Development, Ohio's Standards for Stormwater Management, Land Development and Urban Stream Protection* (Ohio Department of Natural Resources, 2006), and install inlet protection to meet these standards (such as Block and Gravel Drop Inlet Filter).

- **Silt fence and filter sock has not been installed in a functional manner or has not been maintained.** All sediment controls, including silt fence, must be capable of ponding runoff in order to settle sediment. Several stretches of silt fence were not trenched or backfilled and thus, were not capable of ponding runoff. The joint stakes of the silt fence also need to be connected by twisting the stakes together prior to staking them into the ground and sediment build up must be removed regularly. Please install/repair silt fence so that it is functional, particularly on the north end of the site and along the utility project. Replace silt fence in areas where it is missing or where there are holes in the silt fence. Due to maintenance concerns expressed by the City of Beachwood, it is recommended to relocate the silt fence upslope of the sidewalk area and utilize filter sock instead of silt fence along Harvard Road. Filter sock must be backfilled and staked. It must remain in place until the upslope contributing drainage area has reached final stabilization, i.e., a vegetative growth density of 70% or greater has been achieved, which is not expected to occur until the spring of 2013.

- **Stabilization, i.e., seeding and mulching, has not been initiated on the soil stockpile and utility line project area as required by the NPDES permit.** Temporary stabilization must be initiated within seven days of last disturbance on any disturbed area of the site if it will not be further disturbed within 21 days of last disturbance. Permanent stabilization must be initiated within seven days of reaching final grade. No temporary or permanent stabilization was evident on the stockpile area on the east side of the site or along the utility line. As we are now past the growing season, stabilization can be achieved either through mulching or dormant seeding. Specifications can be found in the Storm Water Pollution Prevention Plan (SWP3) or the *Rainwater* manual.

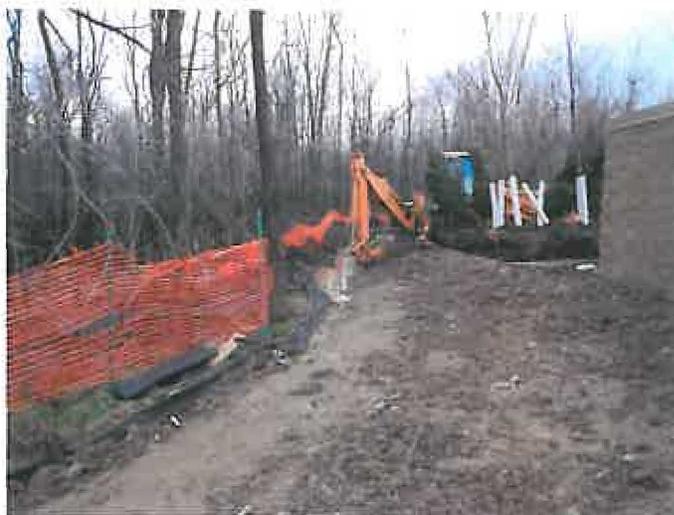
Figure 2: Silt fence to be replaced, repaired or installed
Sediment buildup to be cleaned out from front of fence

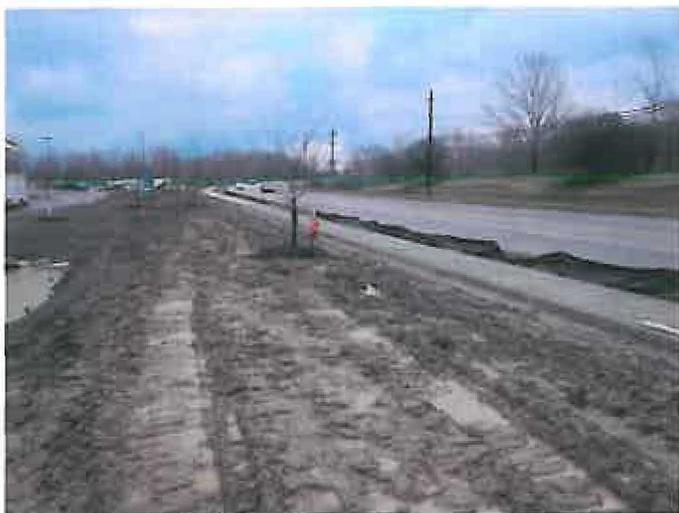
Figure 3: Relocate silt fence upslope of the sidewalk
Area to be stabilized through mulching or dormant seeding

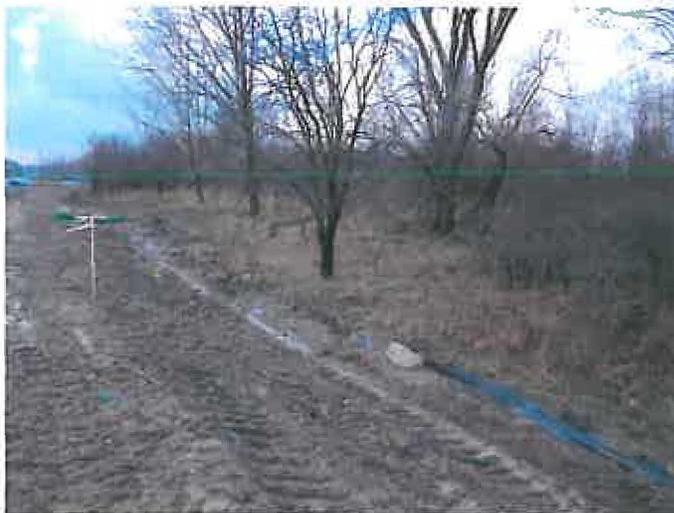
Figure 4: Replace silt fence along utility line on wooded side
Install filter socks along roadway; Stabilize disturbed area

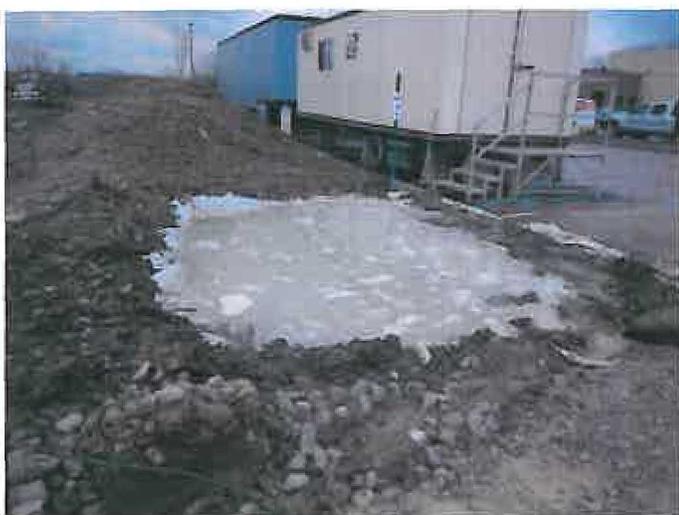
Figure 5: Concrete pit is full and close to overflowing.

- **The concrete washout pit is full.** A berm must be added to provide additional storage or the wastewater in the pit must be properly disposed. Wastewater may be able to be disposed of in the sanitary sewer system, please contact the operator of the sanitary sewer system for permission.

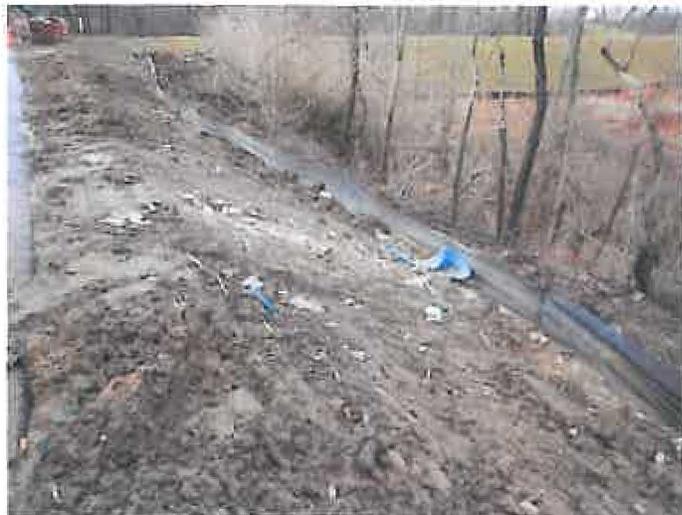
Figure 6: Properly dispose of grout and contaminated soil
Regularly cleanup trash/debris (including any blown offsite)

- **Trash/debris has blown offsite.** Please cleanup all trash regularly and placed in a covered dumpster. Grout appears to have been dumped on the northwest end of the project site. Please properly dispose of this material and any contaminated soil. Grout should be placed in a container and disposed of in the dumpster.
