January 7, 2013

RE: CUYAHOGA COUNTY
CITY OF BEACHWOOD
CONSTRUCTION STORM WATER
ALOFT HOTEL
PERMIT NO: 3GC06128

On December 6, 2012, Ohio EPA conducted a compliance inspection of storm water best management practices (BMPs) at the above referenced construction site. I was accompanied on my inspection by Molly Drinkuth and Dean Stoll of our Division of Surface Water and Brian Booth, project manager for Pride One Construction. Our records indicate that Brown Gibbons Lang & Co have obtained authorization to discharge storm water under the Ohio EPA General National Pollutant Discharge Elimination System (NPDES) Permit for Storm Water Associated with Construction Activities #3GC06128*AG.

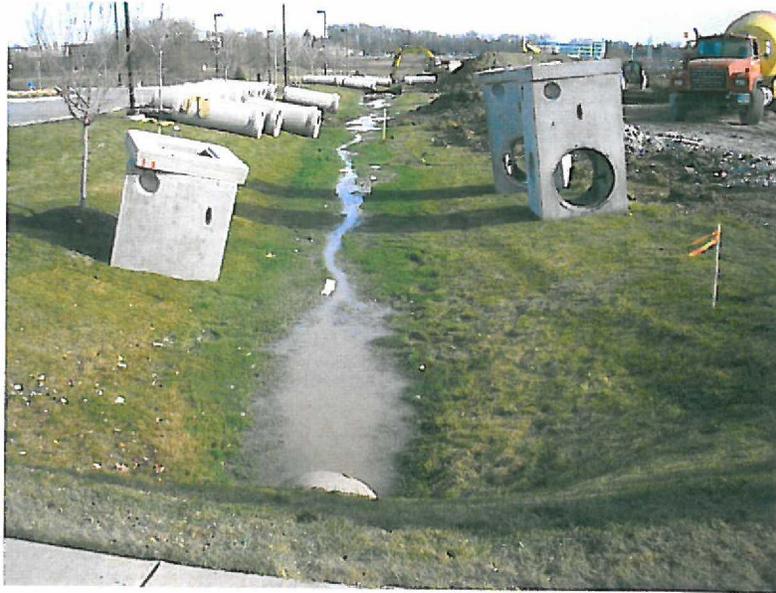
Fig 1. North side drainage channel looking east. Note that there is no silt fence or other perimeter control to protect the channel.

- **Perimeter controls were not installed to protect the drainage channel along the north side of the site from sediment-laden runoff.** Mr. Booth was instructed to install a silt fence, filter sock or compost berm along the north edge of disturbance to establish perimeter sediment control. NOTE: It is understood that the drainage channel will be enclosed in a pipe. These perimeter controls may have to be relocated or may not be required once the channel is enclosed. After the channel is enclosed, please assess site grades and if disturbed areas are still sloped toward the north, provide one of the aforementioned perimeter controls. Ensure storm drain inlet protection is installed on all storm sewer catch basins.

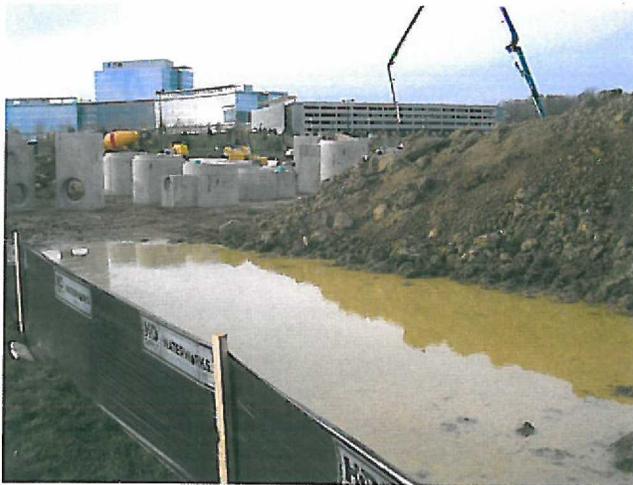
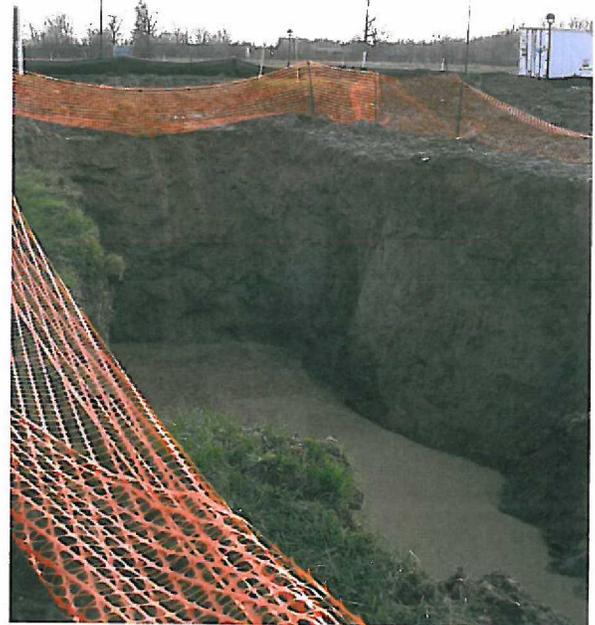
Fig 2 & 3. Sediment-laden runoff is collecting within depressional areas or within excavations on the site. Ensure the contractor uses approved dewatering methods when releasing this runoff. Methods include pumping to a sediment pond, use of a dewatering bag or dewatering in place after allowing at least 24 hours of settling time. The pump intake must either be floated on top or placed in a perforated riser wrapped in geotextile.

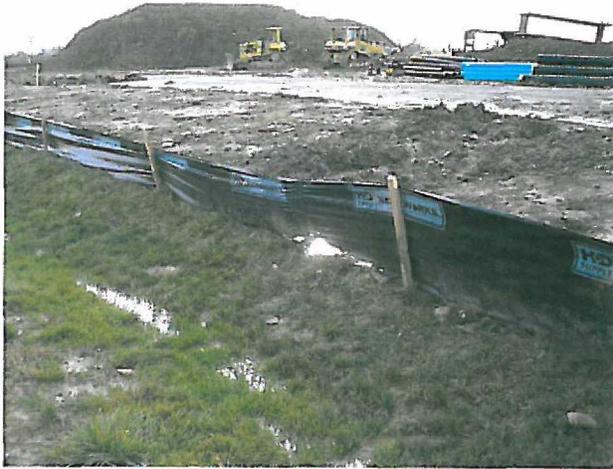
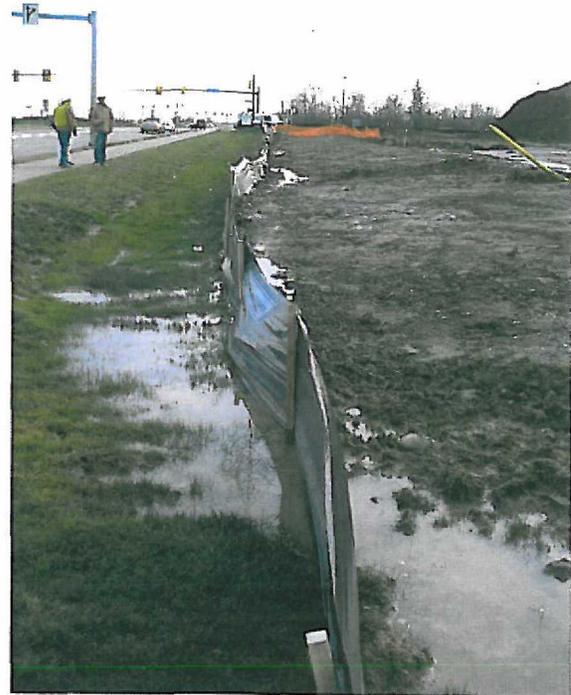
Fig 4 & 5. Silt fence along Richmond Rd has a hole in it or is not trenched and backfilled to cause runoff to pond behind it. Sediment was observed in the drainage channel along Richmond Rd.

- **Silt fence along the east side of the site is in need of repair.** Mr. Booth was instructed to replace and repair silt fence that has torn or otherwise been damaged. We observed sediment in the open drainage channel along Richmond Road as a result of non-maintenance.

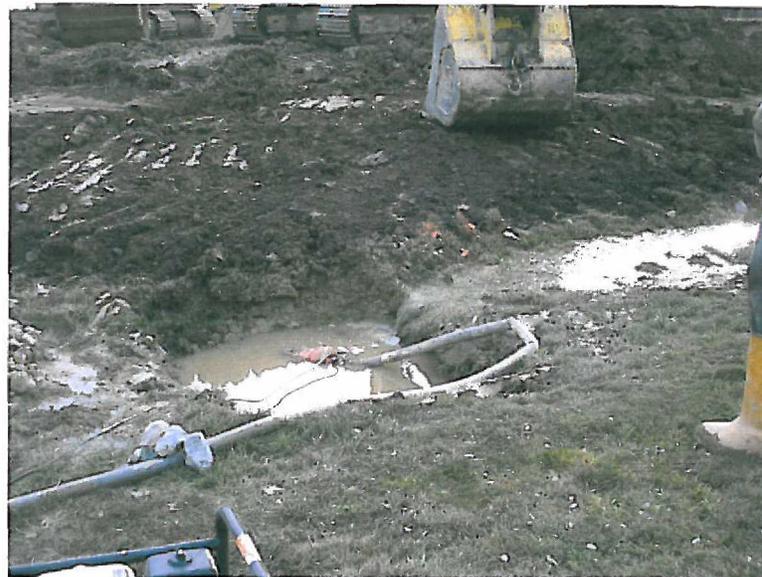
- **The storm water pollution prevention plan (SWP3) does not provide measures for temporary routing of flow conveyed through the north side drainage channel during the culverting process.** The contractor had installed a sump upslope of the area of current construction to pump flow past the work zone; however, the sump pit was small and constructed by excavation, exposing soil. Further, the pump was resting on

Fig 6. A small sump pit was excavated to route flow through the northern drainage channel around the area where culvert was being placed. The method used was not executed in a manner that would minimize the discharge of sediment.

the bottom of the now-bare drainage channel. This will result in sediment being discharged by the pump. If culverting has not yet been completed, please review the specifications in Section 5.7: Dewatering Measures in *Rainwater and Land Development, Ohio's Standards for Stormwater Management, Land Development and Urban Stream Protection* (Ohio Department of Natural Resources, 2006) and add appropriate measures to the SWP3 to address this concern.
