**Re: Peyton Ridge / Fairfield County
Construction Storm Water General Permit #4GC02107*AG**

This letter is written regarding the storm water inspection I conducted on January 17, 2013, of the construction activities at Peyton Ridge, located along Milnor Road. I understand this site is currently covered under the General Storm Water Permit Associated with Construction Activities. Based on my site inspection and the conditions set forth in the General Permit, the following items must be addressed:

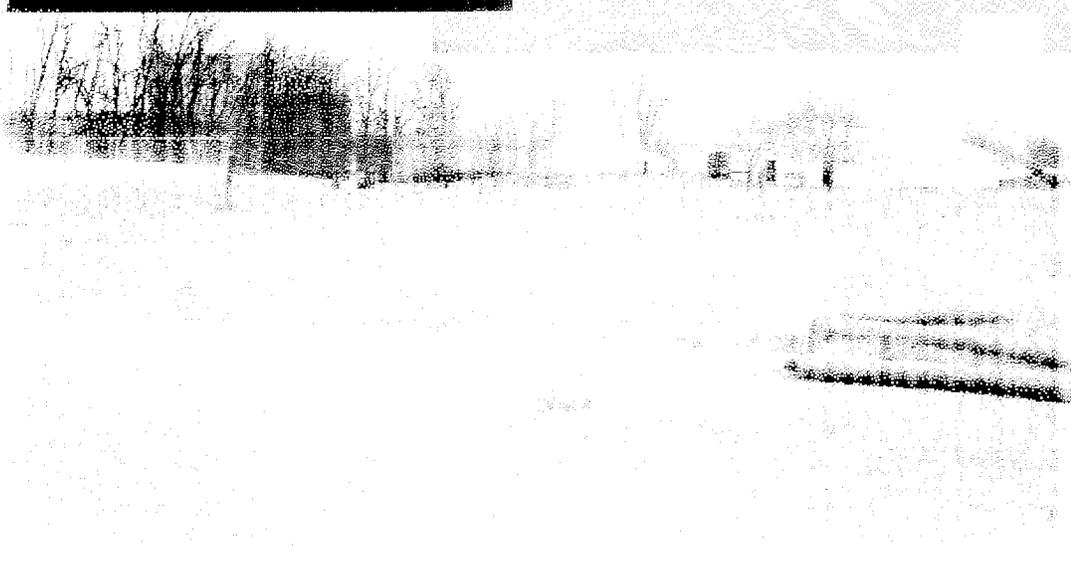
Peyton Ridge
install & maintain erosion controls
Stabilize barren area
Walnut Creek Watershed
January 17, 2013
Photo by Greg Sanders

The development had one lot that was barren. Please be aware the General Permit mandates specific permanent and temporary stabilization requirements. All disturbed areas which remain idle in excess of 21 days must be protected from erosion within seven days of the last earth disturbing activities. All areas of final grade must be protected within seven days. The barren area appeared to be at final grade. All earth disturbing activities should be clearly logged in your inspection reports to ensure the 21 day / seven day requirement is not violated. Given the time of year alternate erosion control measures such as erosion control matting, crimped mulching, mulch with netting and/or tackifier, or an approvable alternative must be implement for this site to ensure effective erosion control during the winter months. Please see attached pictures.

The General Permit requires the permittee to conduct inspections of all sediment and erosion controls every seven days or within 24 hours of a rain event equal to or greater than 0.5 inches. A log of the inspections and resulting corrective actions must be maintained on site available for review. All earth disturbing activities must be clearly documented in your inspection reports to ensure the temporary or permanent stabilization requirements are not violated. It appears that there was an attempt to install straw wattles, however they were in need of repair and replacement.
