**Environmental  
Protection Agency**

RE: MAHONING COUNTY  
SOIL REMEDIATION, INC.  
NPDES PERMIT NO. OHR000005  
OHIO EPA PERMIT NO. 3GR01022\*EG  
INDUSTRIAL STORMWATER INSPECTION

**NOTICE OF VIOLATION**

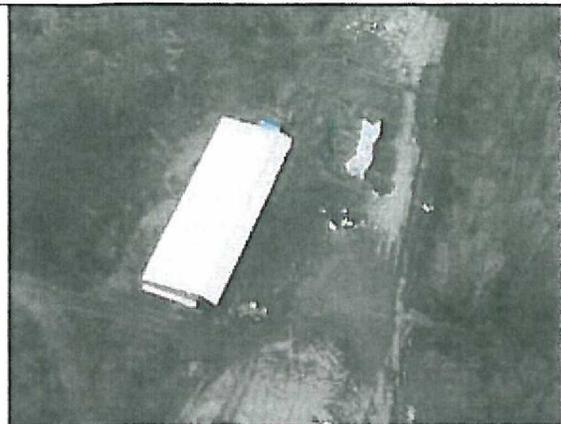
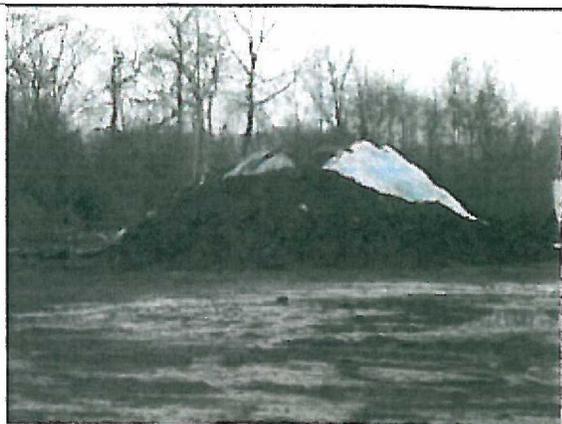
1. Three semi-trucks were located at the weigh station at the time of arrival;
2. The semi-trucks were actively adding to the contaminated soil stockpile that was stored outside of the constructed shelter adjacent to the soil remediation unit. The contaminated soil stockpiles were partially tarped (Figures 1 to 2);
3. An oil sheen was observed on the stormwater runoff that has been contained by the berm constructed northwest of the soil remediation unit (Figure 3);
4. A salt dome structure is being evaluated for purchase that would store contaminated soils delivered to the facility:

**Figure 1** - The contaminated soil stockpiles were partially tarped.

**Figure 2** - The contaminated soil stockpiles were partially tarped.

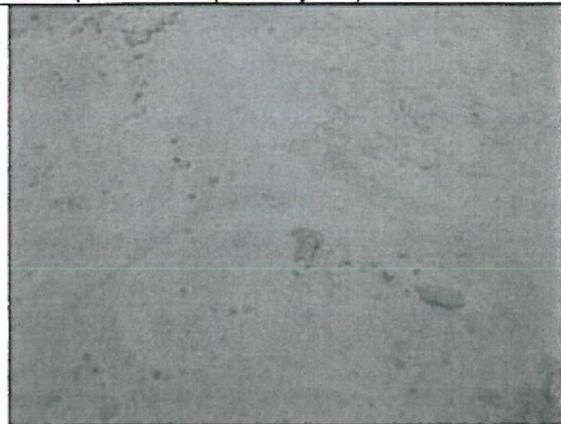
**Figure 3** - An oil sheen was observed on stormwater runoff that has been contained by soil remediation unit.

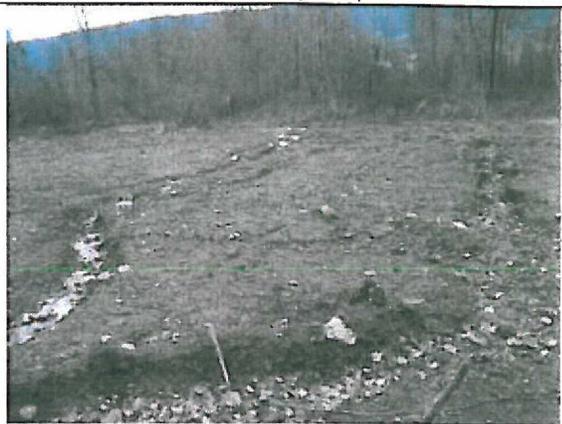
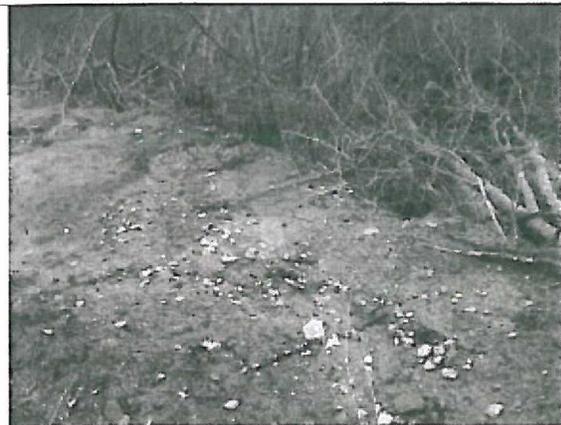
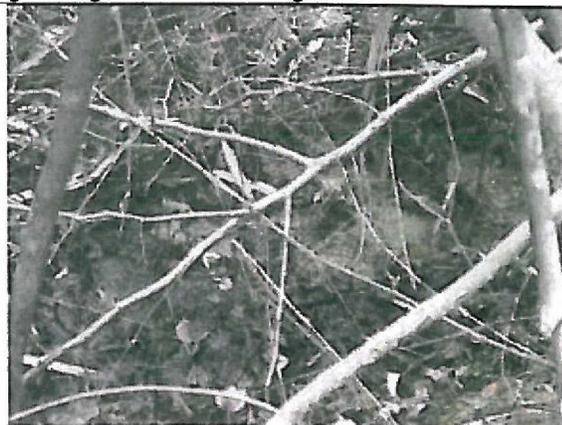
Additional grading and excavating activities are occurring east of the portion of the site that was previously disturbed and treated by a temporary sediment trap. No BMPs have been installed to prevent erosion and the discharge of sediment-laden runoff from this additional area (Figures 4 to 6). Ohio EPA recommends extending the diversion channel and resizing the existing temporary sediment trap, based upon the applicable drainage areas, in order to properly capture and treat sediment-laden runoff prior to discharge.

**The failure to prevent erosion and the discharge of sediment constitute violations of Ohio Revised Code (ORC), Chapter 6111.07 and Part 2.1.2.5, of the Multi-Sector General Permit.**

**Figure 4** - No BMPs have been installed to prevent erosion and the discharge of sediment-laden runoff from the additional grading and excavating activities.

**Figure 5** - No BMPs have been installed to prevent erosion and the discharge of sediment-laden runoff from the additional grading and excavating activities.

**Figure 6** - No BMPs have been installed to prevent erosion and the discharge of sediment-laden runoff from the additional grading and excavating activities.

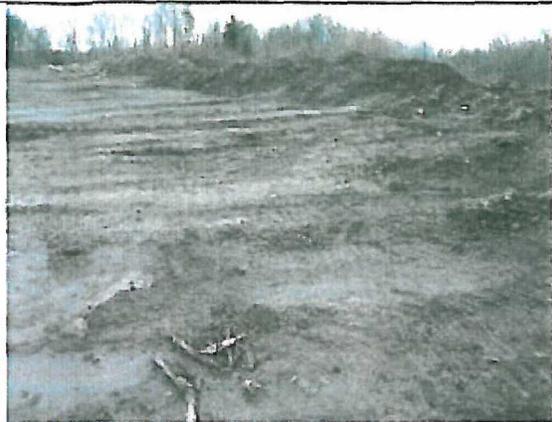
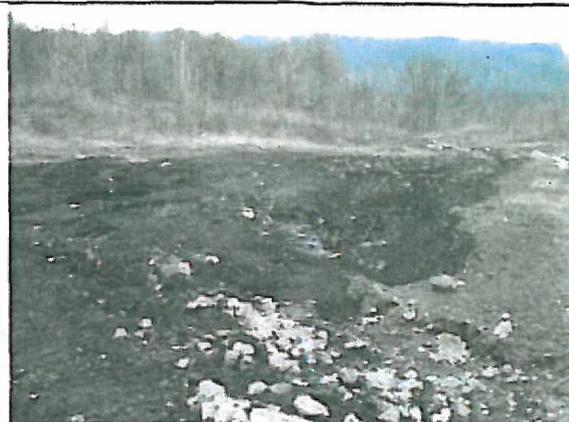
6. The screener was relocated from the soil remediation unit area to the "gravel/slag processing" area.
7. A fine black material (FBM) was observed in an area where additional grading and excavating activities are occurring, located northwest of the "settling basin" and northeast of the "gravel/slag processing" area, as depicted on Figure 2 of the facility's SWP3 (Figure 7 to 8). A very strong odor was present in this location. No BMPs have been installed to prevent the discharge of the FBM to "waters of the State" as the material traveled approximately 300 feet from the source and into a storm sewer catch basin that was flowing at the time of the inspection (Figures 9 to 15). The discharge of the FBM to "waters of the State" must be immediately terminated.

**Figure 7** - A FBM was observed in an area where additional grading and excavating activities are occurring.

**Figure 8** - A FBM was observed in an area where additional grading and excavating activities are occurring.

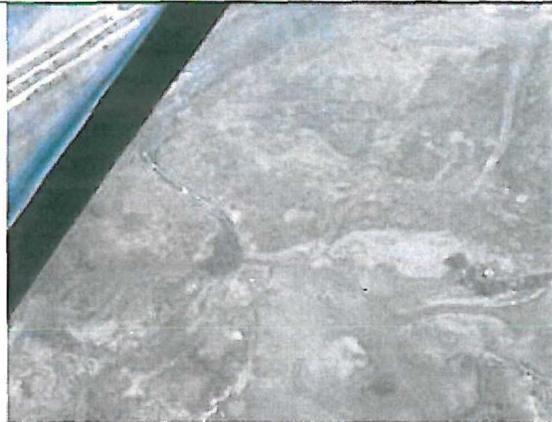
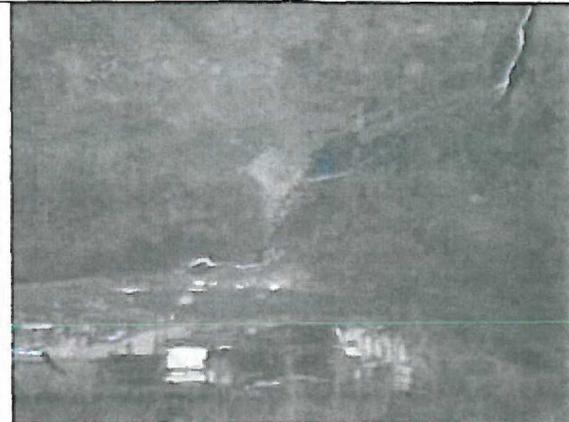
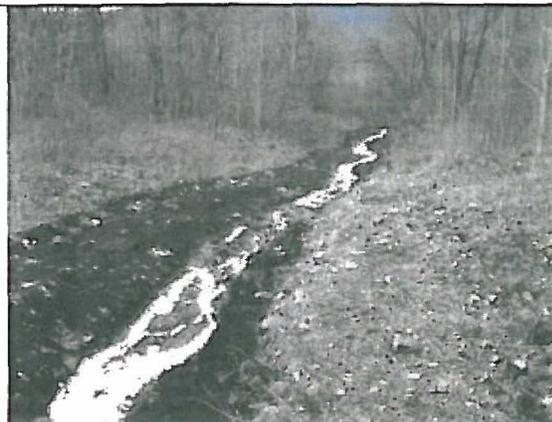
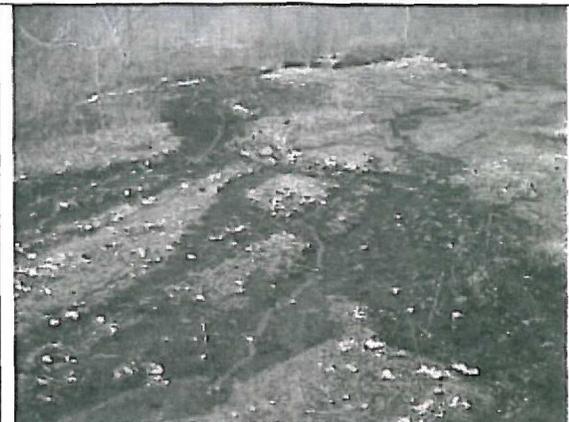
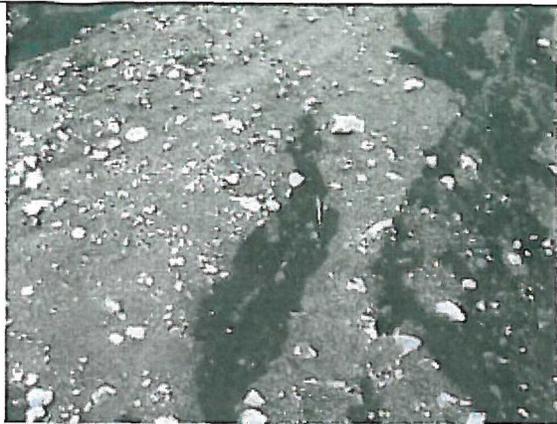
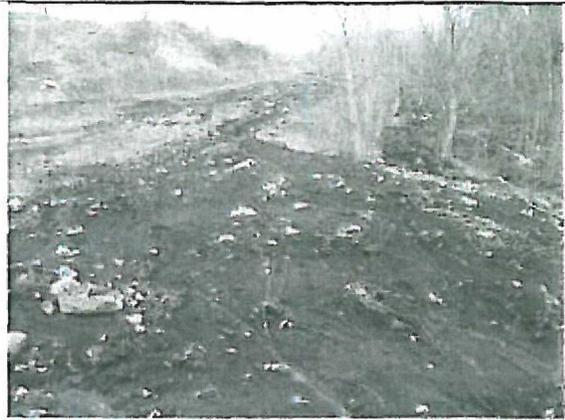
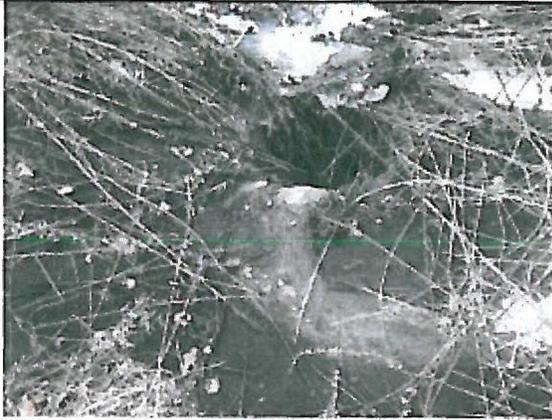
**The discharge of FBM to "waters of the State" constitutes violations of ORC 6111.07, Ohio Administrative Code, Chapter 3745-1-04, and Part 2.1 of the Multi-Sector General Permit.**

**Figure 9** - The FBM traveled approximately 300 feet from the source and into a storm sewer catch basin.

**Figure 10** - The FBM traveled approximately 300 feet from the source and into a storm sewer catch basin.

**Figure 11** - The FBM traveled approximately 300 feet from the source and into a storm sewer catch basin.

**Figure 12** - The FBM traveled approximately 300 feet from the source and into a storm sewer catch basin.

**Figure 13** - The FBM traveled approximately 300 feet from the source and into a storm sewer catch basin.

**Figure 14** - The FBM traveled approximately 300 feet from the source and into a storm sewer catch basin.

**Figure 15** - The FBM was discharging into a storm sewer catch basin.

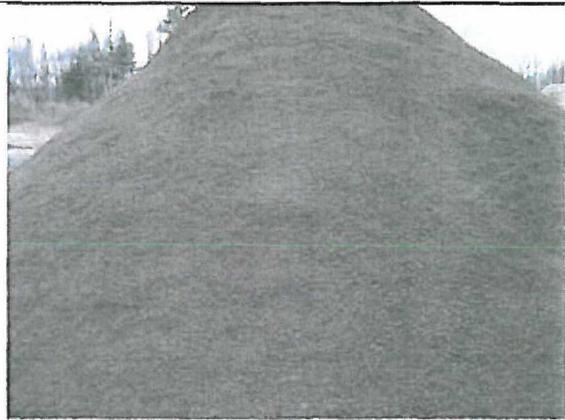
When questioned about the FBM, Mr. Naples stated that it was fine slag and then directed Ms. Dejanovic and me to an onsite stockpile of fine slag for comparison. The stockpile of fine slag had a different color, consistency, and odor than the FBM (Figure 16). Mr. Naples then directed us to discuss the FBM with you. Upon meeting you at the office, you clarified that the FBM was flue dust or mill scale with a possible cutting oil present.

**Figure 16** - The stockpile of fine slag had a different color, consistency, and odor than the FBM.
