Re: Jackson County
Village of Oak Hill WWTP
Reconnaissance Inspection
Ohio EPA Permit 0PB00055*HD
NPDES Permit OH0026859
Correspondence (PWW)

Municipal NPDES Compliance Inspection Report

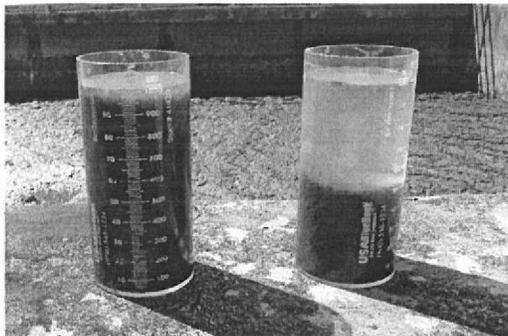
Left jar contains 100% mixed liquor, Right jar is 50% mixed liquor and 50% effluent. The jar on the left should have fell below the 80 mark by the time this picture was taken. The facility needs to waste sludge. The diluted jar on the right proves that better settling can occur with less solids. This can translate into significant energy savings, by reducing RAS flow needing to be pumped by the plant's pump station. The plant currently has to operate with a real high RAS in order to provide for the poor settling shown by the jar on the left. With improved

wasting, the RAS could be scaled back saving on pump run time. Additionally, the high amount of solids contained in the plant have led to past TSS violations along with ammonia violations. I routinely have commented that this facility is not wasting sufficiently. A considerable amount of the plant's capacity is being limited by the way it is being operated. For example, on the day of the inspection had the facility been properly wasting it could have been running on one clarifier in lieu of two with less than half the RAS being circulated through the pump station. The plant's low F:M ratio may lead to filaments; it already exhibits extreme accumulations of scum common to low F:M.

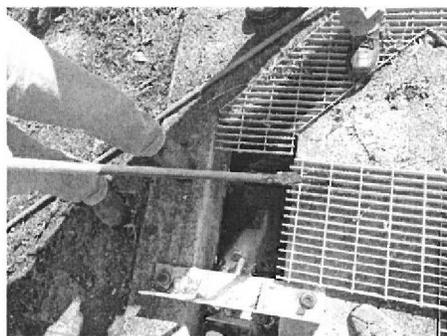
1. Correct the headworks for proper velocity management in the grit channel. The screen causes the water elevation to climb way too far causing the incoming line to be submerged. This leads to grit falling out in the incoming sewer, which can cause overwhelming amounts of grit to enter the plant during heavier flows. I believe a recessed pit in the current grit chamber may accomplish this for the screen bottom to drop into.

The wet level on the spud bar above indicates multiple feet of water level. The water depth should be approximately half a foot to keep average velocities around 1 foot per second. This area could also be improved with extending walls above grade elevation. The incoming sewer should not be submerged, if possible.
