RE: CUYAHOGA COUNTY  
CITY OF NORTH OLMSTED  
NORTH OLMSTED WWTP  
NPDES PERMIT NO. OHC000003  
OHIO EPA PERMIT NO. 3GC06343\*AG  
CONSTRUCTION STORM WATER

On May 23, 2013, Ohio EPA conducted an inspection of the North Olmsted WWTP project located at 23775 Mastick Road, City of North Olmsted, Cuyahoga County. This inspection was conducted as a follow-up to an OEPA site visit on April 17<sup>th</sup> of this year. Ohio EPA records indicate that the site is covered by the General National Pollutant Discharge Elimination System (NPDES) Permit for Storm Water Associated with Construction Activity (General Storm Water Permit), permit No. 3GC06343\*AG. During this inspection, I was accompanied by Bobby Hrusovsky of OEPA as well as Pete DiFranco from the City of North Olmsted. The inspection documented the following:

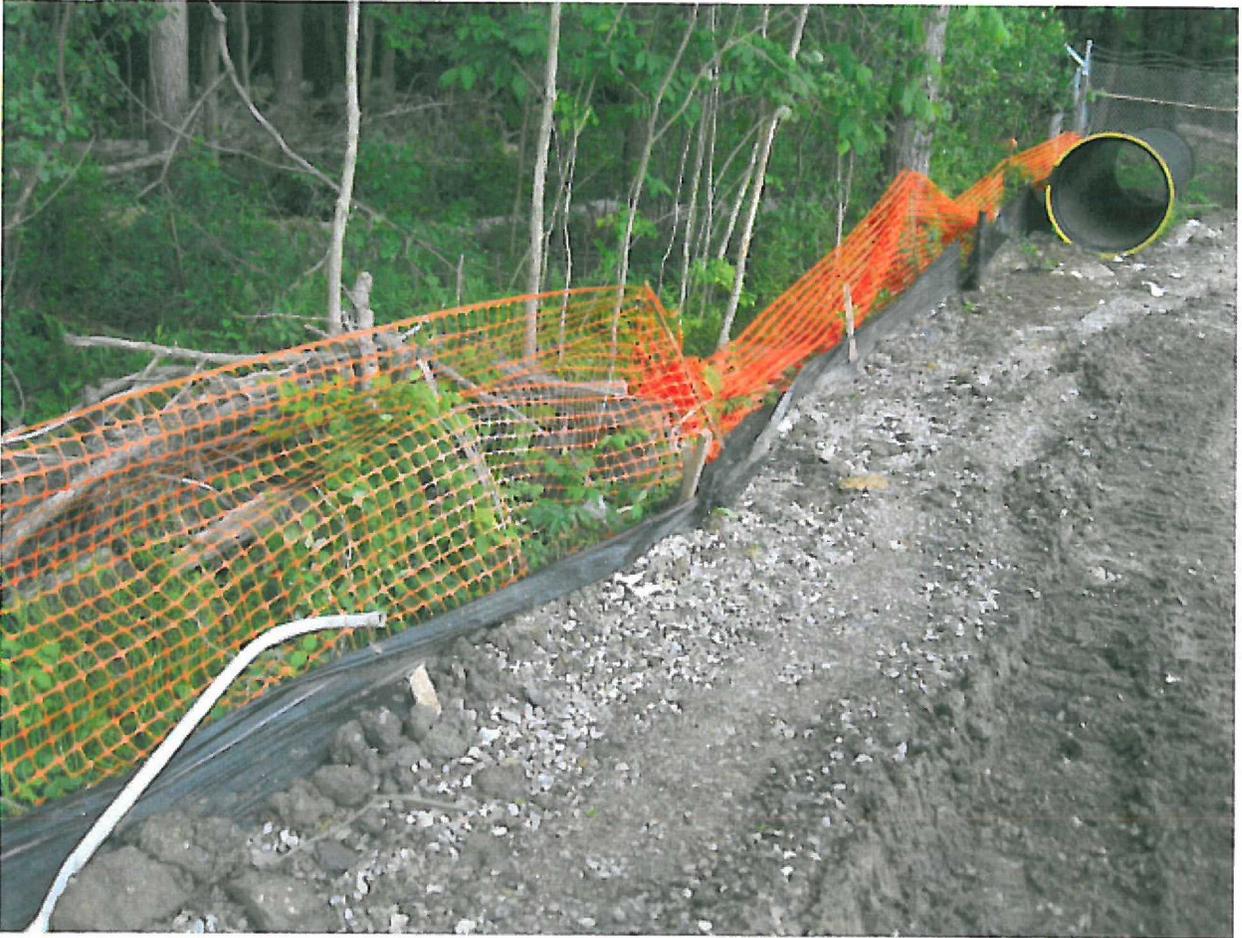
- The silt fence located near the final clarifiers which are currently being constructed has been knocked over. Please repair or replace the silt fence as necessary to ensure that it will function as intended (See Figure 1).
- During the site visit on April 17<sup>th</sup>, OEPA observed that the trash dumpsters lacked adequate cover to prevent exposure to storm water. The follow-up inspection conducted on May 23<sup>rd</sup> determined that this issue has not yet been corrected. Per our discussion on site, the last WWTP Superintendent on site should ensure that GLCC covers the exposed dumpsters with a lid or a tarp at the end of each work day.

Figure 1. The silt fence has been knocked over and needs to be repaired.
