**RE: PAS Technologies Inc.; NPDES Permit # 1GC04340\*AG; Notice of Violation**

On Thursday, June 6, 2013, I inspected the PAS Technologies Inc. project located in Hillsboro, Ohio, to determine compliance with its NPDES construction sites storm water discharge permits. I walked the property but did not meet with anyone on the site.

**Ohio EPA DSW Storm Water Section, Construction Site Visit Information Form**

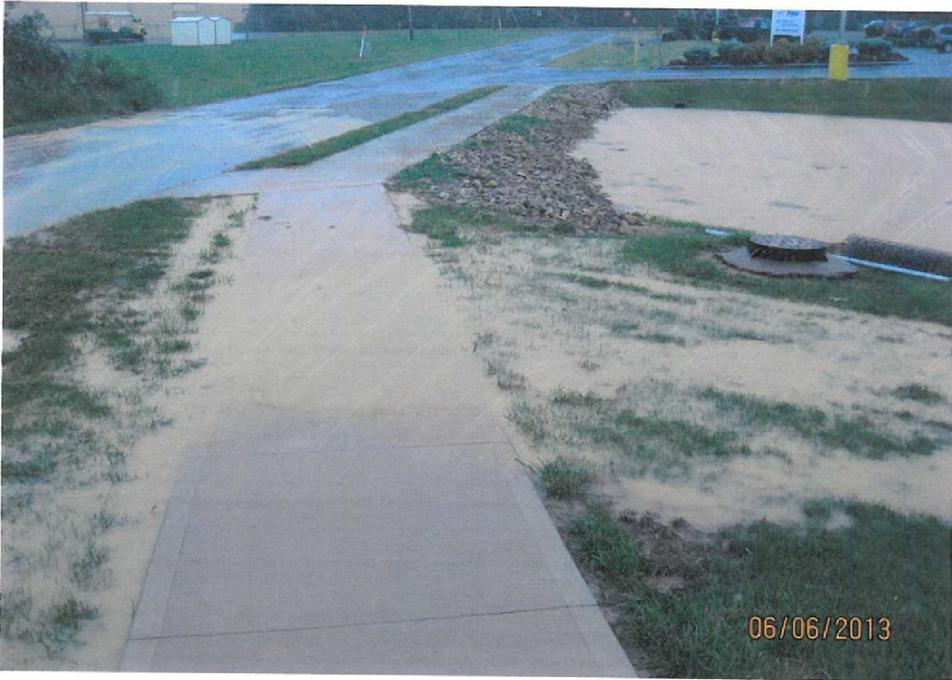
As you can see in the first attached photo, the silt fence along Homestead Drive on the south end of the property has been knocked over and needs repaired. Also, as shown in photos 2, 3, and 4, sediment is flowing over the road and into the drainage ditch instead of flowing into the sediment basin. It appears that the majority of this flow is coming from the disturbed area located on the north area of the property (seen in photo 5). Sediment flow from this area is shown in photos 6 and 7.

1. The site's storm water pollution prevention plan (SWPPP) that clearly shows property boundaries.
2. Copies of sediment control inspection records since work on the project begun.
3. An explanation and timetable of measures that will be taken to minimize as much as possible the sediment discharge over the roadway and into the drainage ditch.

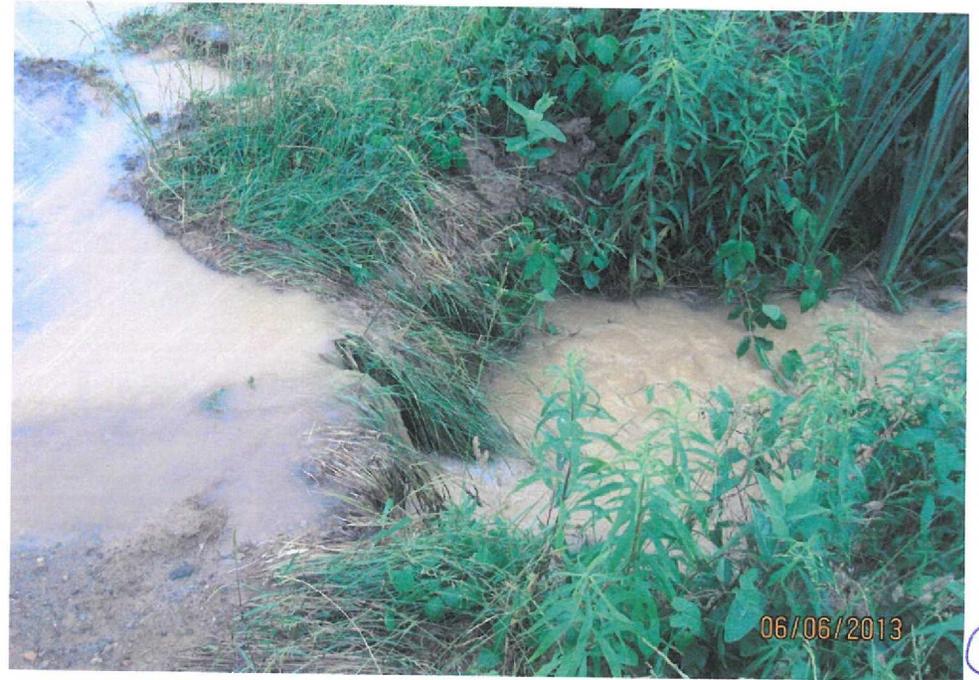
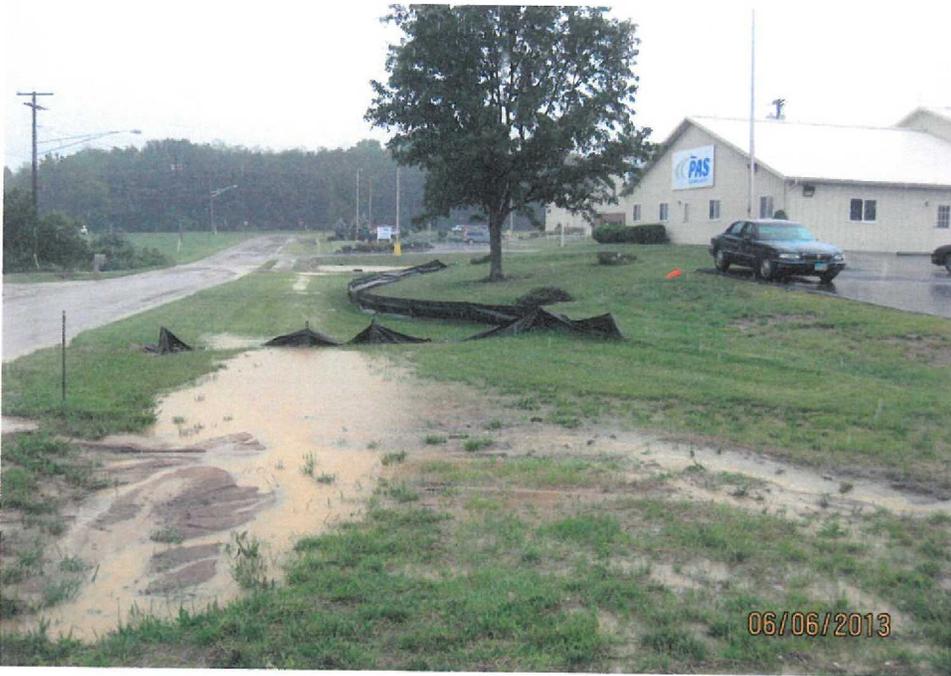
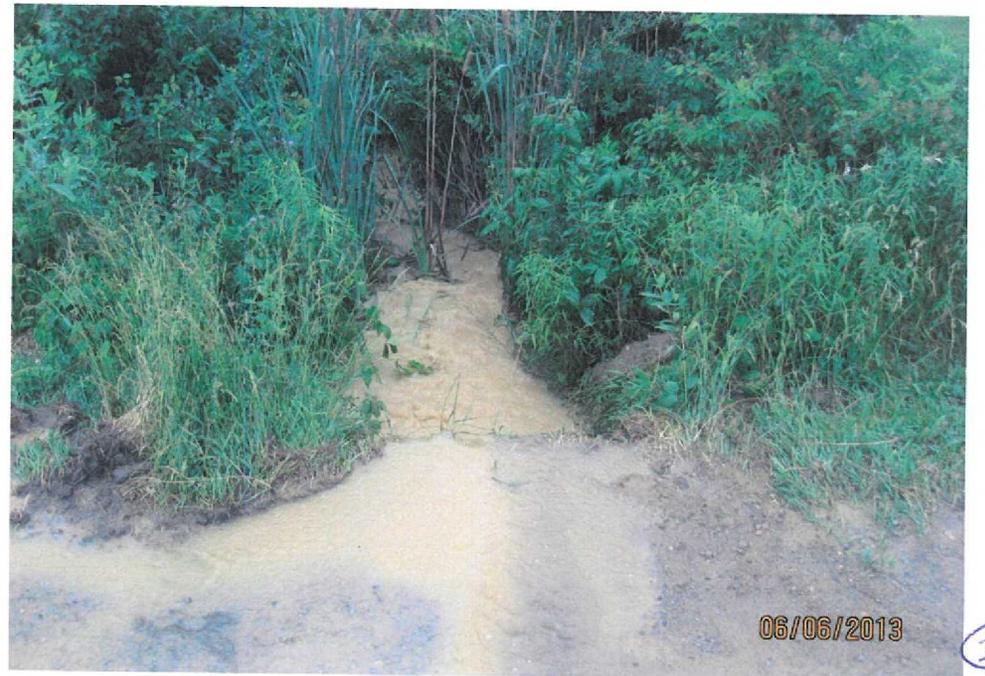
sed. in water drains all the way to stream near SR 62  
~~the~~ water runs from site through drainage ditch to Southern State pond then out into another ditch and then to stream

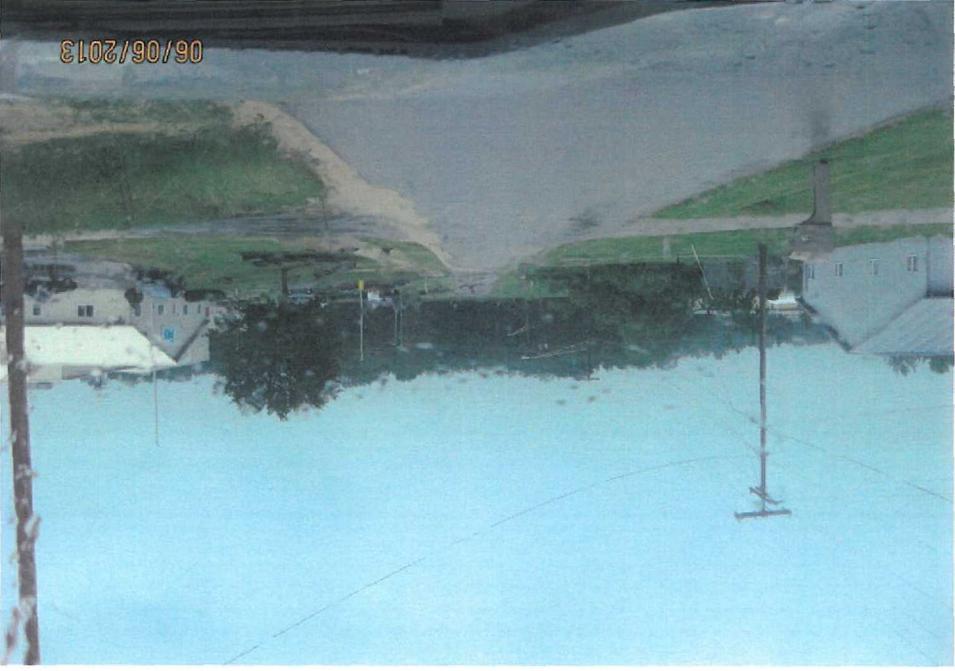
The bare soil in photo 8 appears to be at final grade, and therefore, is required to be stabilized per this section (see charts on page 16 of permit OHC000003). It is unclear whether or not the area described in the area depicted in photo 5 is at final grade, or even part of the property. For this reason, I am requesting to see the site's storm water pollution prevention plan that clearly shows property boundaries. If this area in question is part of the project, then requirements for stabilization must be instituted here as well.
