**RE: Notestine Manor; NPDES Permit #1GC04374\*AG  
Compliance Inspection Findings**

**Ohio EPA DSW Storm Water Section, Construction Site Visit Information Form**

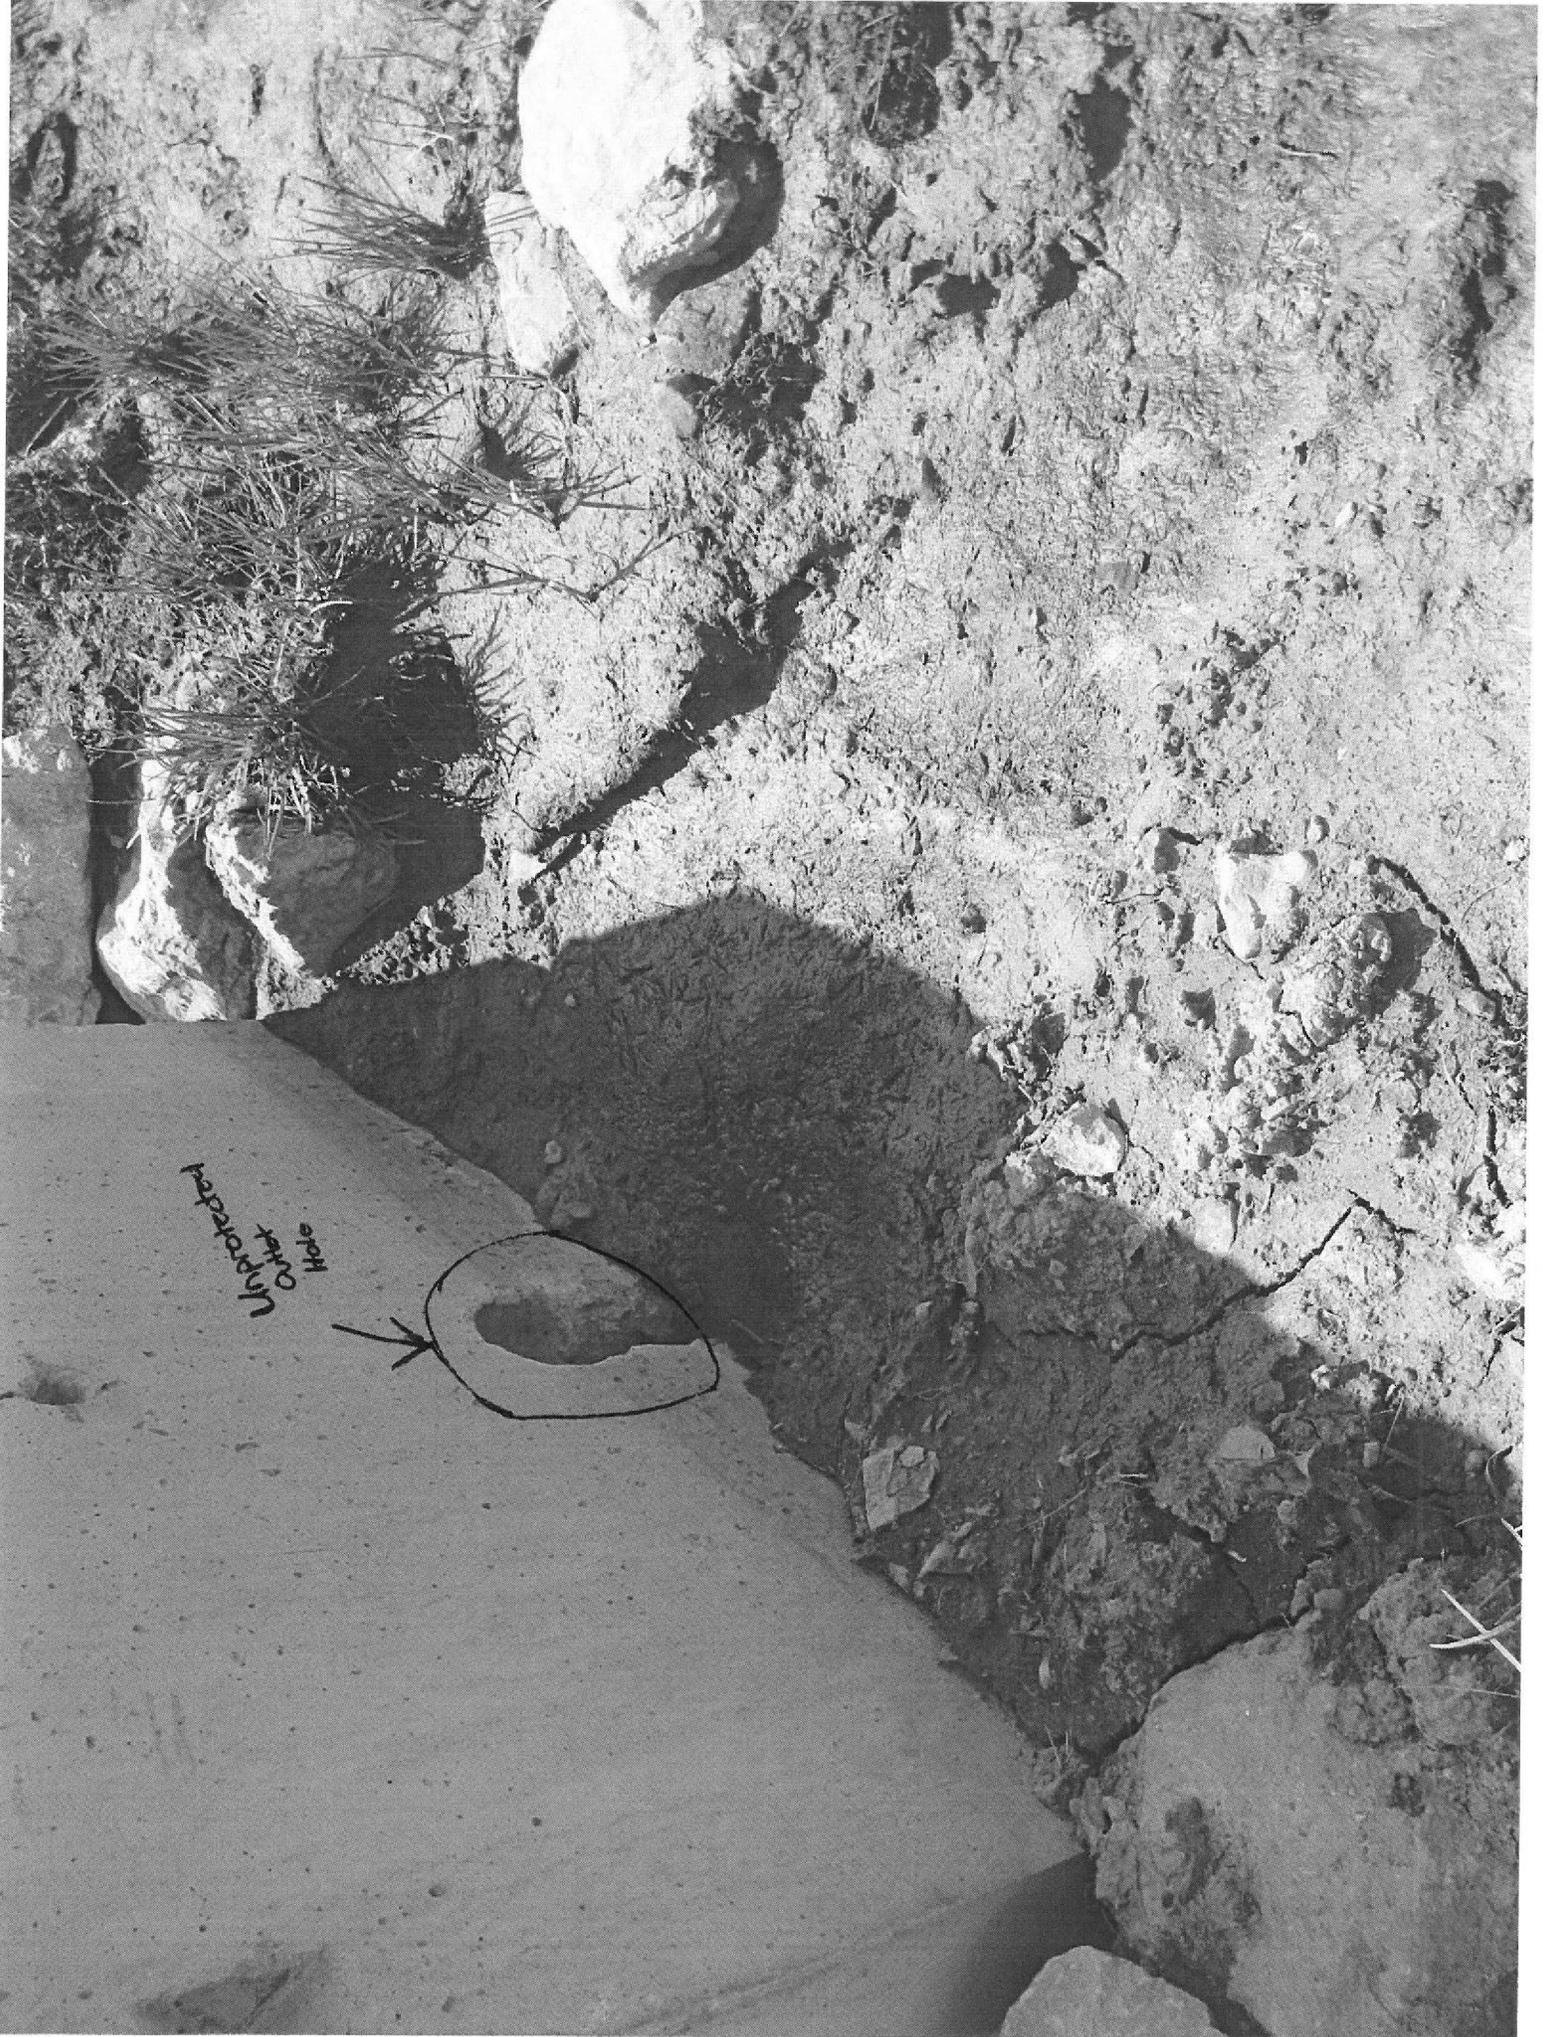
The basin located near Kristina Drive is currently allowing sediment-laden water to leave the basin through a small hole at the base of the outlet structure. The storm water entering the basin from the storm inlet structure has eroded a swale that leads straight to the small hole at the base of the outlet structure near the road. However, as the hole is right at the bottom of the structure, the muddiest water is being discharged. The sediment-laden water is being washed out onto the street, which is a violation of the NPDES permit. See the attached photographs. In order for this basin to function as a permanent sediment basin, while some bare dirt areas remain draining to the outlet structure, it should be modified temporarily using a perforated riser as shown in the Rainwater and Land Development Manual, chapter 6, page 12.

- Silt fence can be discarded on south + west side of site
- Outlet storm drain structure has an unprotected outlet hole that is allowing sediment to leave site and go onto Kristina Drive.
- Who has been conducting Post-Construction Maintenance Inspections

Unprotected  
Outlet  
Hole

Please respond by July 5, 2013, with a description of how the basin at Notestine Manor is to be modified to allow it to function as a permanent sediment basin. Please include any post construction best maintenance practices (BMPs) that provide a maintenance plan for the sediment basin.
