**RE: Yamada North America Inc.; NPDES Permit #1GC04212*AG;
Compliance Inspection Findings**

Ohio EPA DSW Storm Water Section, Construction Site Visit Information Form

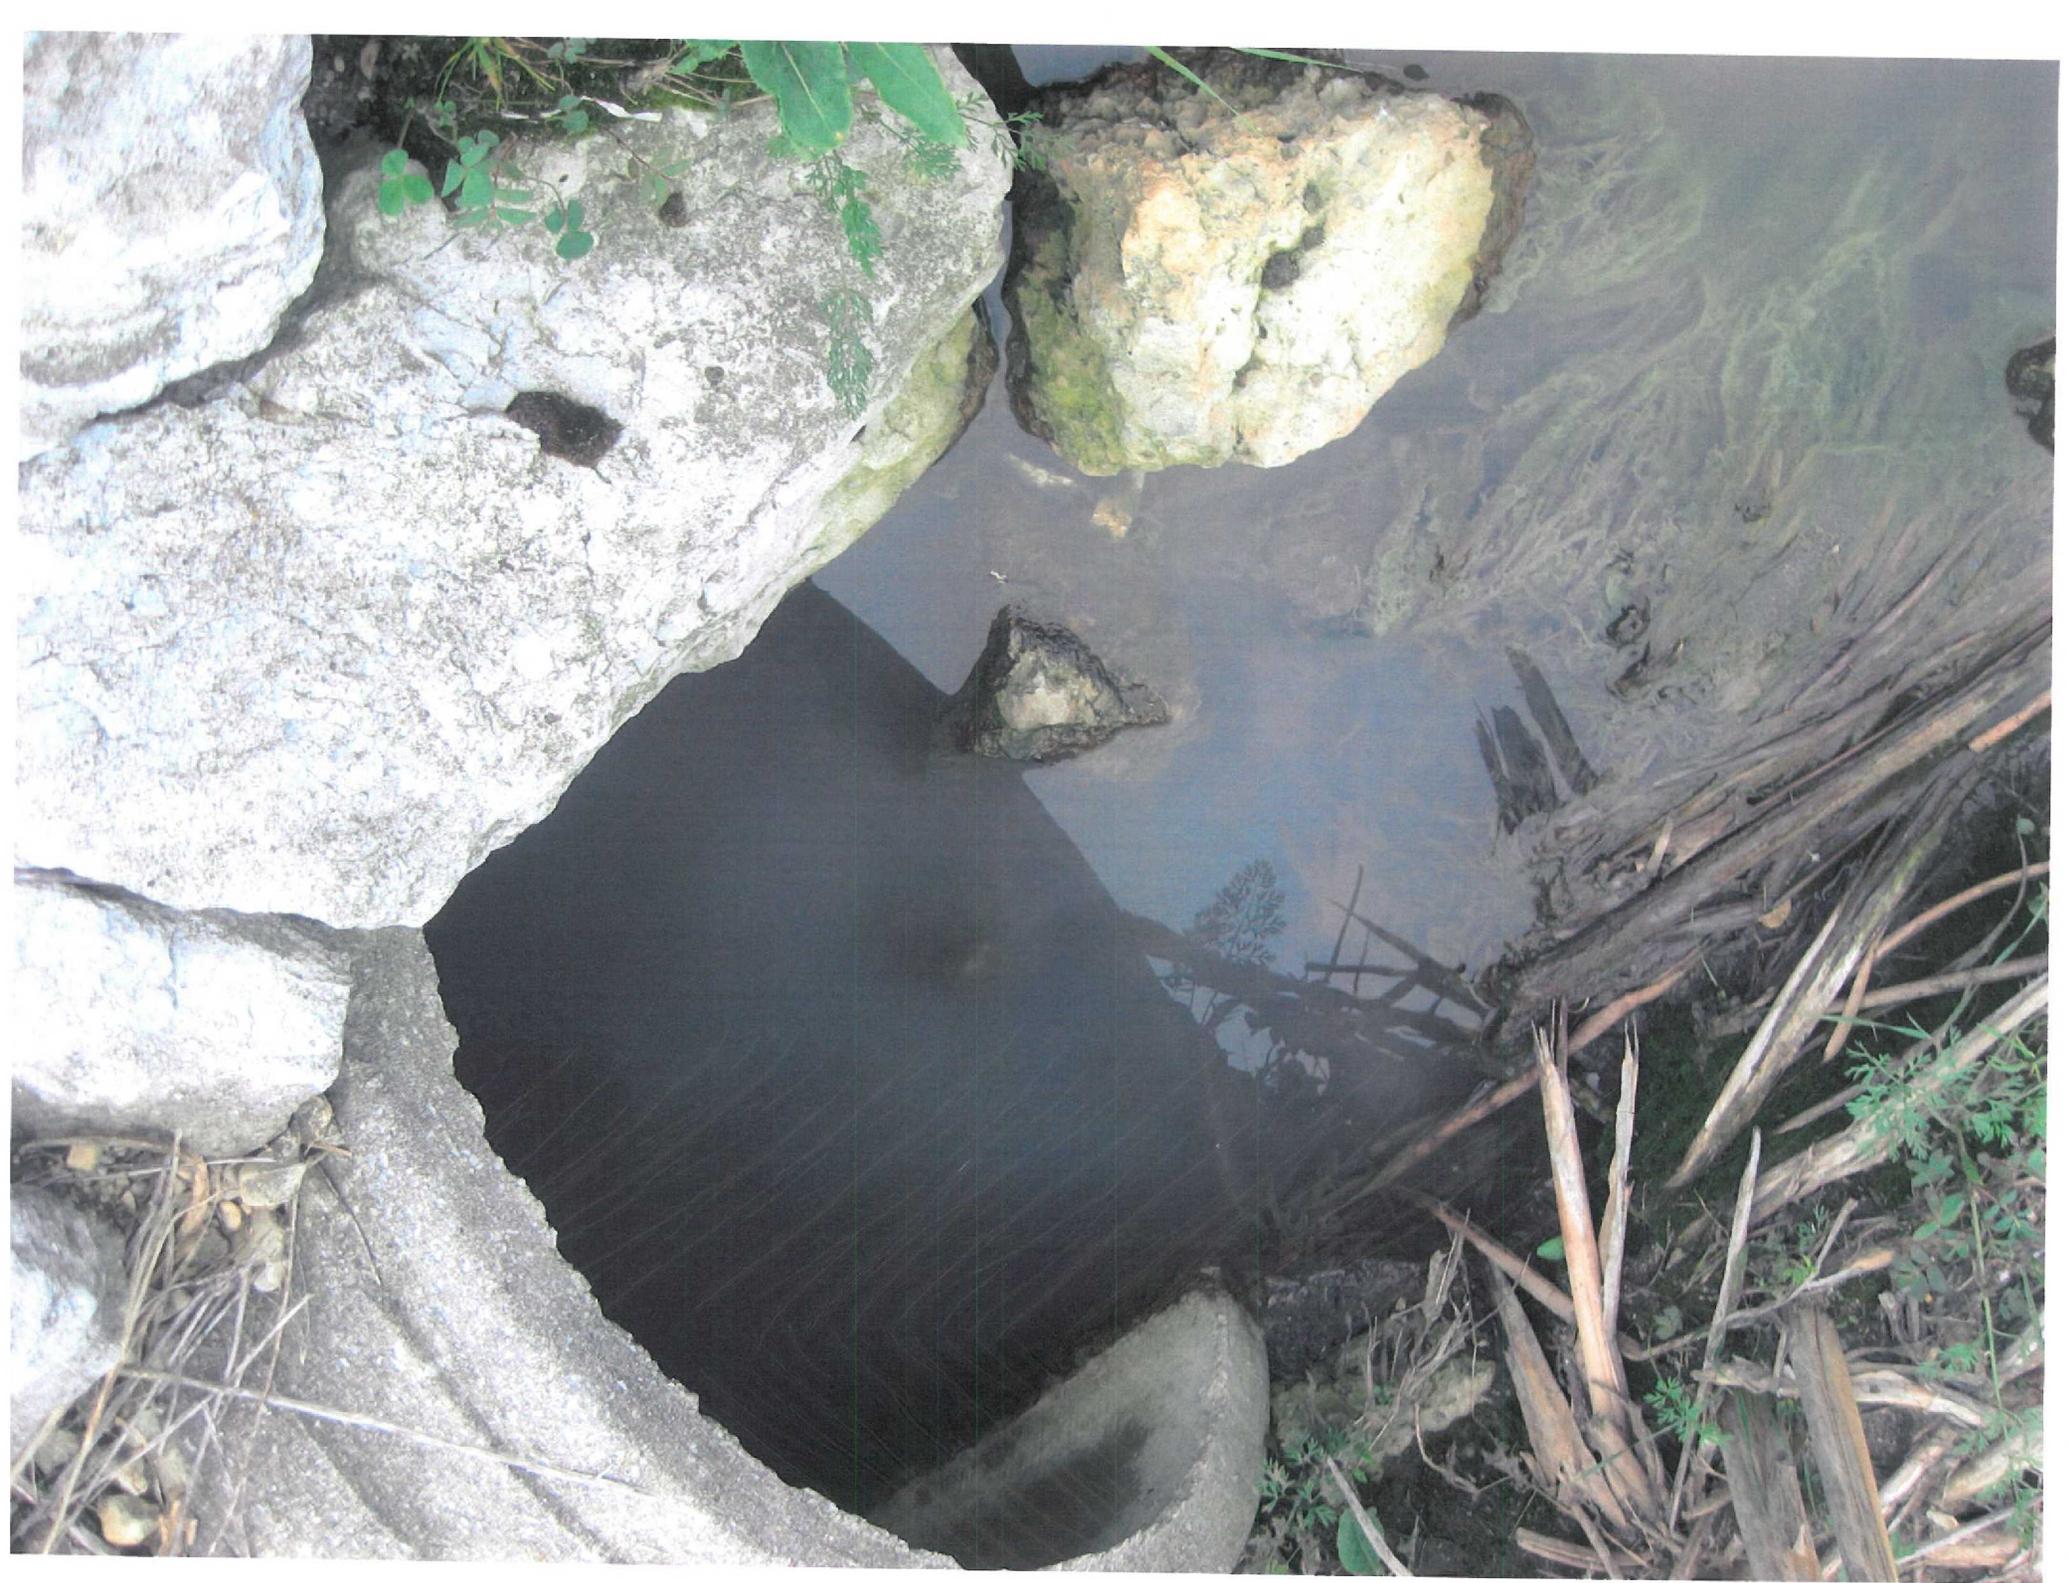
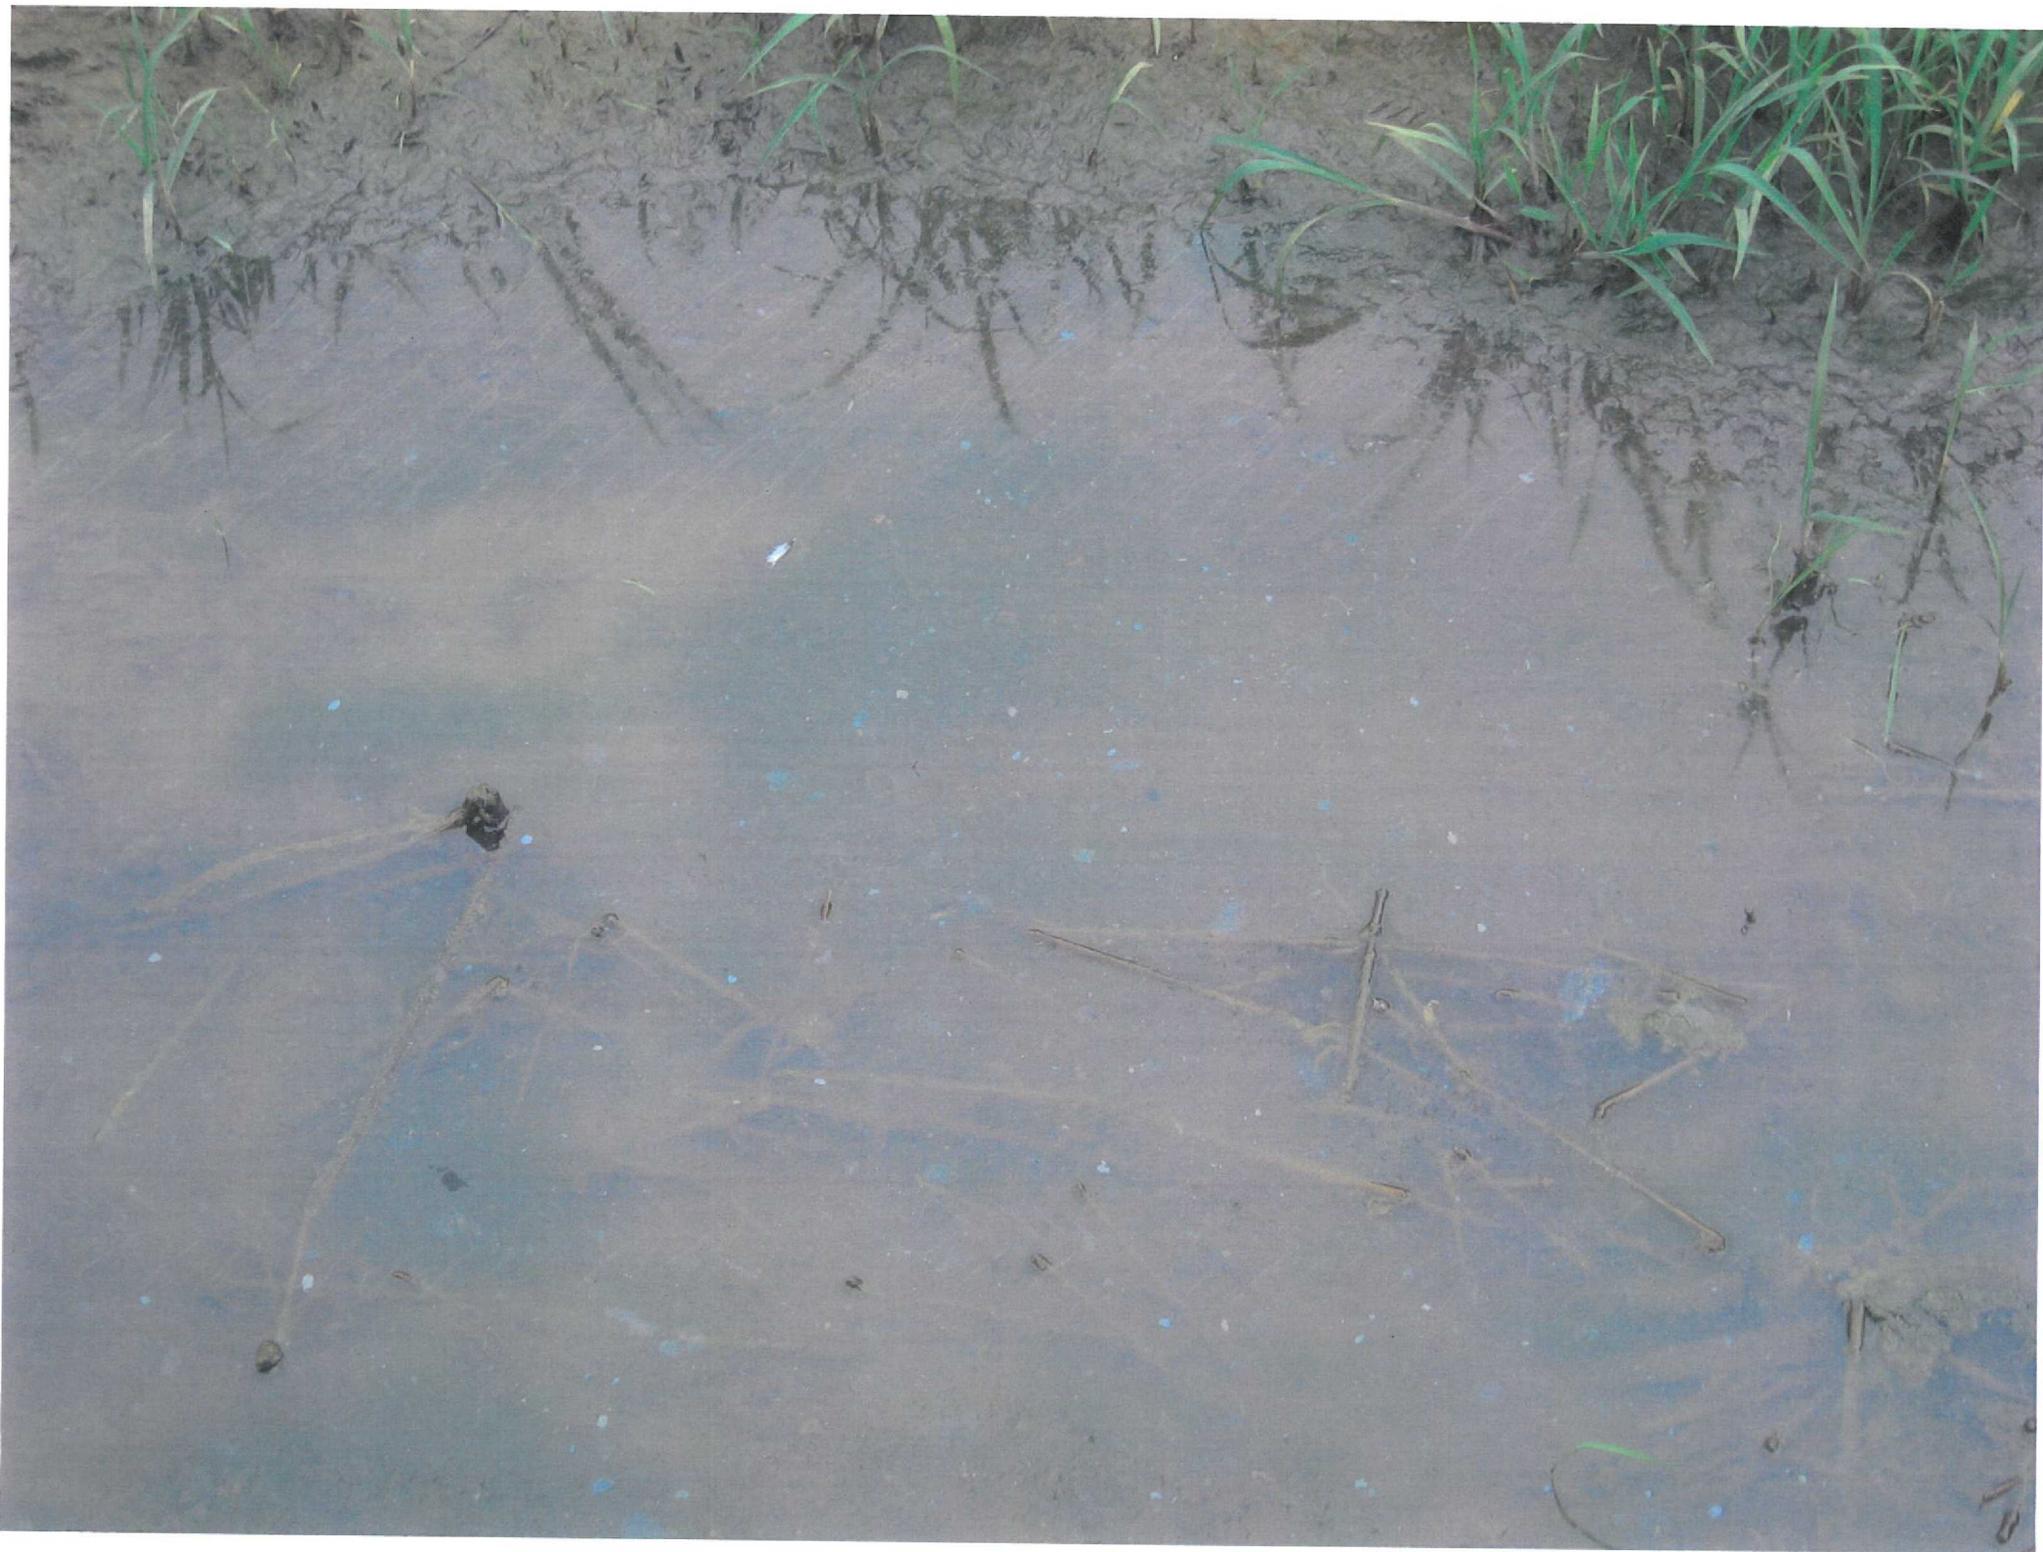
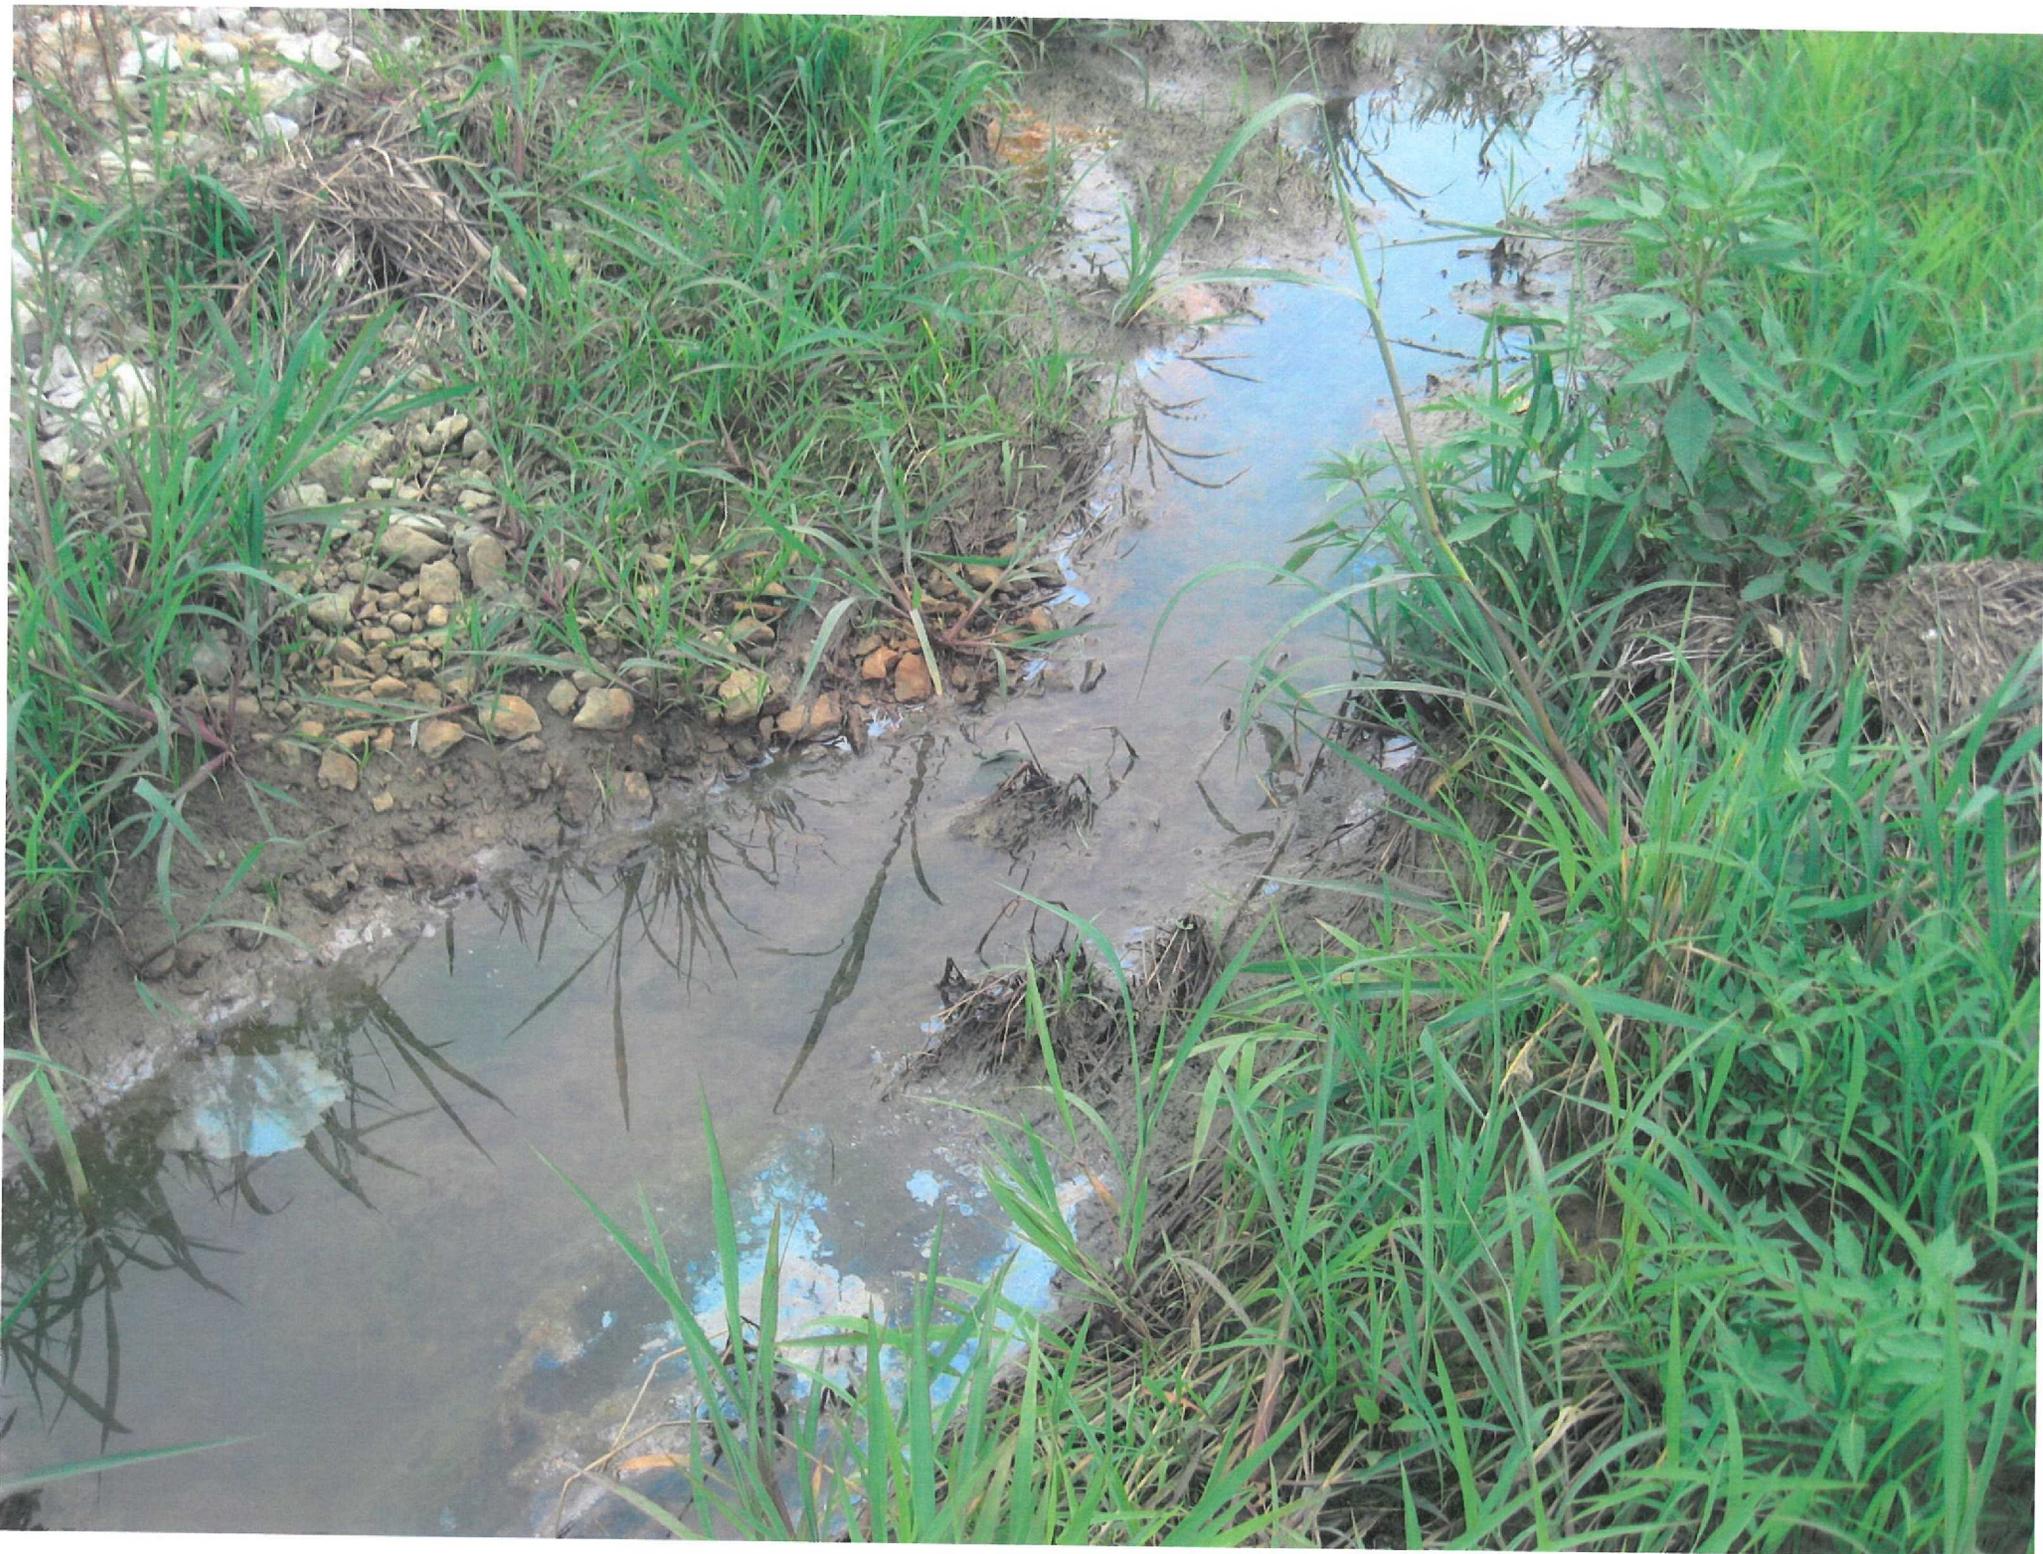
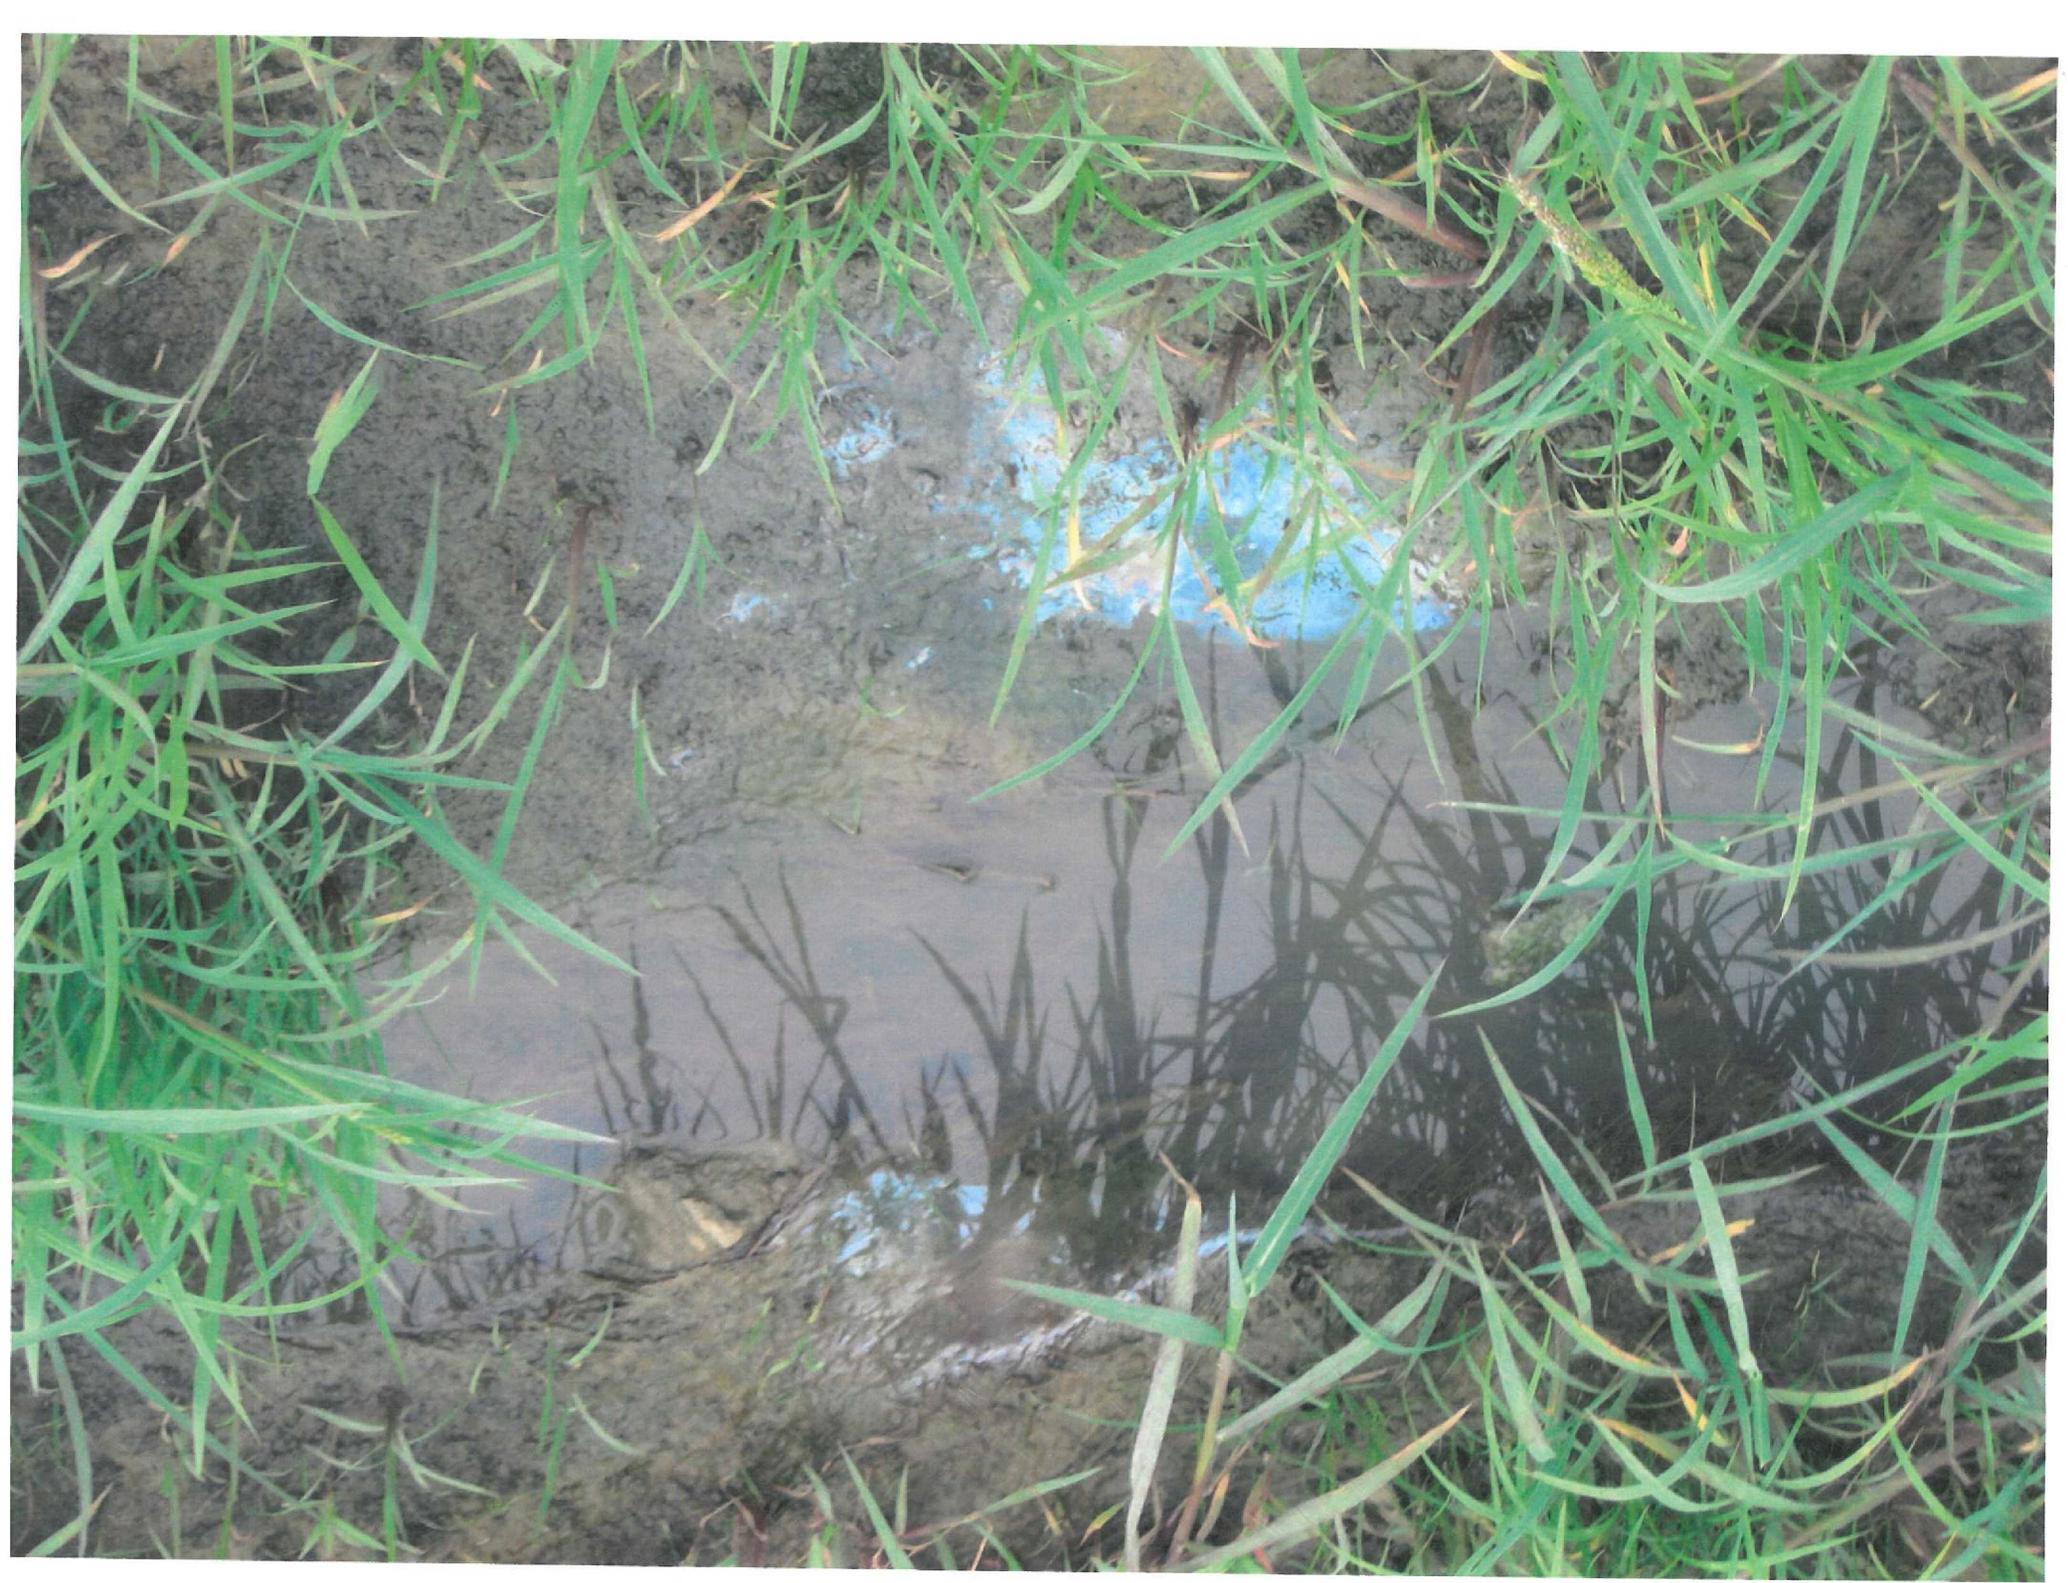
I noticed that the water in the ditch on the west end of the property contained oil sheen. The sheen seemed to be entering the ditch from a large cement pipe near the newly constructed parking lot. The photographs included, with this letter, document my observation. This ditch leads to an unnamed tributary of the Little Miami River. Yamada North America is not covered under any Ohio discharge permit which makes it illegal to discharge pollutants into a state water way.

- Sunk/Ditch on west end of property has some pollutant (oil, grease) in water. Ditch leads to a tributary of the Little Miami River

Please provide an explanation of what possible current activities may have caused a spill or leak of an oil/grease substance. What is the source of the water draining into the ditch on the west side of the building? Also, what actions will be implemented to eliminate the discharge of pollutants into the ditch? This information must be provided within 14 days of the receipt of this letter. This information will be used for an inspection of the Yamada plant at a later date.
