July 5, 2013

RE: WAYNE COUNTY
CITY OF ORVILLE
CONSTRUCTION STORM WATER
PERMIT NO: 3GC06104*AG
ORVILLE GOODWILL
NOTICE OF VIOLATION

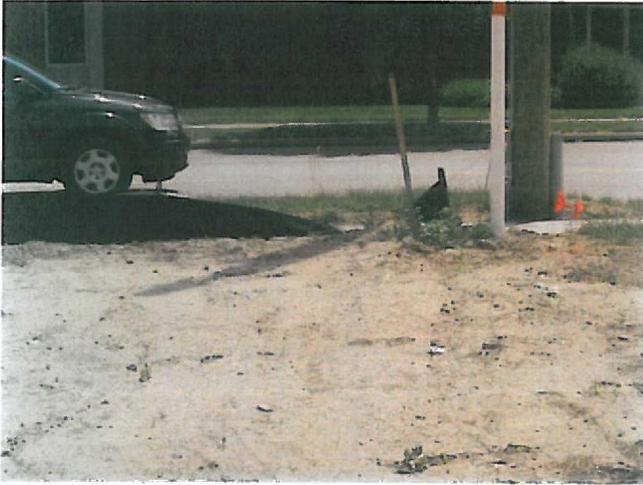
Figure 1: Silt fence in need of repair; stabilization needed.

- **Silt fence has not been installed in a functional manner or has not been maintained as required by Part III.G.2.d of the NPDES Permit.** All sediment controls, including silt fence, must be capable of ponding runoff in order to settle sediment. Silt fence must be trenched or backfilled and the joint stakes of the silt fence must be connected by twisting the stakes together prior to staking them into the ground. **Please ensure that all joints are twisted together and repair silt fence so that it is functional.** Silt fence must remain in place until the upslope contributing drainage area has reached final stabilization. (i.e., a vegetative growth density of 70% or greater has been achieved.) **In areas where the site is not graded inwards, such as near the entrance, silt fence is required to prevent runoff into the street. (Figure 1)**

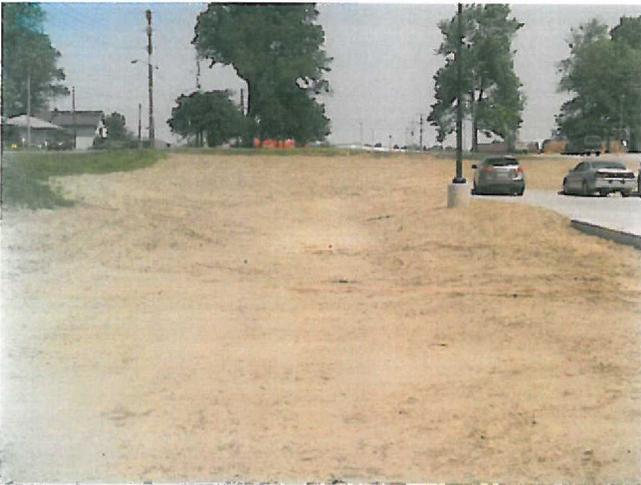
Figure 2: No stabilization on site, inlet covers need to be cleaned off

- **Stabilization, i.e., seeding and mulching, has not been initiated as required by the NPDES permit.** Temporary stabilization must be initiated within 7 days of last disturbance on any disturbed area of the site if it will not be further disturbed within 14 days of last disturbance. Permanent stabilization must be initiated within 7 days of reaching final grade. **It appears that construction activities have been completed on site, however, the site is yet to be stabilized. (Figure 2)**

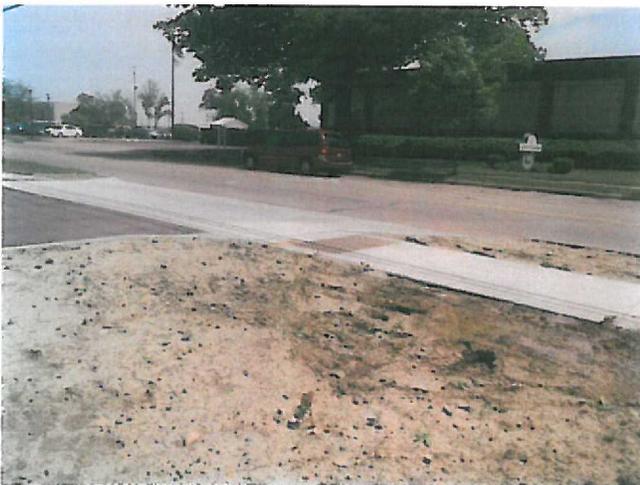
Figure 3: Water line break needs to be addressed, silt fence needed to prevent runoff into street
