July 5, 2013

RE: CUYAHOGA COUNTY
CITY OF CLEVELAND
CONSTRUCTION STORM WATER
PERMIT NO: 3GC06200*AG
MILES POINTE SENIOR LIVING CENTER

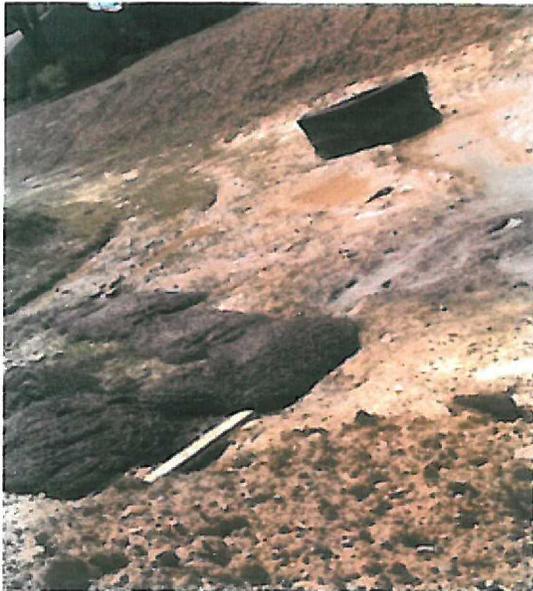
- **Non-sediment pollution controls require repair and maintenance as per the NPDES Permit.** There was no concrete washout pit on site. Having a concrete washout pit greatly reduces the chance of any contaminated runoff from entering the wetlands that are located on site. **(Figure 1)** Please note that secondary containment, such as a containment dike or drip pan, and a spill kit are required for fuel tanks. **(An email sent June 11 stated that the fuel cell had been removed)** The construction entrance on Miles Avenue failed to prevent sediment from being tracked off of the site. Sediment tracking can be minimized by ensuring that good housekeeping practices are being followed. Having somebody sweep the entrance once or twice a day will largely reduce the sediment build up on and outside the entrance. **(Figure 4)**

Figure 1: Wastewater associated with concrete washout could adversely affect the wetlands.

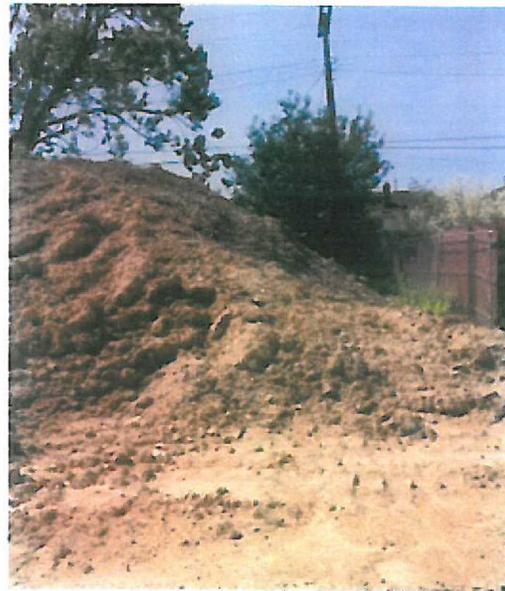
- **Stabilization, i.e., seeding and mulching, has not been initiated as required by the NPDES permit.** The seeding attempt that had taken place the previous fall is inadequate. Temporary stabilization must be initiated within 7 days of last disturbance on any disturbed area of the site if it will not be further disturbed within 14 days of last disturbance. Permanent stabilization must be initiated within 7 days of reaching final grade. The soil stockpile is specifically in need of stabilization. **(Figure 2)**

Figure 2: Stabilization is inadequate.

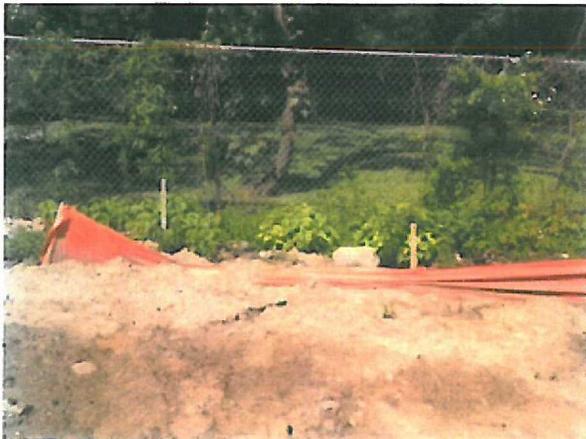
- **Silt fence has not been installed in a functional manner or has not been maintained as required by the NPDES Permit. (Figure 3)** All sediment controls, including silt fence, must be capable of ponding runoff in order to settle sediment. Silt fence must be trenched and backfilled and the joint stakes of the silt fence must be connected by twisting the stakes together prior to staking them into the ground. **Please ensure that all joints are twisted together and repair silt fence so that it is functional.** Silt fence must remain in place until the upslope contributing drainage area has reached final stabilization. (i.e., a vegetative growth density of 70% or greater has been achieved.)

Figure 3: Fallen silt fence needs repair.

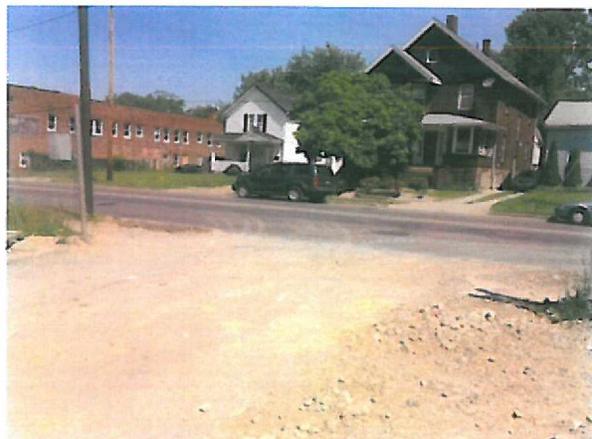
Figure 4: Construction entrance must be up kept.
