RE: California Yacht Club Vacant Land; NPDES Permit # 1GC04367*AG; Notice of Violation

On Wednesday, July 17, 2013, I inspected the California Yacht Club Vacant Land project located at 5731-5783 Panama Street in Cincinnati, Ohio, to determine compliance with its NPDES construction site storm water discharge permits. I walked the property but did not meet with anyone on the site. I did not review sediment control inspection logs, or the site's storm water pollution prevention plan (SWPPP).

Ohio EPA DSW Storm Water Section, Construction Site Visit Information Form

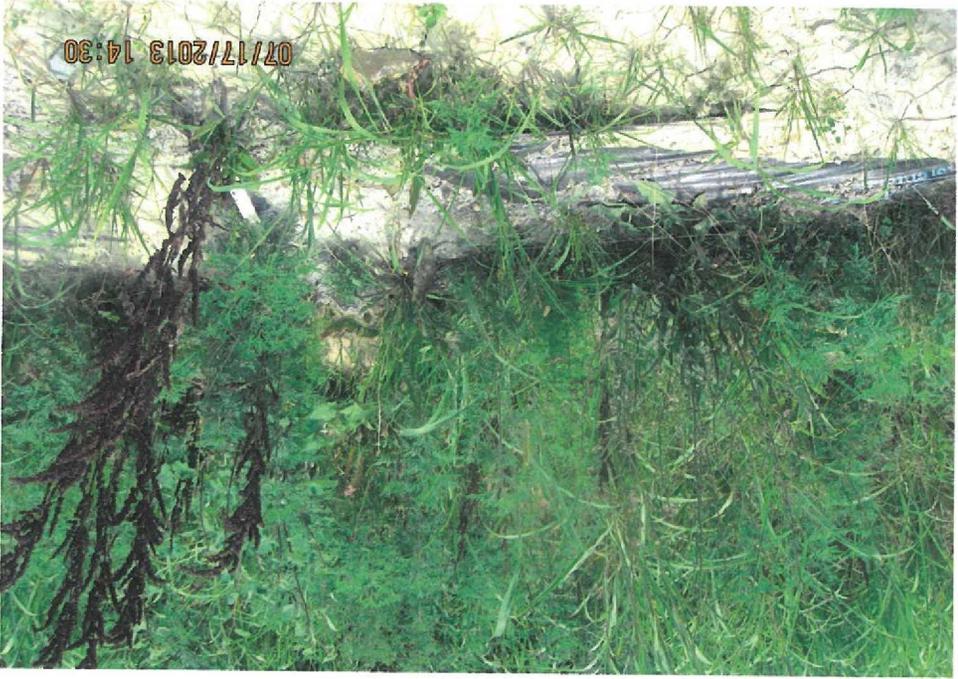
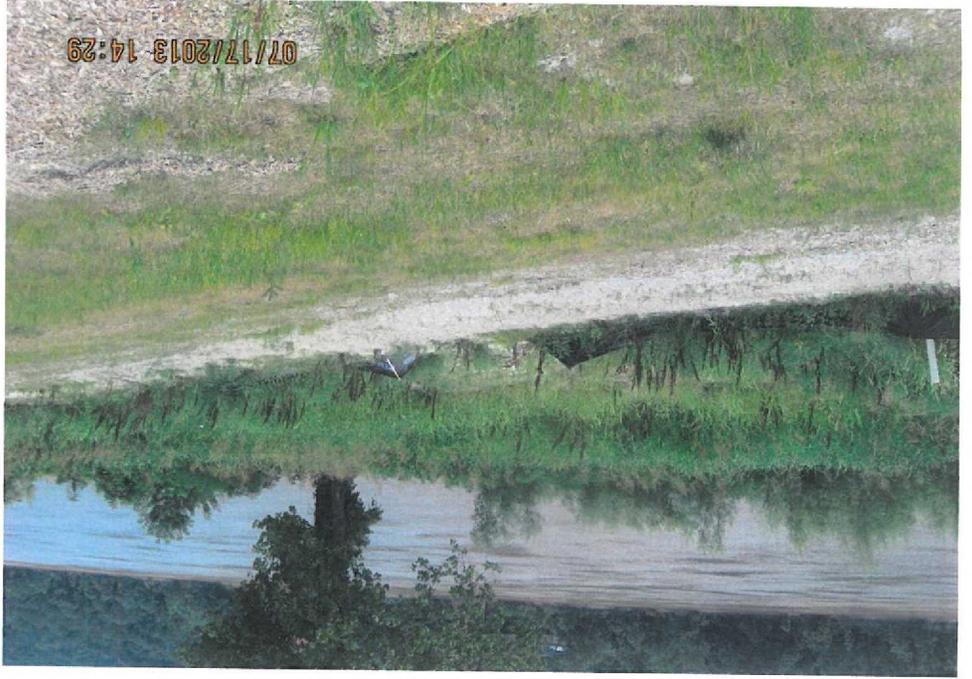
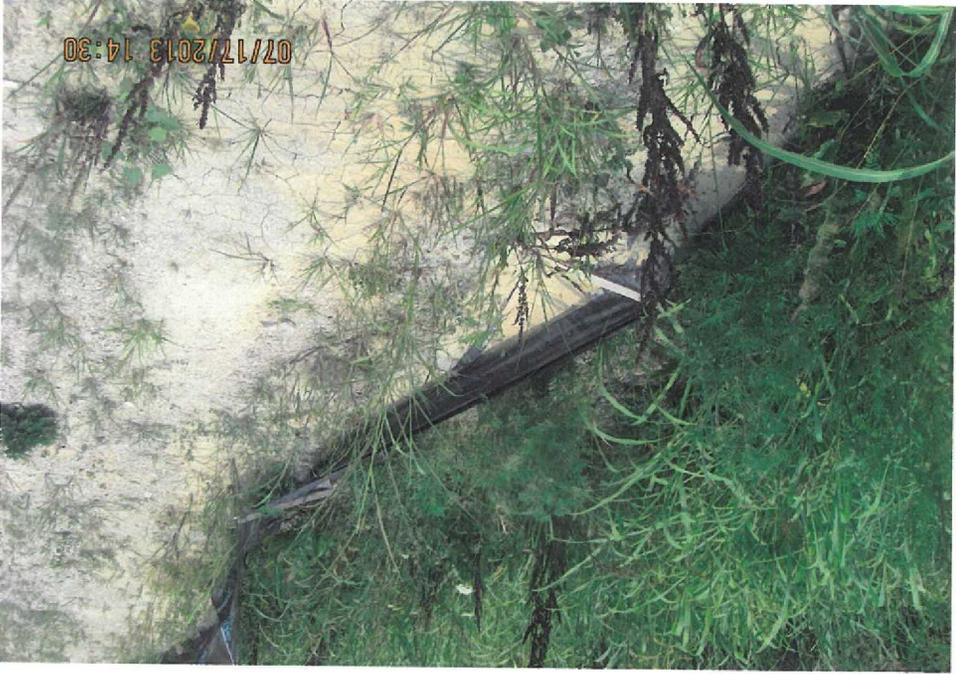
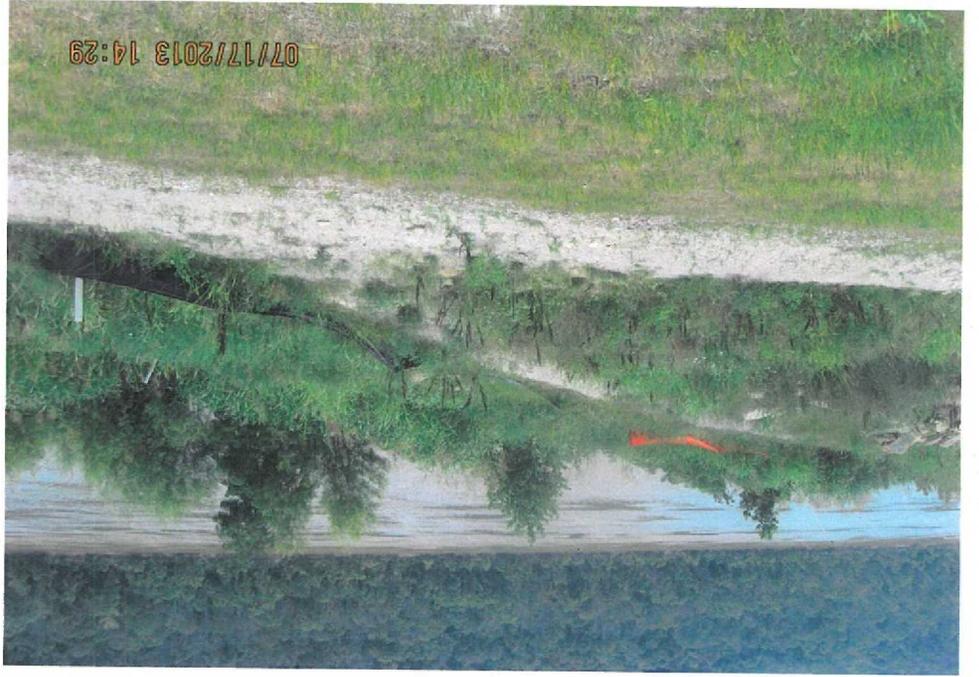
As shown in the attached photos, there are multiple areas along the western side of the property where silt fence has failed completely. Failure in these areas is allowing eroded sediment to be carried directly into the Ohio River during rainstorms. Repair and/or replacement of nearly all silt fence is needed for the entire length of the site that borders the river. Alternative sediment controls such as shallow earthen berms or berms made of mulch, wood chips or woody debris could be useful here, but should be located where a moderate rise in the river will not carry the material away.

4. Are BMPs needed: silt fence at base of river needs fixed/replaced

- almost all silt fence at base of Ohio River has failed
- appear no work has taken place in a while
- most land is unstabilized

Corrective action in this area would benefit in greatly reducing sediment runoff from the site.
