RE: Infinity Fitness; NPDES Permit # 1GC04545*AG; Compliance Inspection Findings

Ohio EPA DSW Storm Water Section, Construction Site Visit Information Form

Site Name: Infinity Fitness

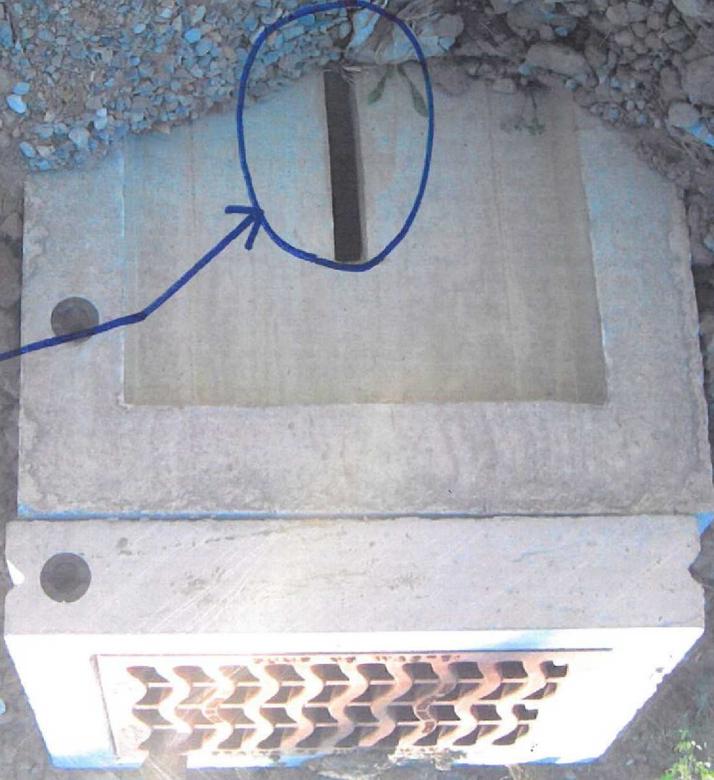
I do have a few questions concerning the unmodified storm water outlet/inlet structures in front of the Infinity Fitness building. The outlet is currently unprotected and is capable of letting sediment laden water leave the site. In order for this basin to function as a temporary sediment basin, the outlet structure should be modified using a temporary perforated riser as shown in the Ohio Department of Natural Resources (ODNR) Rainwater and Land Development Manual, chapter 6, page 12. This manual will be found at <http://www.dnr.state.oh.us/tabid/9186/default.aspx>. This outlet must be protected until all up slope areas are stabilized. The photograph included with this letter documents this issue.

Inlet Drain Structure is unprotected and could allow sediment laden water to enter the Tipp City storm sewer

Unprotected Outlet
Hole - leads to City
of Tapp City Sewer System

Another option would be to permanently stabilize the barren soil. Any areas at final grade must be permanently stabilized within seven days of the most recent disturbance. Stabilizing the barren soil with seed and straw will reduce erosion and minimize discharges of sediment from the site.

Stabilize Burren Soil
