RE: WAYNE COUNTY
CHIPPEWA TWP
SUNDIAL MHP
NPDES #3PV00121

NOTICE OF VIOLATION

On July 10, 2013, Dean Stoll and this writer conducted an inspection of the wastewater treatment plant (WWTP) serving the above referenced facility. The intent of the inspection was to evaluate the progress of the WWTP since this office's previous inspection. You represented the facility during the inspection.

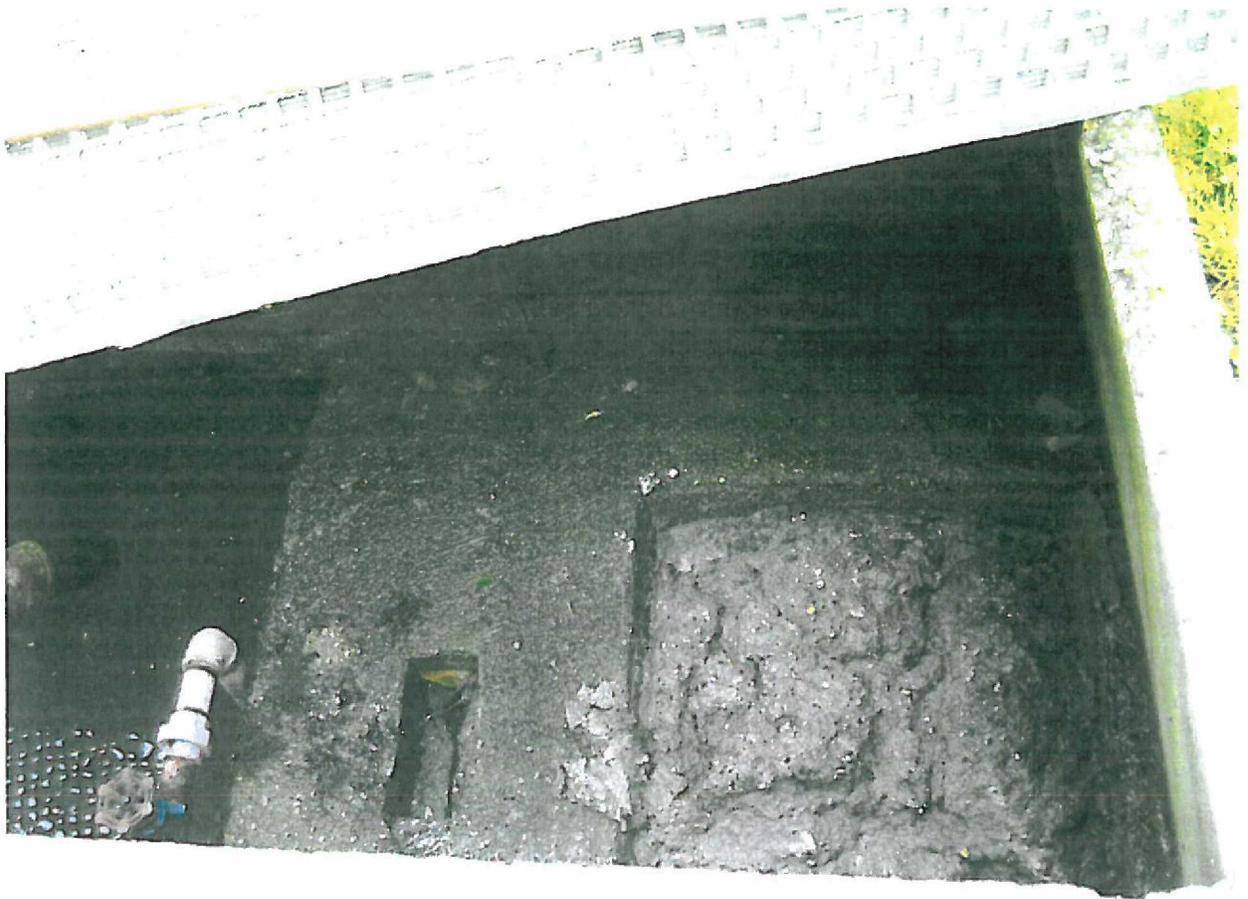
- 2) The trash trap was full on solids and needed to be pumped out. You need to schedule a licensed hauler to pump out the trap. Attached photo 1 shows the condition of the trash trap.

Photo 1: Trash trap full of solids.

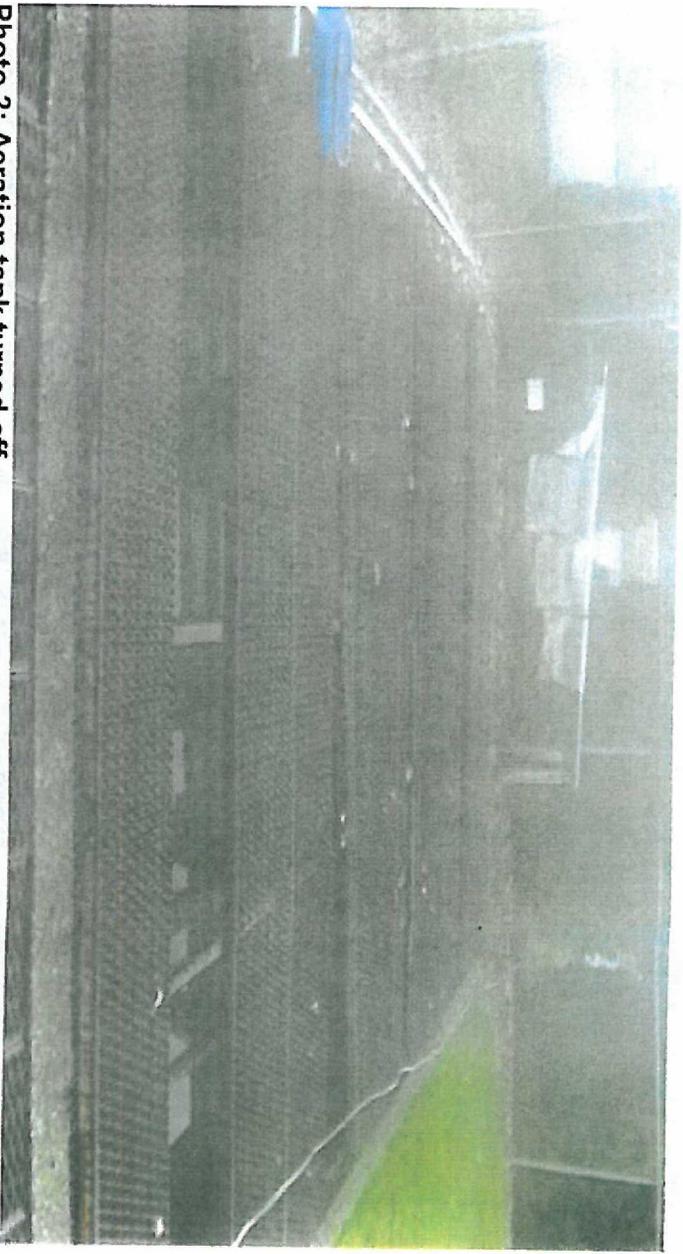
- 3) When Ohio EPA arrived on site, the air to the aeration tank was turned off. You stated this was so the solids could settle and the tank could be pumped out. By not having the air turned on the sewage was not receiving proper treatment. Attached photo 2 shows the aeration tanks turned off.

Photo 2: Aeration tank turned off.

Your expired NPDES permit contained a compliance schedule that required you to submit a Permit-to-Install (PTI) for a sludge holding tank. To date a PTI has not been received and the sludge holding tank has not been installed. You are in noncompliance with your NPDES permit for failing to comply with your compliance schedule.

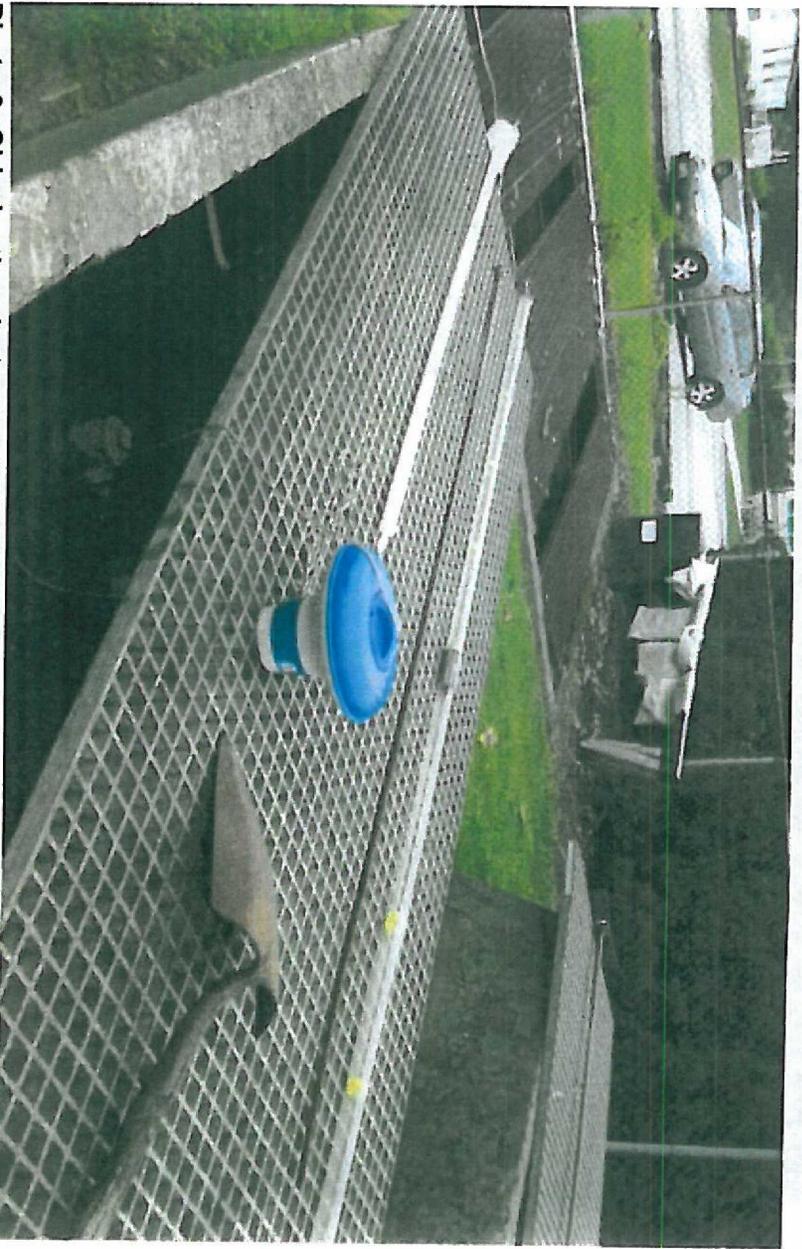
- 4) The WWTP does not have a chlorination/dechlorination contact tank. Currently, you feed chlorine into the clarifier with a device made for a swimming pool. This method of chlorination does not meet treatment standards and does not provide disinfection to the wastewater. Attached photo 3 shows the chlorine device.

Photo 3: Chlorination device in clarifier.

Your expired NPDES permit contained a compliance schedule that required you to submit a Permit to Install (PTI) for a disinfection system. To date a PTI has not been received and a disinfection system has not been installed. You are in noncompliance with your NPDES permit for failing to comply with your compliance schedule.

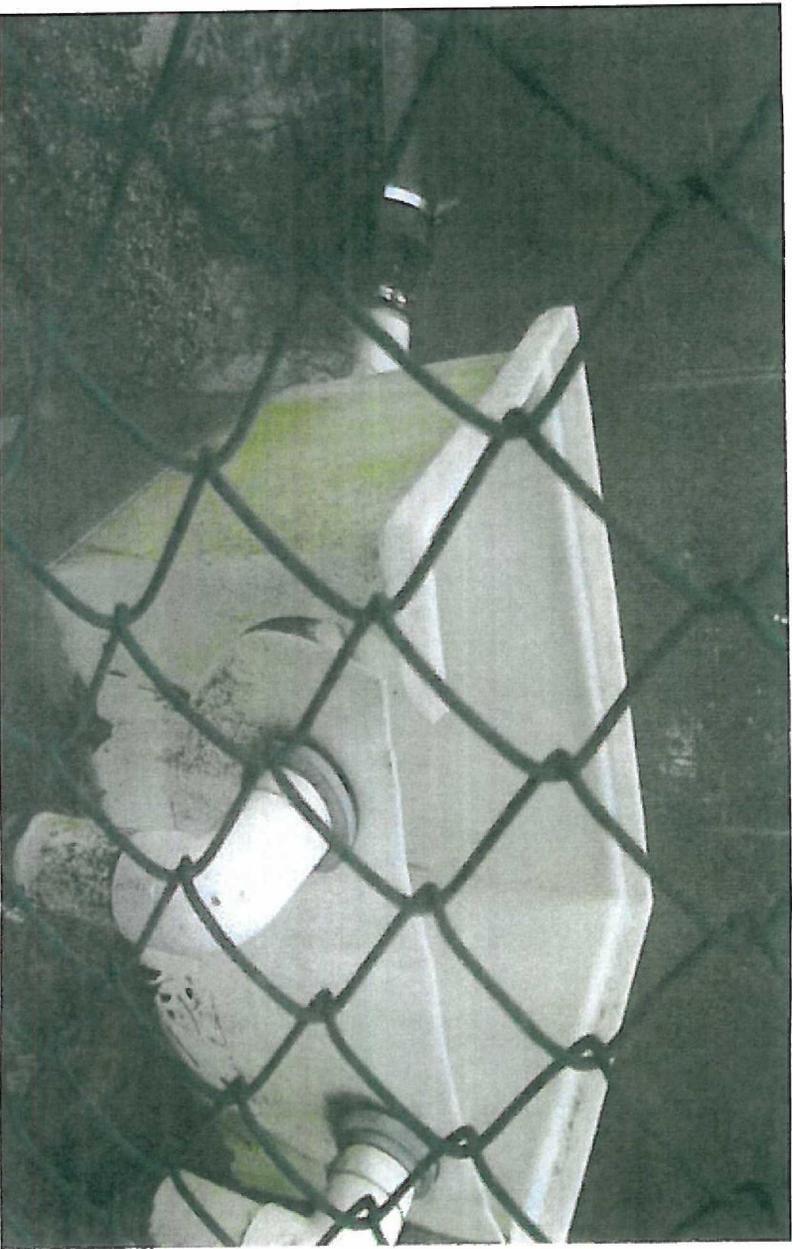
- 6) The splitter box for the sand filter beds was broken and leaking wastewater on the ground. Bypassing around any portion of your treatment system violates the conditions of your NPDES permit, specifically Part III, item 11. Photo shows the broken splitter box. Attached photos 4 and 5 show the splitter box.

Photo 4: Broken splitter box.

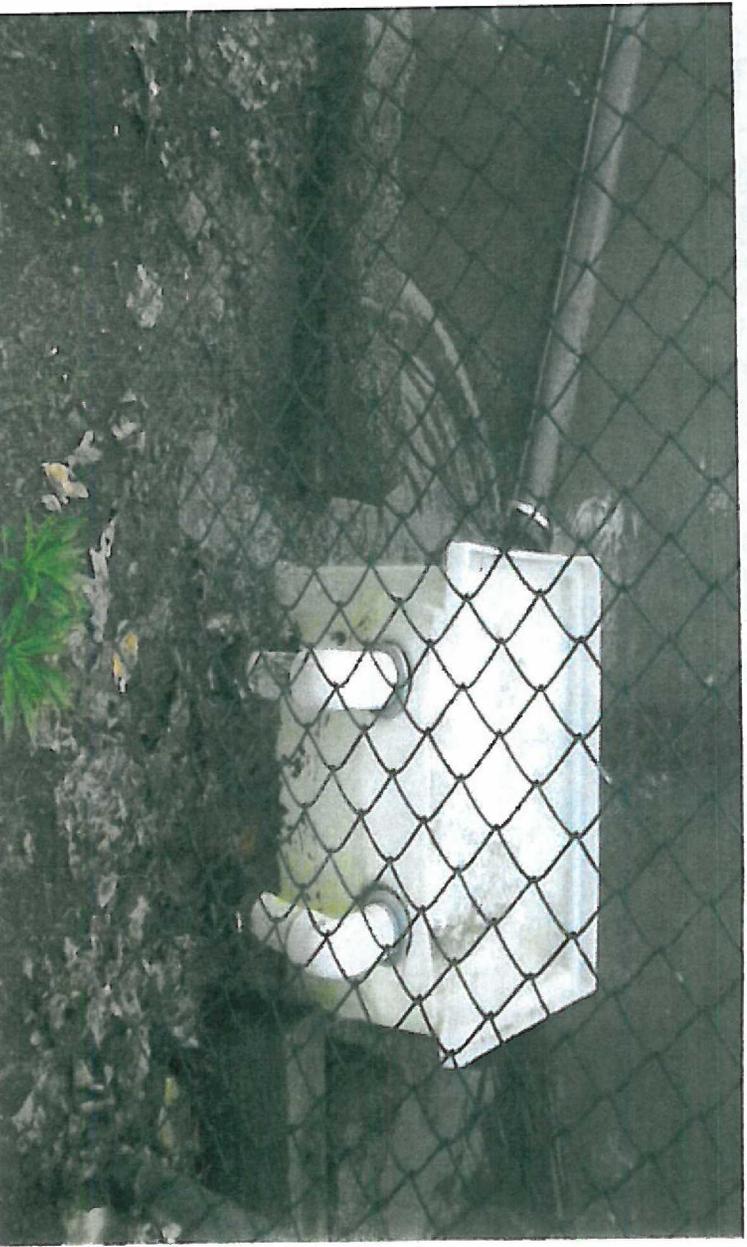
Photo 5: Broken splitter box discharging wastewater onto the ground.

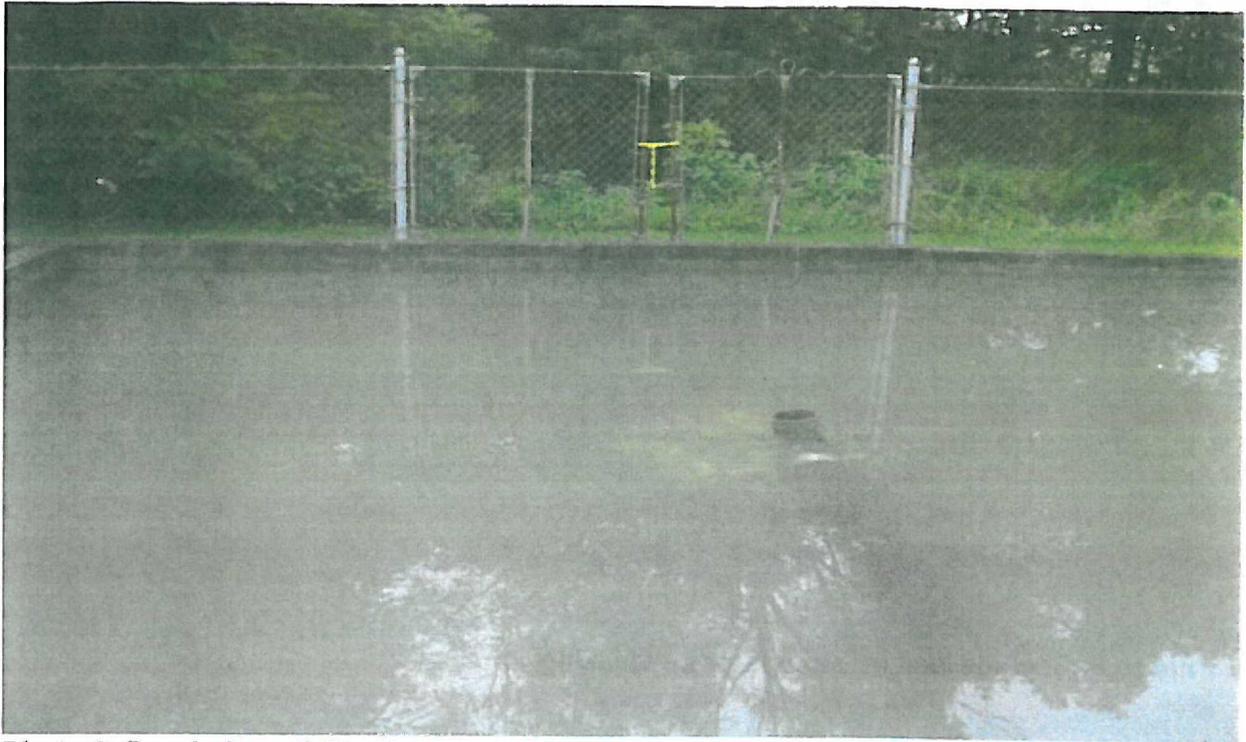
- 7) The sand filter beds were found in poor condition. The walls were cracked and wastewater could be seen spilling from one bed to another. Additionally, the sand was in poor condition and solids were accumulating on the surface. Water was pooling on the surface of the filter beds and was slow to drain which is another indication that the beds are full of solids. You stated during the inspection that the sand has not been replaced. Photo shows the poor condition of the filter beds. Attached photos 6, 7 and 8 show the condition of the sand filter beds.

Photo 6: Ponded sand filter bed.

Your expired NPDES permit contained a compliance schedule that required you to replace the sand in the sand filter beds and to repair the beds. To date, the sand filter beds have not been addressed. You are in noncompliance with your NPDES permit for failing to comply with your compliance schedule.

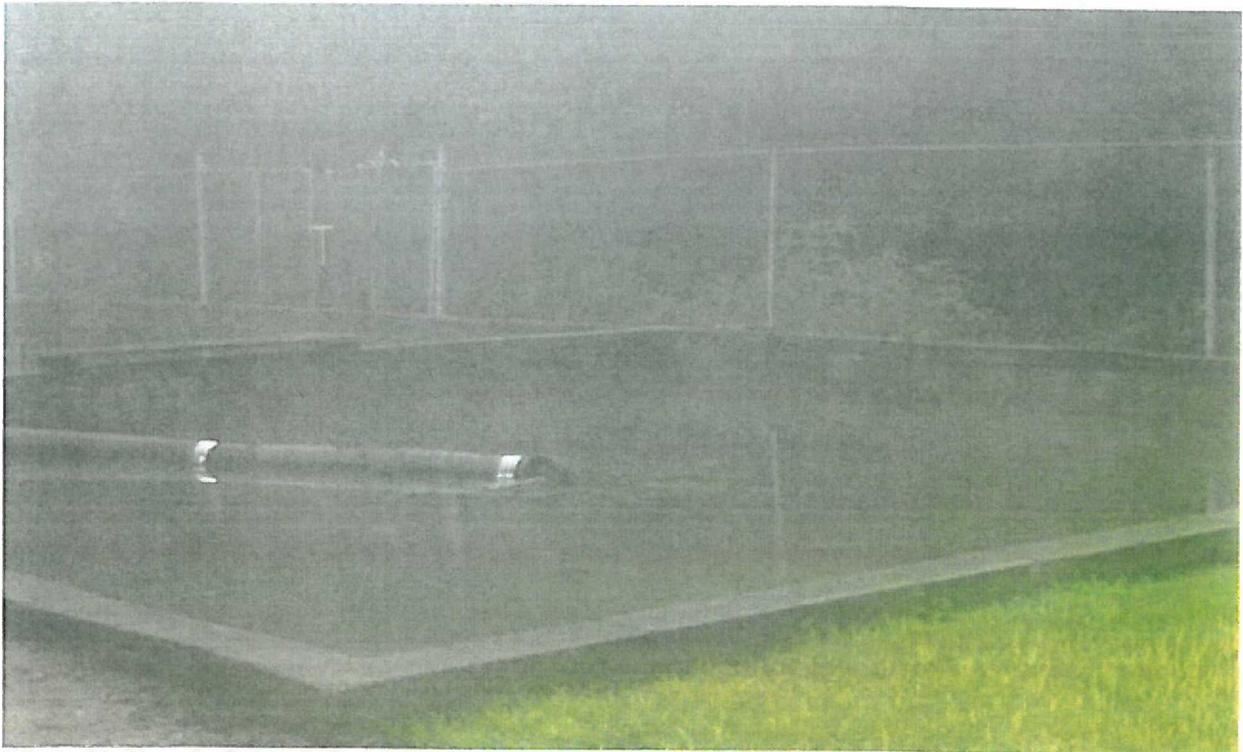
Photo 7: Ponded sand filter bed in poor condition.

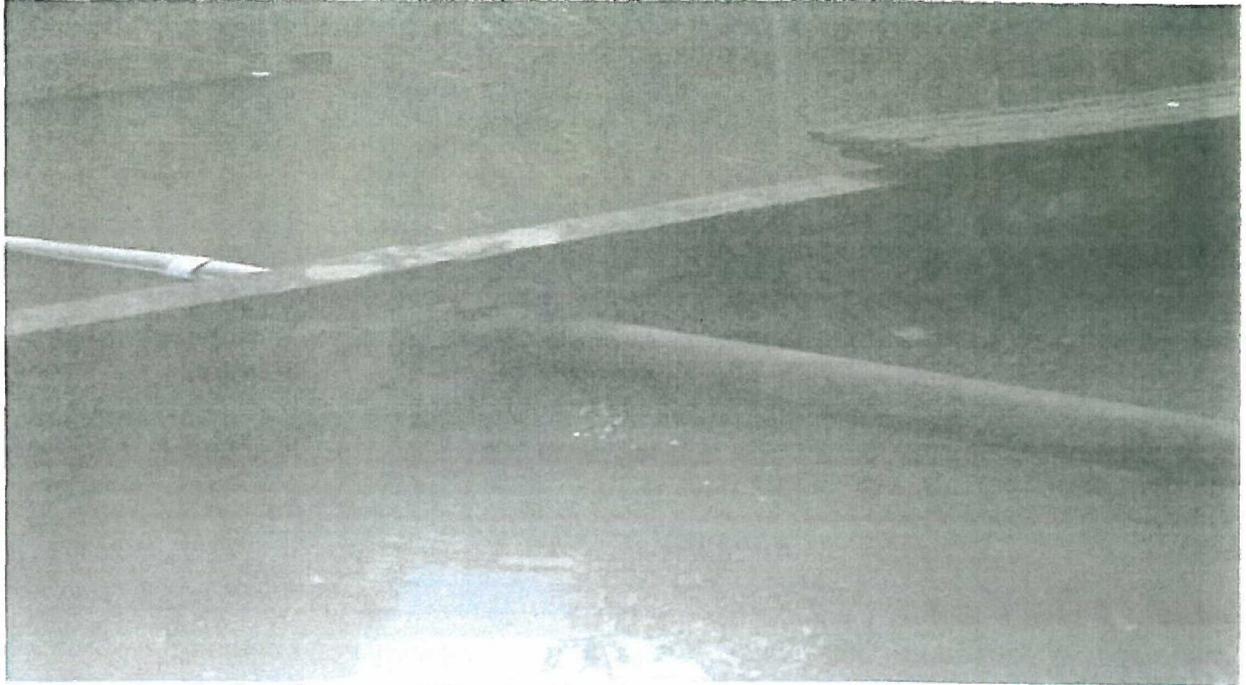
Photo 8: Cracked wall on sand filter bed leaking.

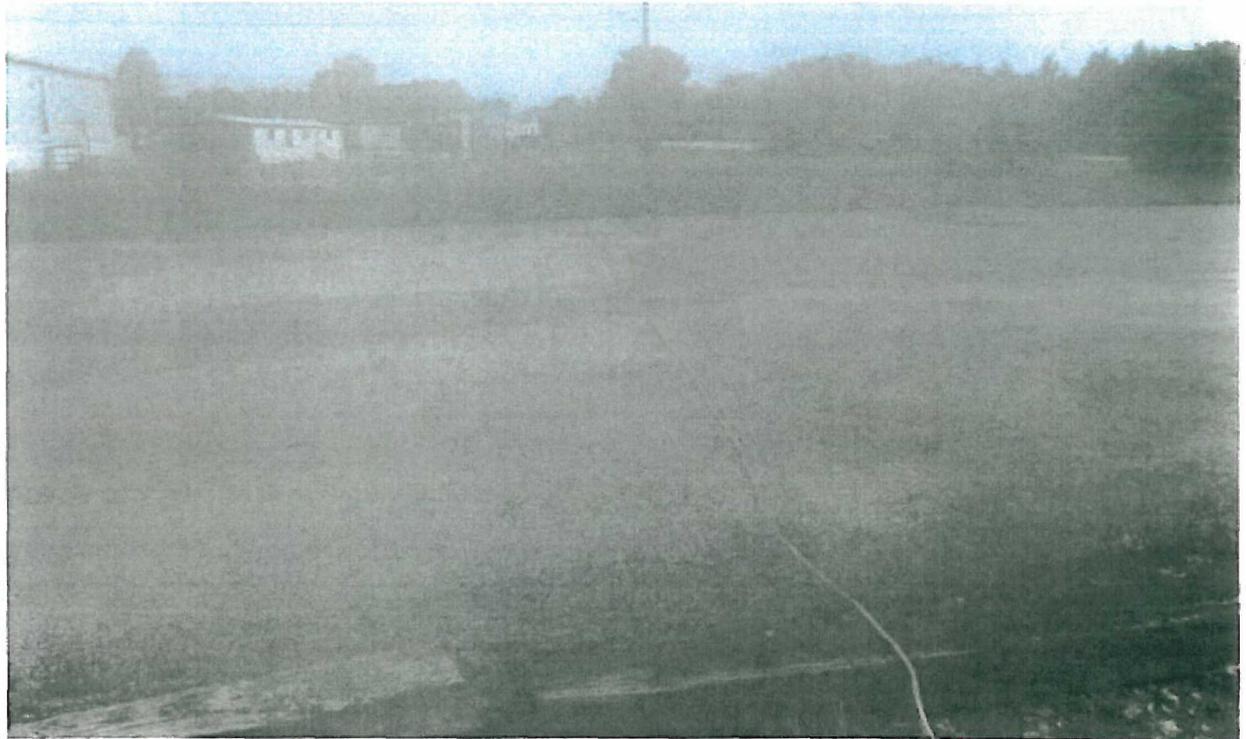
- 8) The electric service to the plant is being provided by an exposed wire stretched on top of the ground. The wire crosses the roadway which cars are driving over and people are walking over. The exposed electrical wire is a health and safety issue which should be fixed immediately. Photo shows the exposed electrical connection. Attached photo 9 shows the exposed electrical connection.
- 9) A review of your Discharge Monitoring Reports (DMR) covering the period January 1, 2010, through June 30, 2013, reveals that you did not start submitting reports till July 1, 2012. Since July 1, 2012, you have been submitting monthly DMR. Not submitting discharge monitoring reports is a violation of your NPDES permit. Since July 1, 2012, records reveal no limit violations.

Photo 9: Exposed electrical connection across the road.
