RE: CUYAHOGA COUNTY  
CITY OF CLEVELAND  
INDUSTRIAL STORM WATER  
BROKEN WHEEL AUTO PARTS &  
WRECKING  
#3GR00135\*EG

**NOTICE OF VIOLATION**

On June 18, 2013, Ohio EPA conducted an inspection at the Broken Wheel Auto Parts & Wrecking facility located at 4343 West 130<sup>th</sup> Street. Our inspection's purpose was to determine compliance with the Ohio EPA General Storm Water National Pollutant Discharge Elimination System (NPDES) Permit for Industrial Activity #OH000005. The site's industrial activities are categorized by the Standard Industrial Classification (SIC) Code 5015: Automobile Salvage Yard. During the inspection, you represented Broken Wheel Auto Parts & Wrecking. Josh Bewley and I represented the Ohio EPA.

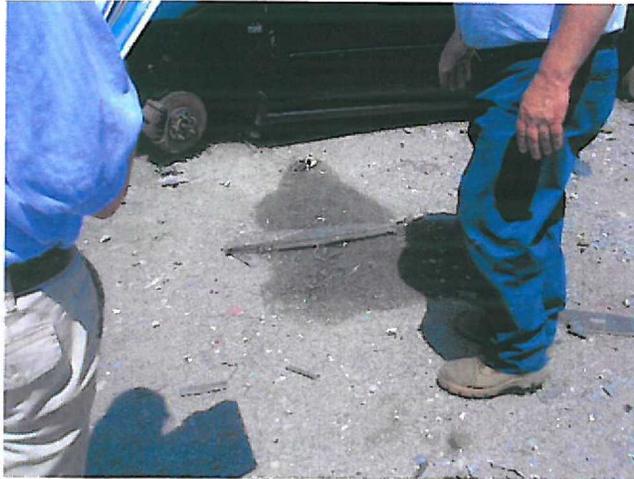
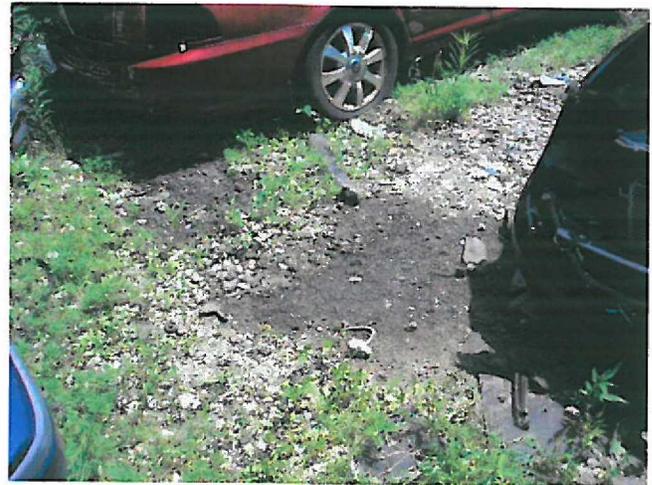
1. There were random oil spills throughout the site. These need to be cleaned immediately and good housekeeping practices need to be set into place to guarantee any future problems. ( See **Fig 1, 2 & 3**)

**Figure 1:** (*Upper Left*) Oil Stain in the lot.  
**Figure 2:** (*Above*) Oil Stain in the lot.  
**Figure 3:** (*Left*) Fluids leaving the tear down building and entering the lot.

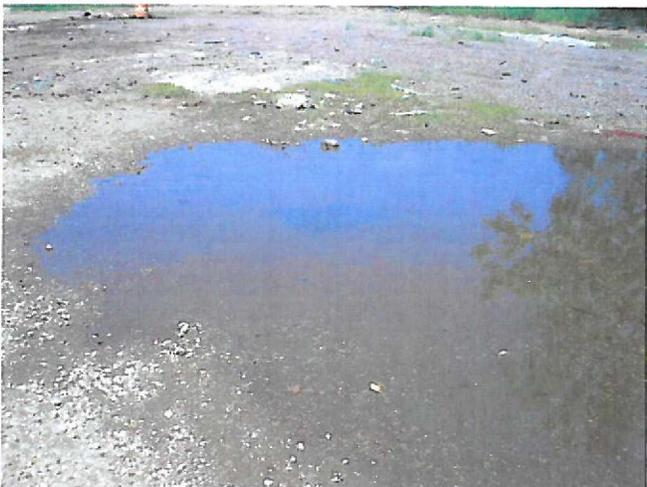
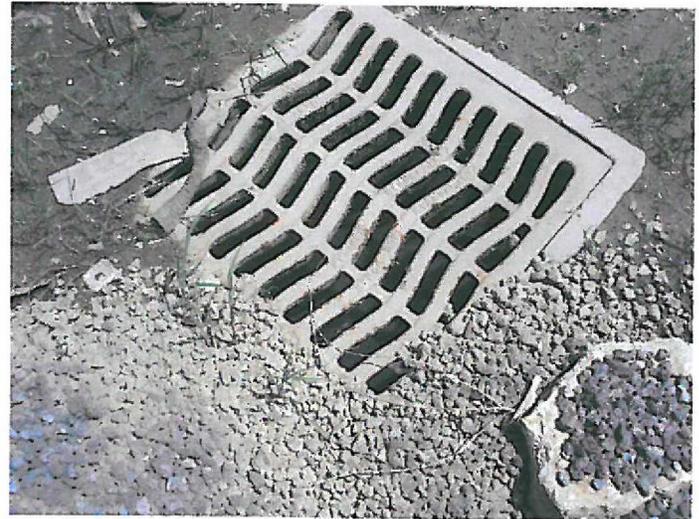
4. The drains on site all experienced a lot of sediment flowing into them. If it is found that these do not flow to combined sewer, a potential pollution problem can occur. Practices need to be put into place to keep the sediment out of the drains. (See **Fig 4 & 5**).

**Figure 4:** (*Above*) Drains on site that sediment and rocks were flowing into.  
**Figure 5:** (*Left*) Drain where majority of the water pools on the lot.
