RE: LAKE COUNTY
PAINSVILLE TOWNSHIP
INDUSTRIAL STORM WATER
AMERICAN ROLL FORMED
PRODUCTS
3GR01761*AG

NOTICE OF VIOLATION

On July 10 2013, Ohio EPA conducted an inspection at the American Roll Formed Products facility located at 892 Callendar Boulevard. Our inspection's purpose was to determine compliance with the Ohio EPA General Storm Water National Pollutant Discharge Elimination System (NPDES) Permit for Industrial Activity #OH000005. The site's industrial activities are categorized by the Standard Industrial Classification (SIC) Code 3449: Fabricates Metal Products, except Machinery & Transportation Equipment, and Coating, Engraving & Allied Metals. This corresponds to Subsector AA1 in Part 8 of the NPDES permit. During the inspection, you, Ryan Mohr, represented American Roll Formed Products. I represented the Ohio EPA.

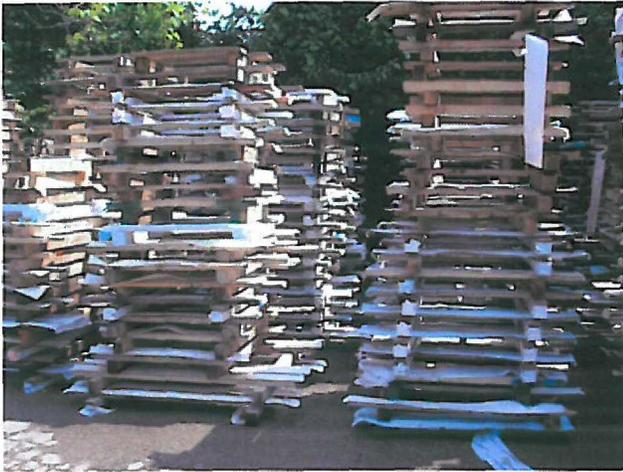
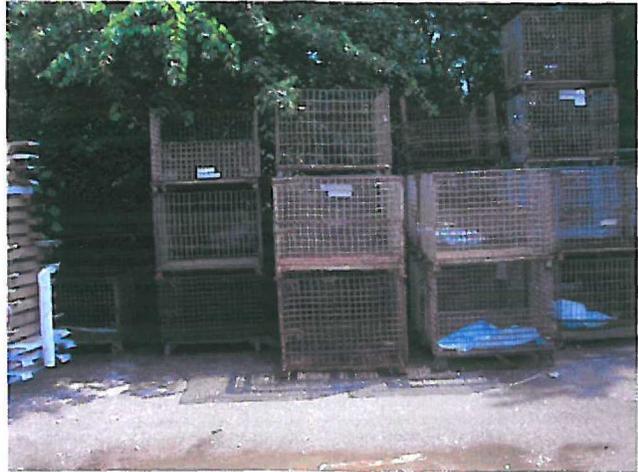
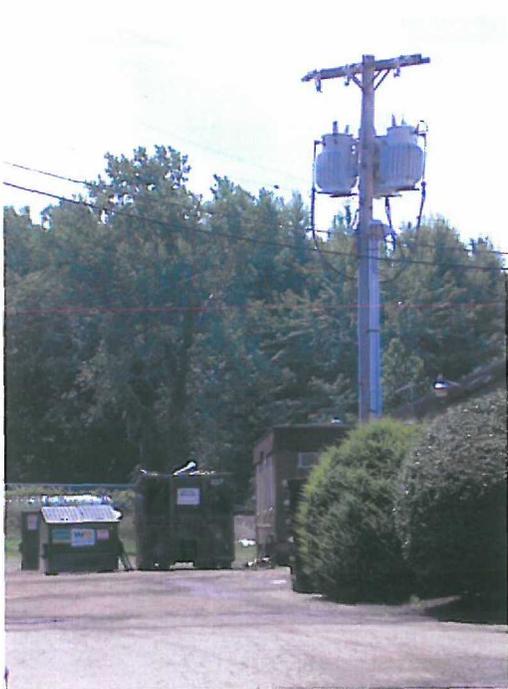
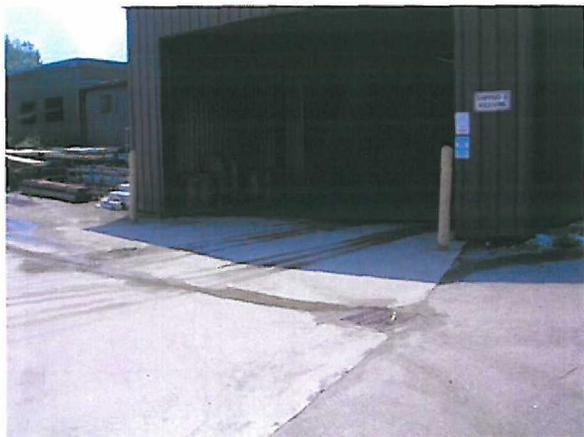
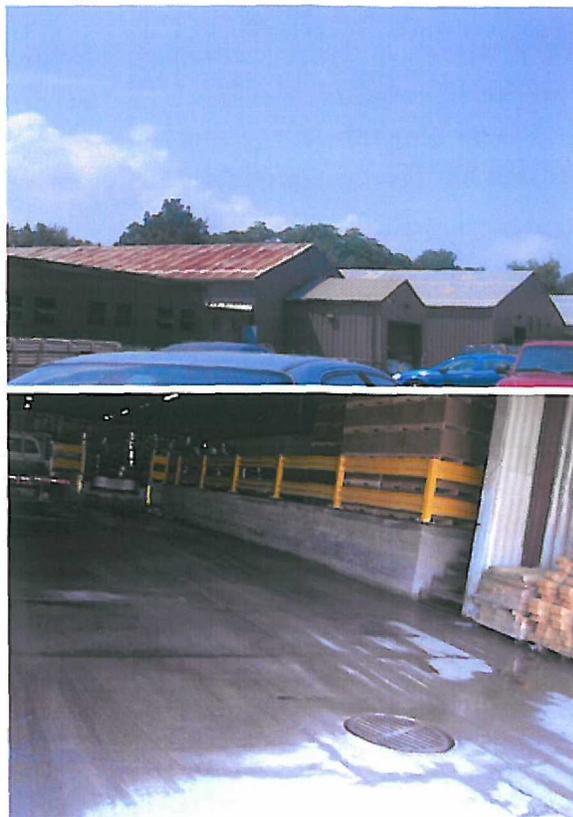
Figure 1: (top left) pallet stock pile
Figure 2: (above) metal scrap stock pile
Figure 3: (left) uncovered dumpsters
Figure 4: (bottom left) drain in front of the shipping and receiving garage
Figure 5: (below) rusted roofs that lead to runoff drains
Figure 6: (bottom right) drain inside S&R garage
