RE: CUYAHOGA COUNTY
CITY GARFIELD HEIGHTS
INDUSTRIAL STORM WATER
TOMLINSON INDUSTRIES
3GR00015*EG

NOTICE OF VIOLATION

On July 16, 2013, Ohio EPA conducted an inspection at the Tomlinson Industries facility located at 13700 Broadway Avenue. Our inspection's purpose was to determine compliance with the Ohio EPA General Storm Water National Pollutant Discharge Elimination System (NPDES) Permit for Industrial Activity #OH000005. The site's industrial activities are categorized by the Standard Industrial Classification (SIC) Code 3432: Fabricated Metal Products, except Machinery & Transportation Equipment, and Coating, Engraving, & Allied Services. This corresponds to Subsector AA1 in Part 8 of the NPDES permit. During the inspection, Christine J. Lucas represented Tomlinson Industries. Dean Stoll and I represented the Ohio EPA.

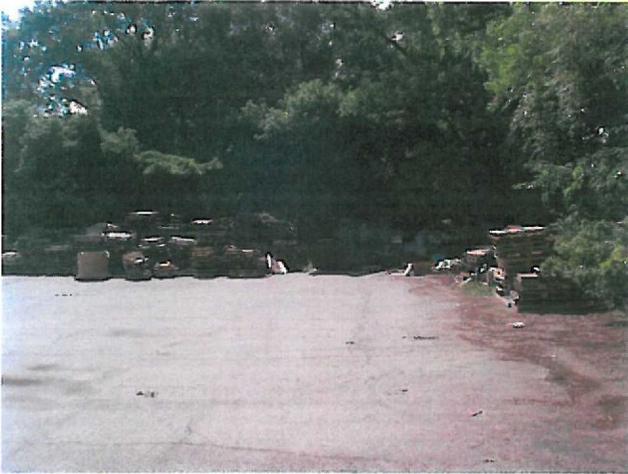
1. The pallet stock piles in the modular area have the potential of leading to possible pollutants if residuals happen to be stored within the wood. It is recommended to keep these stock piles under a covering. **(See Fig 1)**

(Starting top left and going clockwise)
Figure 1: Pallet stock piles
Figure 2: Uncovered dumpsters
Figure 3: Unknown orange discharge from outfall 003
Figure 4: Trash outside of compactor
Figure 5: Sediment getting into drain
Figure 6: Broken asphalt getting into drain.

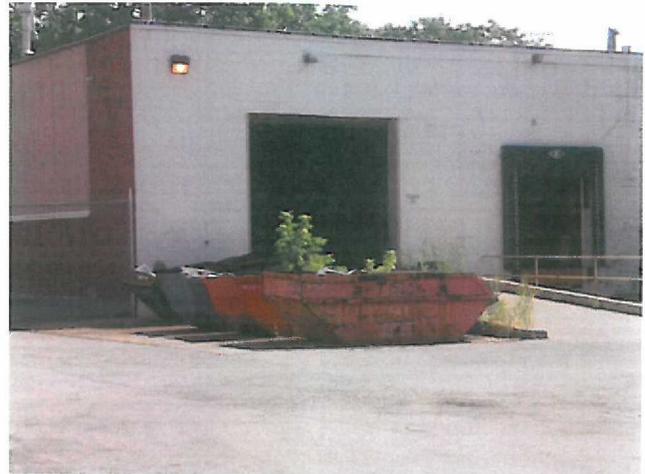
2. All dumpsters on site must have covering unless kept inside. **(See Fig 2)**
3. There was an unknown orange discharge coming from outfall 003. It was discussed that this discharge should be identified, cleaned up, and its source be located to prevent any further pollution. **(See Fig 3)**

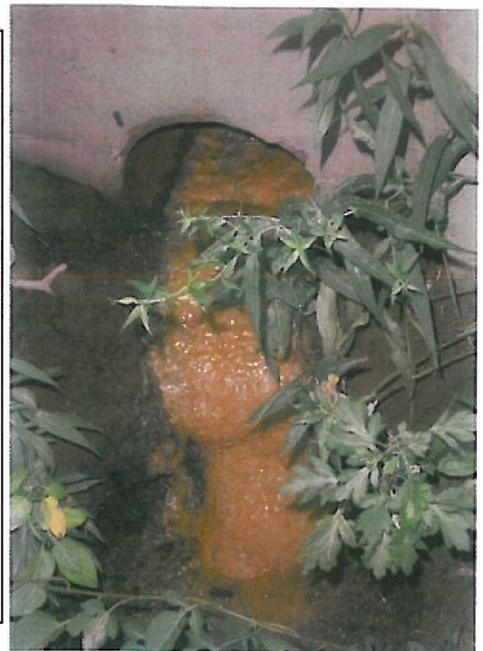
4. The area around the trash compactor needs good housekeeping to keep any of the trash that has spilled over from getting into the storm water. **(See Fig 4)**

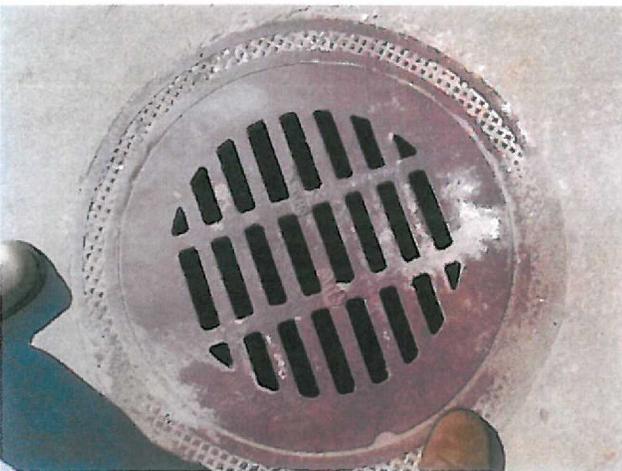
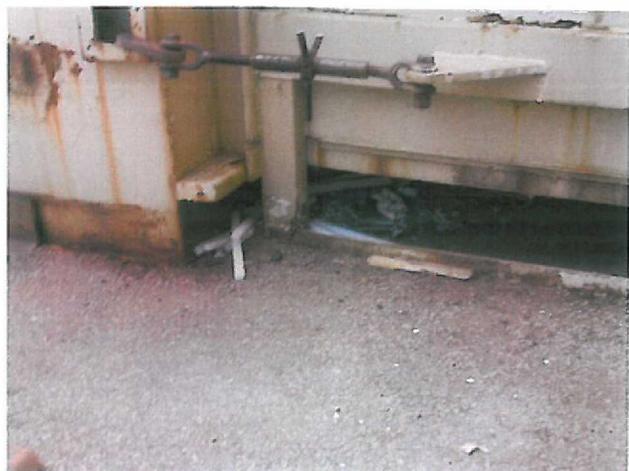
5. The drains on the lot were observed to have sediment and broken up asphalt going into them. Sweeping the lot would cut down on the amount of sediment that reaches the drain. It was also discussed that patching the broken asphalt by the drain would eliminate that specific issue. **(See Fig 5 & 6)**
