RE: CUYAHOGA COUNTY  
VILLAGE OF CUYAHOGA HEIGHTS  
INDUSTRIAL & CONSTRUCTION  
STORM WATER  
CHARTER STEEL  
3GR01053\*EG (INDUSTRIAL)  
3GC06113\*AG (CONSTRUCTION)

**NOTICE OF VIOLATION**

**CHARTER STEEL**  
Cleveland Cuyahoga County

**Photos Taken:** May 30, 2013  
**By:** Juliana Murphy, DSW, NEDO

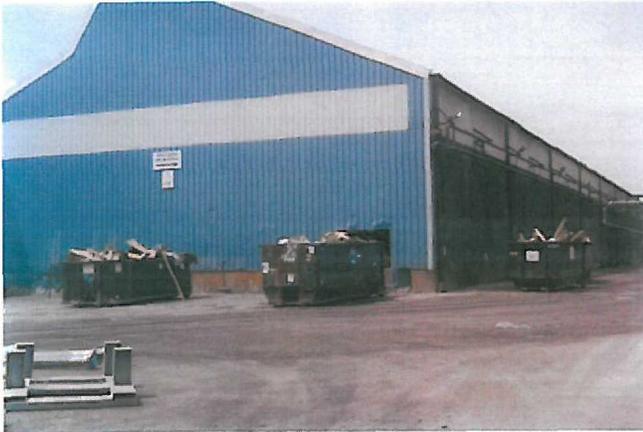
**Figure 1:** *(Top Left)* Uncovered dumpsters  
**Figure 2:** *(Middle Left)* Uncovered coal stock pile  
**Figure 3:** *(Bottom Left)* Sediment from the lot washing directly into the storm drain and clogging it. This is near slag stock piles.  
**Figure 4:** *(Top Right)* Drain with holes in it where runoff from the outdoor scrape is going.

- Section 2.3.2 of the SWP3 states that *all construction-related trash will be collected and stored in a securely **covered** metal dumpster*. The dumpsters that we saw on site were not covered by a tarp or lid. (**Figure 1**)

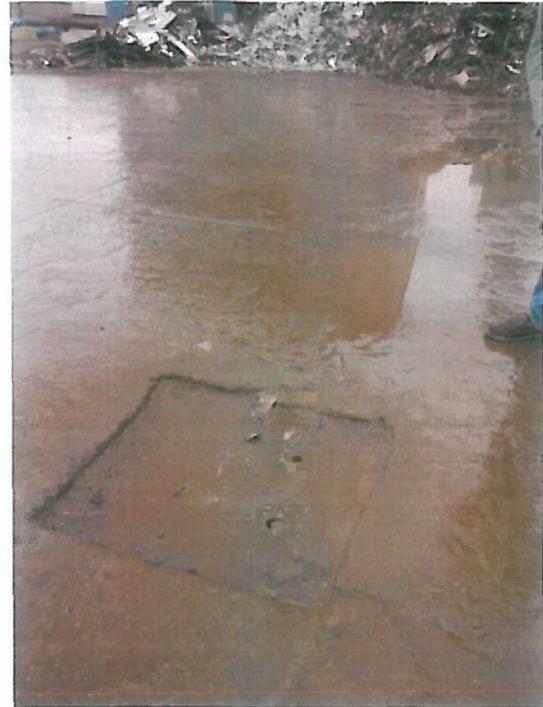
1. **Failure to minimize exposure of manufacturing, processing and material storage areas to rain, snow, snowmelt and runoff.** This is a violation of Part 2.12.1 of the NPDES permit and ORC 6111.04 and 6111.07. In particular, we noted that coal, HPI, scrap metal, billets, coils, refractories, slag, limestone and other waste storage areas were exposed to precipitation. In many instances, exposure could be minimized by moving materials under existing shelters, lidded bins or covering with tarps. This is particularly true for material stored in waste dumpsters (see **Figure 1**) and in the scrap yard (see **Figure 4**). In other instances, shelters may need to be expanded to align with expected storage needs, e.g., coal storage and HPI (see **Figure 2**).

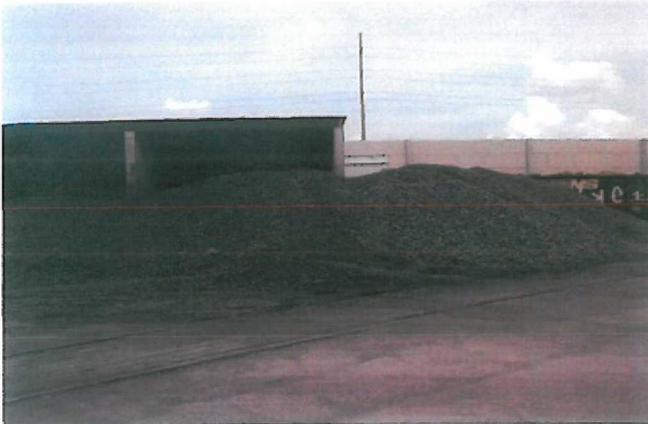
2. **Failure to implement a good housekeeping program that includes a cleaning and maintenance program for all impervious areas of the facility where particulate matter may accumulate.** This is a violation of Part 2.1.2.2 and 8.F.2.1 of the NPDES permit and ORC 6111.04 and 6111.07. Significant accumulations of dust and particulate matter were evident on the ground around the slag hopper of the Alloy System and the carbon fill port of the Moraya Carbon Fill Station (see **Figure 3**). A catch basin near the Alloy System was clogged from dust and debris that has accumulated in the area. To address these concerns, Charter Steel must implement a regular sweeping program or equivalent to clean up spills and minimize off-site tracking. You should also implement storm drain inlet protection on catch basins within these areas. There are a number of commercially-available storm drain inlet protection devices or you may refer to specifications contained in **Rainwater and Land Development** available online at <http://www.dnr.state.oh.us/tabid/9186/Default.aspx>. In addition, rolling mill scale is being tracked outside the containment area by vehicle traffic (see **Figure 5**). You should consider constructing a berm or other barrier to prevent vehicle traffic from contacting rolling mill scale or entering the containment area where it is stored.

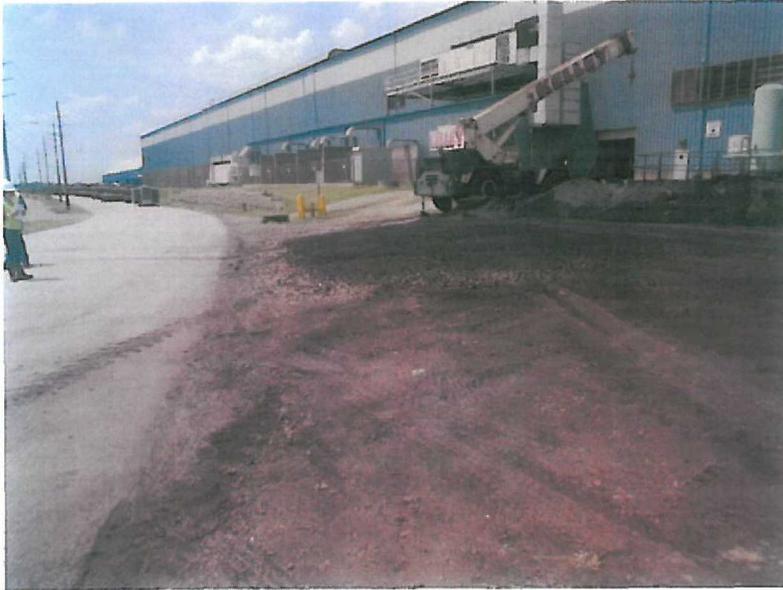
**Figure 5:** *(Top)* Rolling Mill Station getting tracked into the roadway.

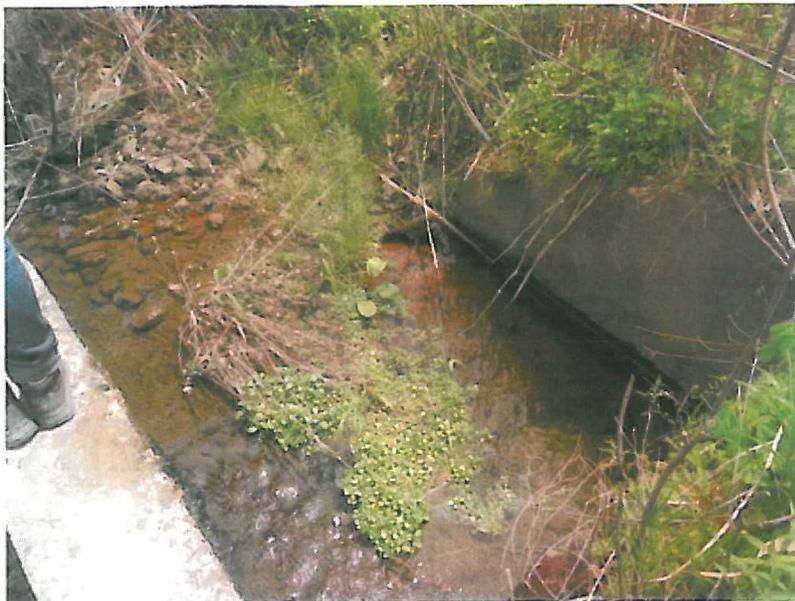
In addition, we observed both storm water outfalls and noted discharges were occurring *at a time of dry weather*. Although the discharges from both outfalls appeared clear, we noted an orange, rust-colored tint to the stone below Outfall 002 (see **Figure 6**). Billet storage occurs within the drainage area of Outfall 002 and we did note that some billets were rusty. Please refer to the recommended BMPs contained in the US EPA Industrial Storm Water Fact Sheet series online at <http://cfpub.epa.gov/npdes/stormwater/swsectors.cfm> to determine appropriate practices for your industry.

**Figure 6:** *(Bottom)* Rust colored in the water coming out of Outfall 002.
