RE: CUYAHOGA COUNTY
VILLAGE OF CUYAHOGA HEIGHTS
INDUSTRIAL STORM WATER
THOMPSON ALUMINUM CASTING CO.
3GR01801*AG

NOTICE OF VIOLATION

THOMPSON ALUMINUM CASTING CO
Cuyahoga Heights Cuyahoga County

Photos Taken: July 16, 2013
By: Julianna Murphy, DSW, NEDO

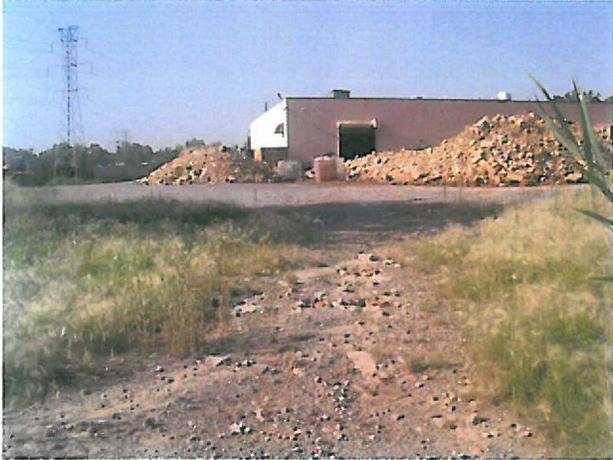
Figure 1: The area draining to the outfall on the northeast corner of the lot.

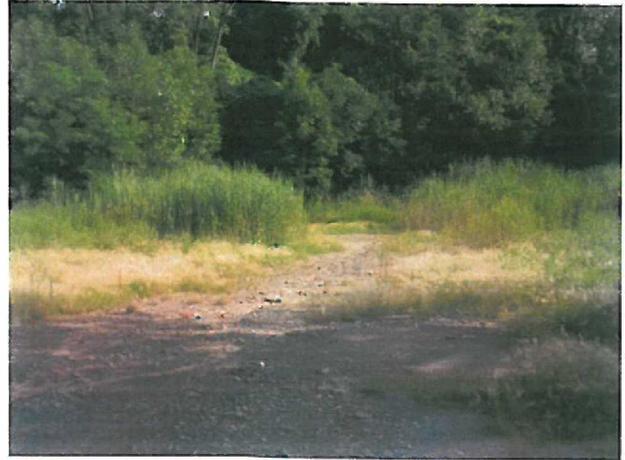
Figure 2: The concentrated flow to the outfall on the northeast corner of the lot

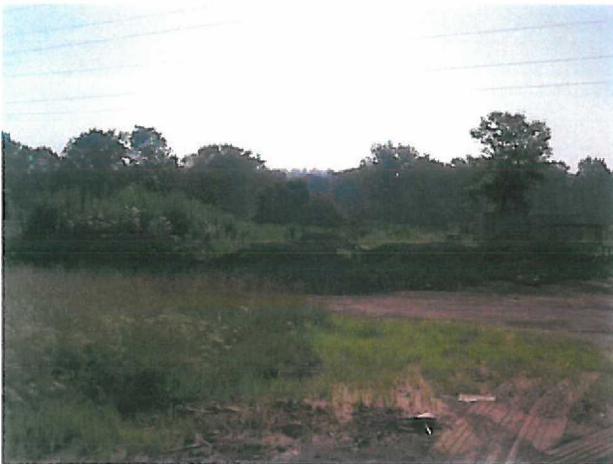
Figure 3: The area that sheet flows to outfall on the east side of the lot.

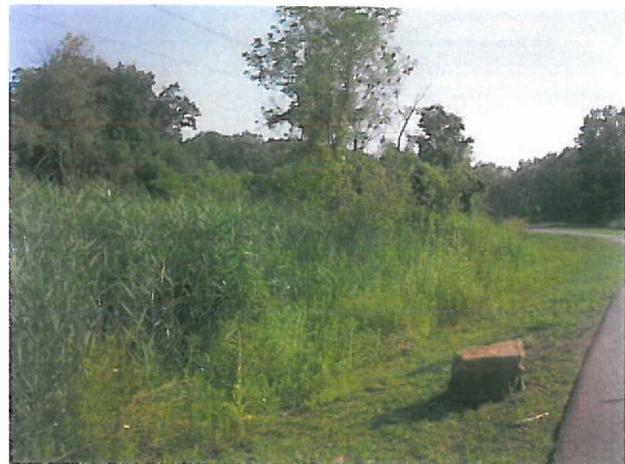
Figure 4: The east edge of the lot that sheet flows onto the parks property.

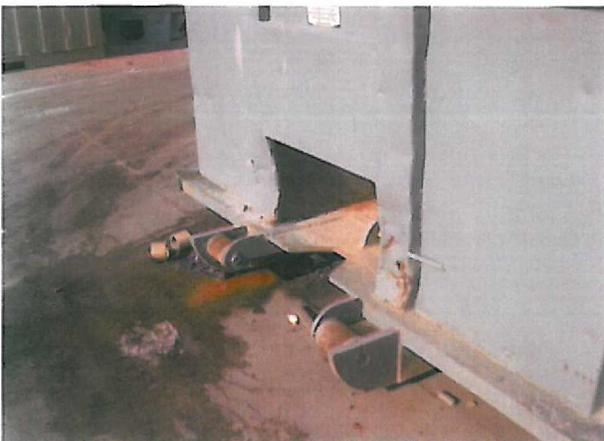
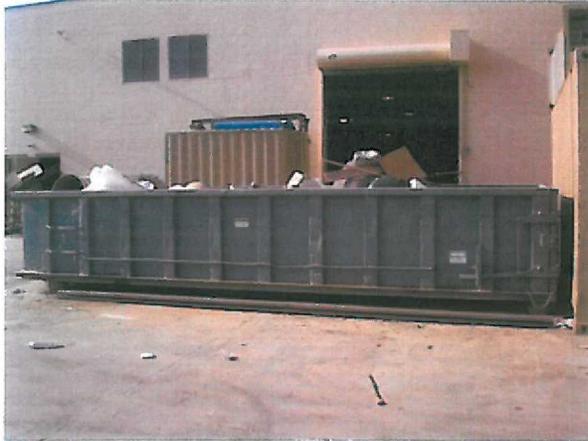
Figure 5: (left) The dumpster in the back lot was leaking. Since dumpsters are a source of possible pollutants, they should be inspected regularly.

Figure 6: Uncovered dumpster

1. In the back lot there was an uncovered dumpster that was also leaking onto the site. All dumpsters must be covered and inspected regularly for any leaks or cracks. **(See Fig 5 & 6)**

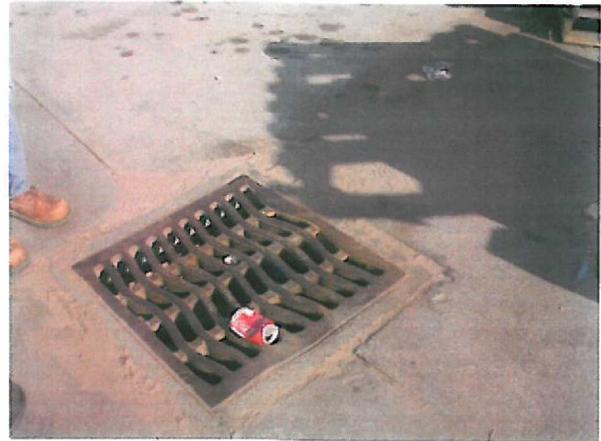
Figure 7: Sediment and trash making its way into the storm drain.

2. The storm drain in the back had sediment and trash built up around it. Best Management Practices (BMPs) need to be put into place to keep the pollution out of the drains. **(See Fig 7)**

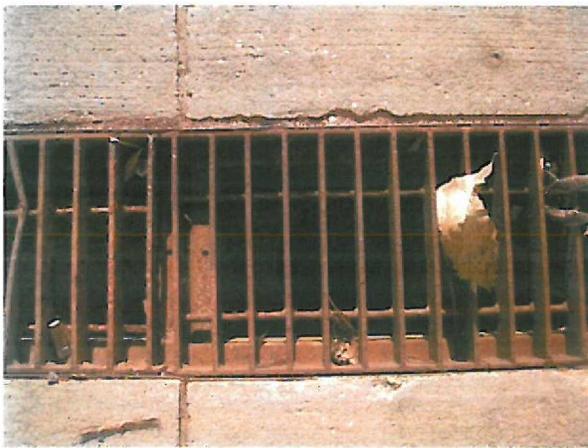
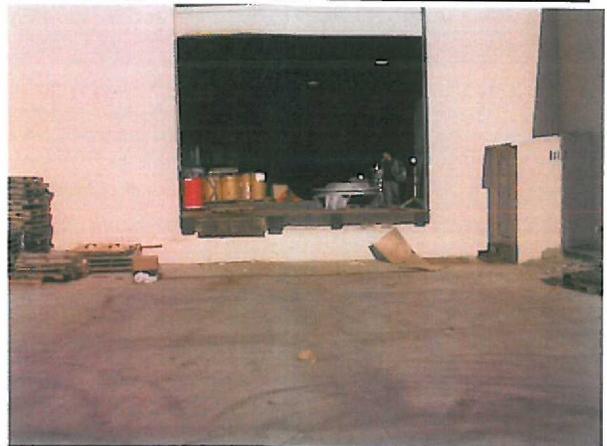
Figure 8: Trench drain in the truck's shipping and receiving area filled with trash and sediment.

Figure 9: The area draining into the trench drain in the truck's shipping and receiving, good housekeeping is needed.

3. The trench drain had trash, cigarette butts, and sediment inside and around it. Good housekeeping practices along with BMPs need to be set in place to keep the situation from worsening and from happening in the future. **(See Fig 8 & 9)**

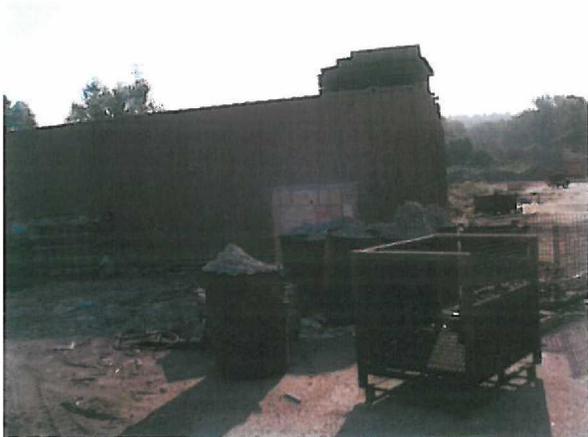
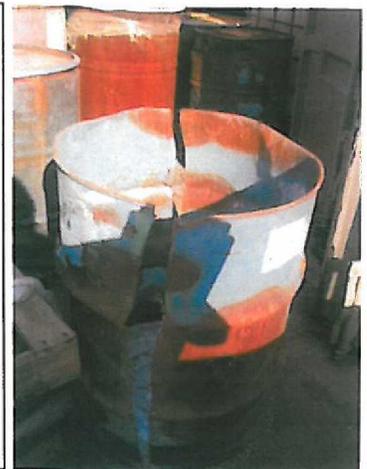
Figure 10: (left) Open piles of slag in old, rusted, broken barrels and spilled over the sides.

Figure 11: (right) broken barrels containing slag.

4. The slag was stored in open, broken, rusted barrels on site. The slag was observed to be exposed to storm water while also spilling out of the barrels. Better containment needs to be set into place to keep the storm water out of contact with the slag. **(See Fig 10 & 11)**

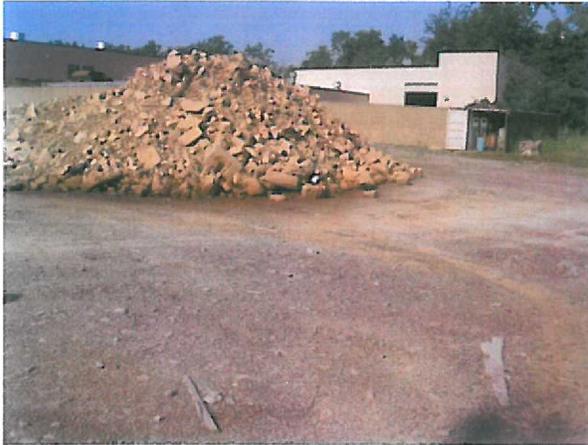
Figure 12: Foundry sand runoff directly toward outfall

5. Containment also needs to be set around the foundry sand stock piles to keep it from polluting the storm water runoff. **(See Fig 12)**
6. The stock piles on the east side of the lot need to either have a berm installed around them or covered to keep the storm water from reaching them and washing the sediment away and into the receiving stream. **(See Fig 13)**

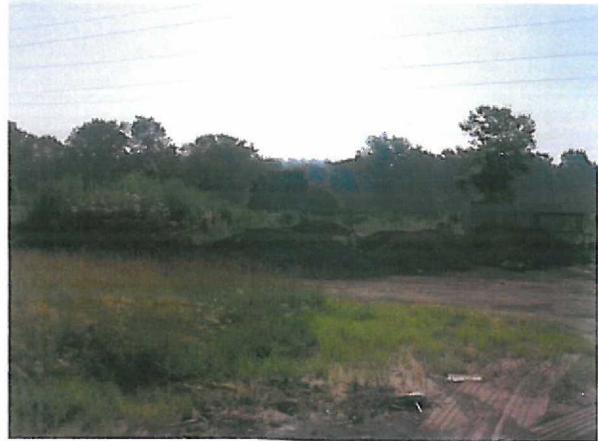
Figure 13: Stock piles that need containment

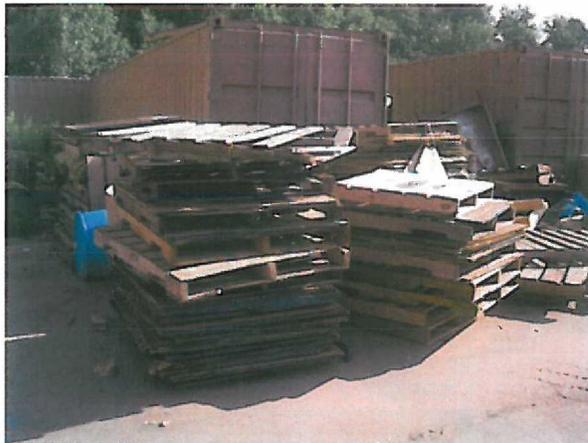
Figure 14: Pallet stock piles

7. Residuals can be stored on the pallets which can potentially lead to a pollution problem. The stock piles of pallets can be kept under a covering to help eliminate this possibility. **(See Fig 14)**

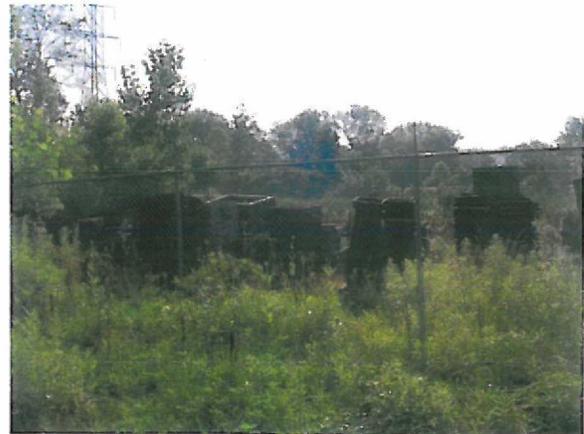
Figure 15: Metal scrap stock piles

8. The stored metal scrap on the northeast corner of the lot was observed to be old and rusty. When this gets hit with storm water it can wash residuals and rust away with it. It is recommended to either paint these to avoid the rust or store them under a type of covering to eliminate storm water contact. **(See Fig 15)**

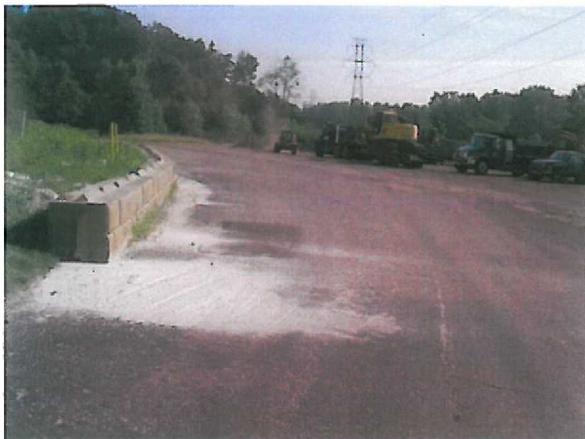
Figure 16: Spilt sand from containers.

9. There was a sand spill on the lot by the sand containers. Sediment is a pollutant. To avoid this pollution problem be sure to sweep up spills as they happen. **(See Fig 16)**

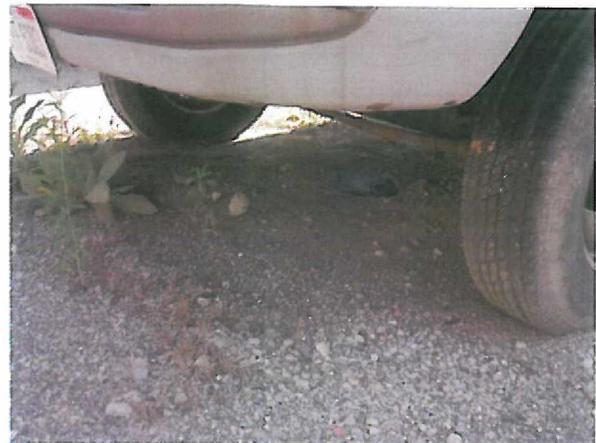
Figure 17: Leaking truck on site.

10. One of the trucks on site was leaking some sort of fluid. These spills need to be cleaned up instantly. If a truck is suspected to have a leak, a drip pan would be a good precautionary action to avoid a potential pollution problem. **(See Fig 17)**
