RE: CUYAHOGA COUNTY
VILLAGE OF MAYFIELD
CONSTRUCTION STORM WATER
PERMIT NO: 3GC06488*AG
DEACONS CHRYSLER JEEP DODGE

On Thursday, August 8, 2013, I conducted an inspection at the above mentioned site to determine compliance with the Ohio EPA General Storm Water National Pollutant Discharge Elimination System (NPDES) Permit for Construction Activities #3GC06488*AG. Accompanying me on my inspection was Tom Cappello, City Engineer for Mayfield Village. Our records indicate that storm water discharges from this site are authorized under the general NPDES permit for construction activities granted on May 1, 2013.

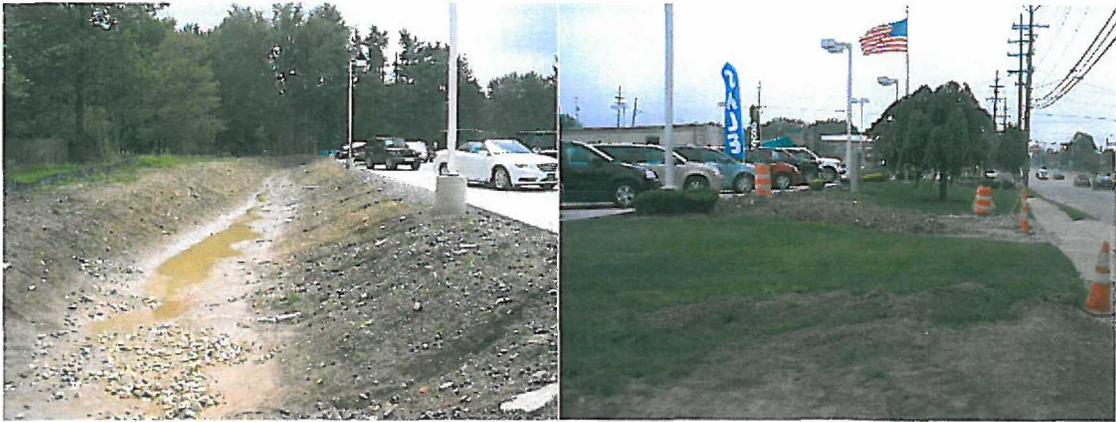
- **Stabilization, i.e., seeding and mulching, has not been initiated as required by the NPDES permit. (Figures 1&2)** Temporary stabilization must be initiated within 7 days of last disturbance on any disturbed area of the site if it will not be further disturbed within 14 days of last disturbance. Permanent stabilization must be initiated within 7 days of reaching final grade. Seeing how the sides of the sediment basin are subject to large amounts of flow, (Figure 1), erosion control matting is recommended in addition to stabilization.

Figures 1&2: Stabilization needed on sides of the sediment basin and where final grade has been reached.

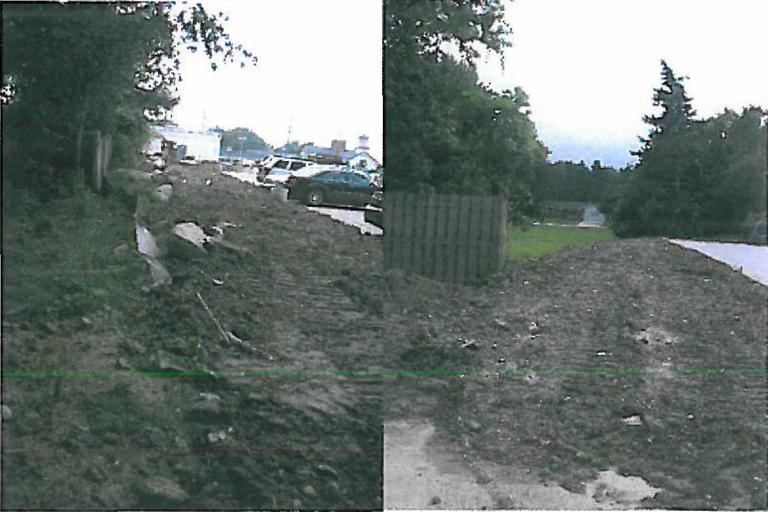
- **Silt fence has not been installed in a functional manner and has not been maintained as required by the NPDES Permit.** All sediment controls, including silt fence, must be capable of ponding runoff in order to settle sediment. Silt fence must remain in place until the upslope contributing drainage area has reached final stabilization, i.e., a vegetative growth density of 70% or greater has been achieved. Perimeter silt fence is missing in several areas, allowing sediment to run directly off site. (Figures 3&4)

Figures 3&4: Perimeter silt fence is missing in certain areas.

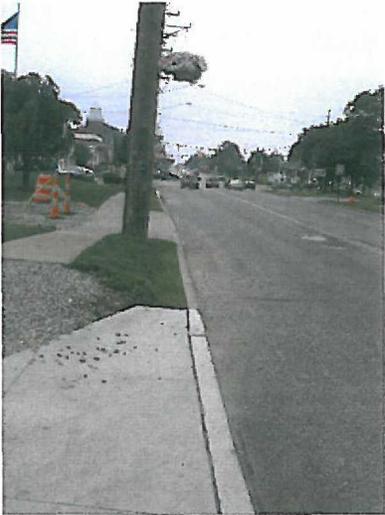
- **The Rock Construction Entrance was inadequate, resulting in sediment tracking off site.** Specifications for a Rock Construction Entrance can be found in Chapter 7 of the *Rainwater and Land Development Manual, Ohio's Standards for Stormwater Management, Land Development and Urban Stream Protection* (Ohio Department of Natural Resources, 2006). (**Figure 5**)

Figure 5: Sediment has tracked off-site and into the street.
