Re: Richland County  
Briarwood Estates MHP  
NPDES Permit

September 6, 2013

OPERATION AND MAINTENANCE INSPECTION  
 WWTP'S LESS THAN 150,000 GPD

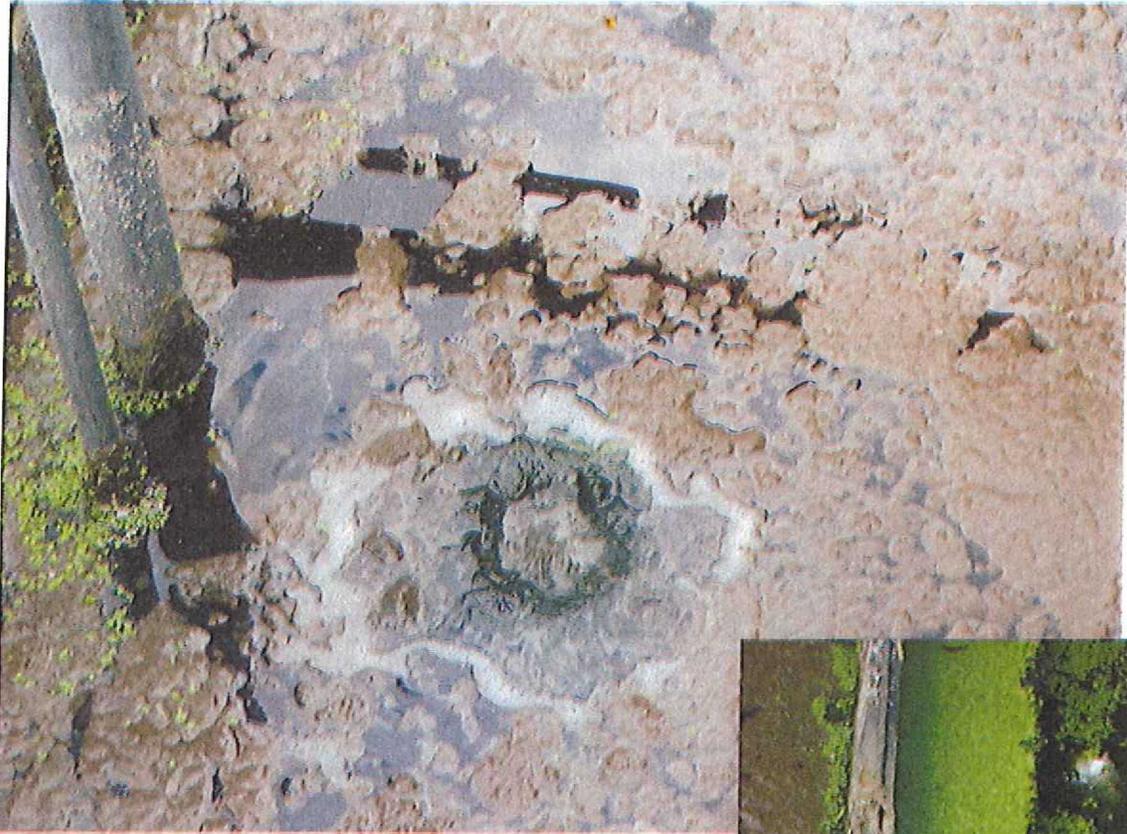
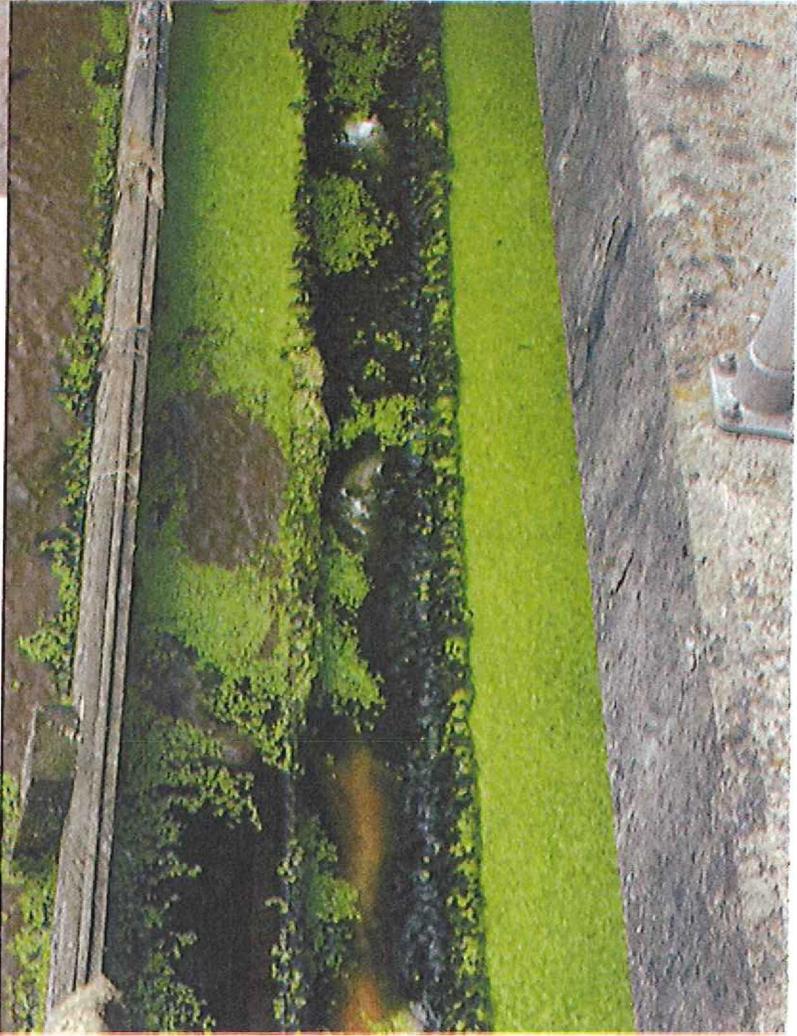
Briarwood Estates MHP 8-7-2013

Excessive algae growth appeared to be adversely affecting the clarifier. Heavy algae build up along the effluent weir was not allowing even flow of water across the entire length of the weir. The weir should be scraped with a scrub brush periodically to remove this buildup of algae. The surface skimmer appeared to have difficulty returning all of the floating surface material to the aeration tanks. A large buildup of algae around the skimmer surface appeared to be getting partially sucked down the skimmer pipe and then blown back out the top. The algae are most likely preventing the skimmer from achieving full suction on the floating surface material. The algae along the skimmer opening should be removed. Please see the enclosed pictures.
