RE: CUYAHOGA COUNTY
CITY OF BEDFORD HEIGHTS
INDUSTRIAL STORM WATER
NEW YORK FROZEN FOODS
3GR01017*EG

On September 12, 2013, I performed a facility inspection to determine compliance with the Ohio EPA's General National Pollutant Discharge Elimination System (NPDES) Permit for Storm Water Associated with Industrial Activities #OHR000005. I was accompanied by Molly Sunkle, also from the Ohio EPA's Division of Surface Water. We met with you and Brad McWithey, a member of the pollution prevention team. Our records indicate that this facility is categorized under Standard Industrial Classification (SIC) Code 2051: Bread and Other Bakery Products, Except Cookies and Crackers. As such, this facility falls under Subsector U3 in Part 8 of the NPDES permit.

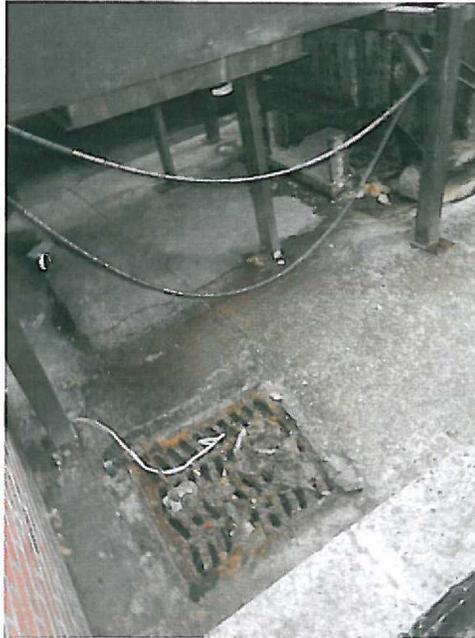
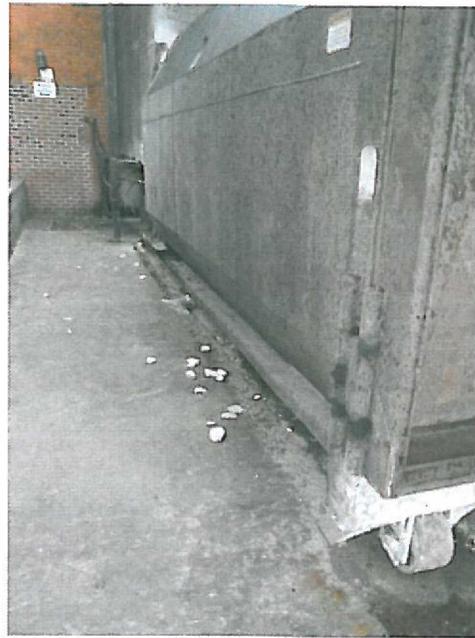
- **Feed Dumpster** – This dumpster is used for the disposal of waste, spoiled and broken food product. Leachate was observed discharging from the dumpster to an adjacent storm drain. Part 5.1 of the SWPPP indicates that, if the contents of the dumpster or compactor leaks, drain covers are to be placed over drains and remain covering the drain until the area has been cleaned up per the response plan. Drain covers were not in place. Rather, inlet protection was installed on the storm drain. Although it was in good condition, please be aware that these devices are only effective for keeping gross pollutants like pieces of food scrap from entering the storm drainage system, but are not effective at preventing the discharge of leachate to the storm sewer system. The storm drain inlet protection device used is not a “drain cover” typically used for spill response. Drain covers temporarily seal off the drain to prevent pollutants from entering.

It appears that leakage from this dumpster was also noted during our last storm water compliance inspection conducted on May 31, 2011. Leachate is a non-storm water discharge and is not authorized under the NPDES permit. Per Part 2.1.2.10 of the NPDES permit, you must eliminate non-storm water discharges not authorized by an NPDES permit. Please utilize drain covers as indicated in the SWPPP and if they are not effective or cannot be implemented effectively, additional control measures will be required. Options may include, but are not limited to, use of leakproof dumpsters; improvements to the trash disposal system that would prevent leaks and product spills; re-routing the storm drain to the sanitary sewer system with the permission of the wastewater treatment plant operator; increase dumpster area inspection frequency and improve good housekeeping and spill response procedures.

Fig 1 & 2. Leachate from the Feed Dumpster leaks into the storm sewer system. Waste food product is spilled on the ground by the dumpster. The dumpster is changed out on a daily basis. The dumpster is not designed to be “leak-proof”.

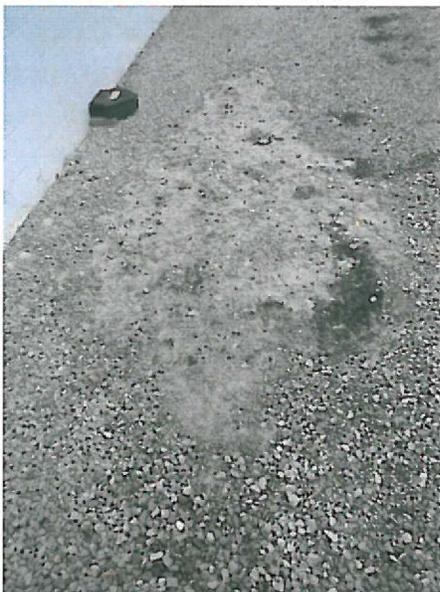
- **Equipment Maintenance** – While conducting this inspection, we noted spilled corn meal outside along the east side of the building. You indicated that an oven had been repaired in this location and the corn meal spilled during that process and was not cleaned up. Please clean up the spilled material and dispose of properly. Equipment repair should occur indoors or under cover whenever possible. If it must be conducted outdoors, conducting maintenance on a tarp or other such protective barrier will facilitate clean up. Temporary control practices can be implemented to prevent the migration of pollutants to storm drains or off-site. Spills must be cleaned up in a timely manner.

Fig 3 (LEFT). Spill of corn meal in area where equipment maintenance was conducted outdoors on east side of building.
Fig 4 (ABOVE). Drip tray at the flour receiving station.

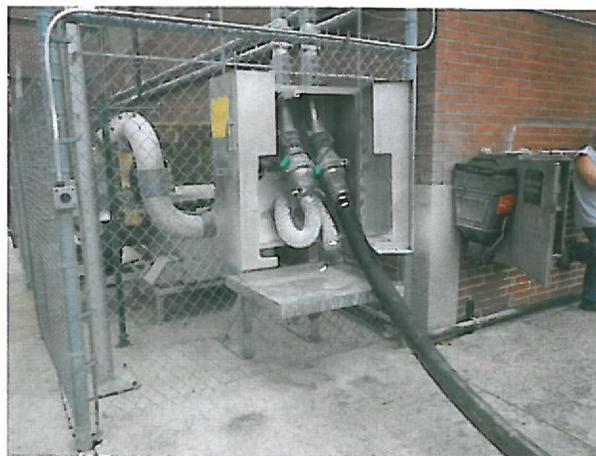
- **Flour Silo Area** – BMPs are in place and in good condition. The BMPs selected appear to be appropriate for the area; however, timelier implementation is needed. Filters have been placed

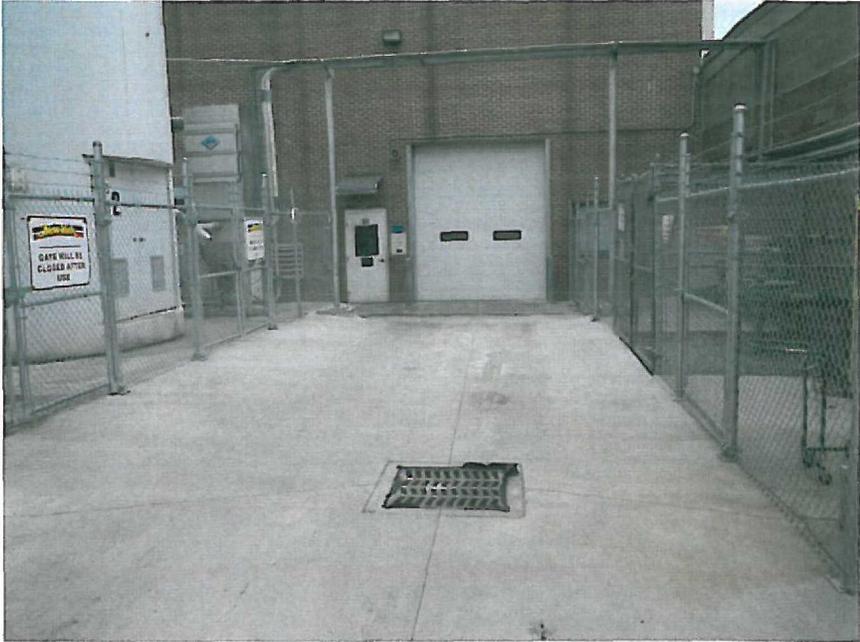
on storm drains and there is a drip tray with valve closed under the main connection port where flour is received. However, we noted some spillage of flour on the ground that had not been cleaned up. The SWPPP indicates that the Flour Silo area is to be cleaned after deliveries, as needed, by the Shipping or Sanitation staff. This generally occurs on a weekly basis, but may need to be done more frequently. As an example, we suggested the delivery clerk sweep up spills after each delivery.

Fig 5. Storm drain inlet protection has been installed on catch basins in the Flour Silo Area. Good housekeeping is the other BMP implemented here, but flour spills and accumulations were noted.

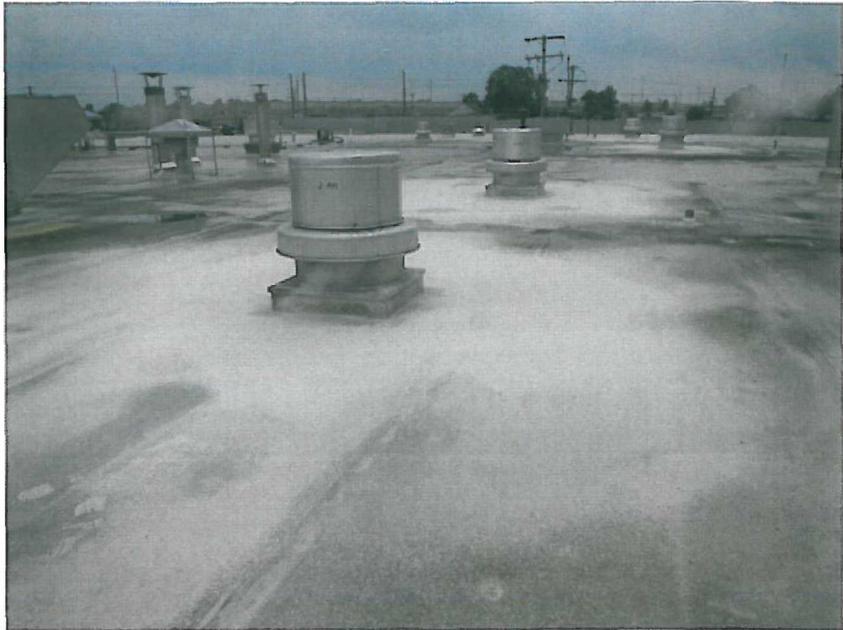
- **Roof Vents** – We noted appreciable deposits of organic dust (primarily flour and corn meal) on the roof near exhaust vents from baking ovens. You indicated that these vents do not have any filters or other such air pollution controls. The SWPPP indicates the roof will be inspected monthly and cleaned, if needed. However, it does not provide a measurable guideline for when this cleaning is to occur. Ohio EPA recommends that a regular cleaning program be established for the roof. In addition, the SWPPP calls for daily good housekeeping of the plant interior to limit dust accumulations that may be released through venting. Please ensure the SWPPP is being followed. Other options New York Frozen Foods may wish to consider include, but are not limited to: install filters or other appropriate air pollution control equipment, ensure existing air pollution control equipment is maintained, place tubs around vents and stacks for easy collection of settling particles, and ensure the good housekeeping program includes removal of fugitive dust from ledges, walls, floors and equipment.

Fig 6. Flour dust is evident around roof vents and stacks.
