**RE: Construction Storm Water Inspection at Camden Yard/ Franklin County.
Permit Number: 4GC03774*AG**

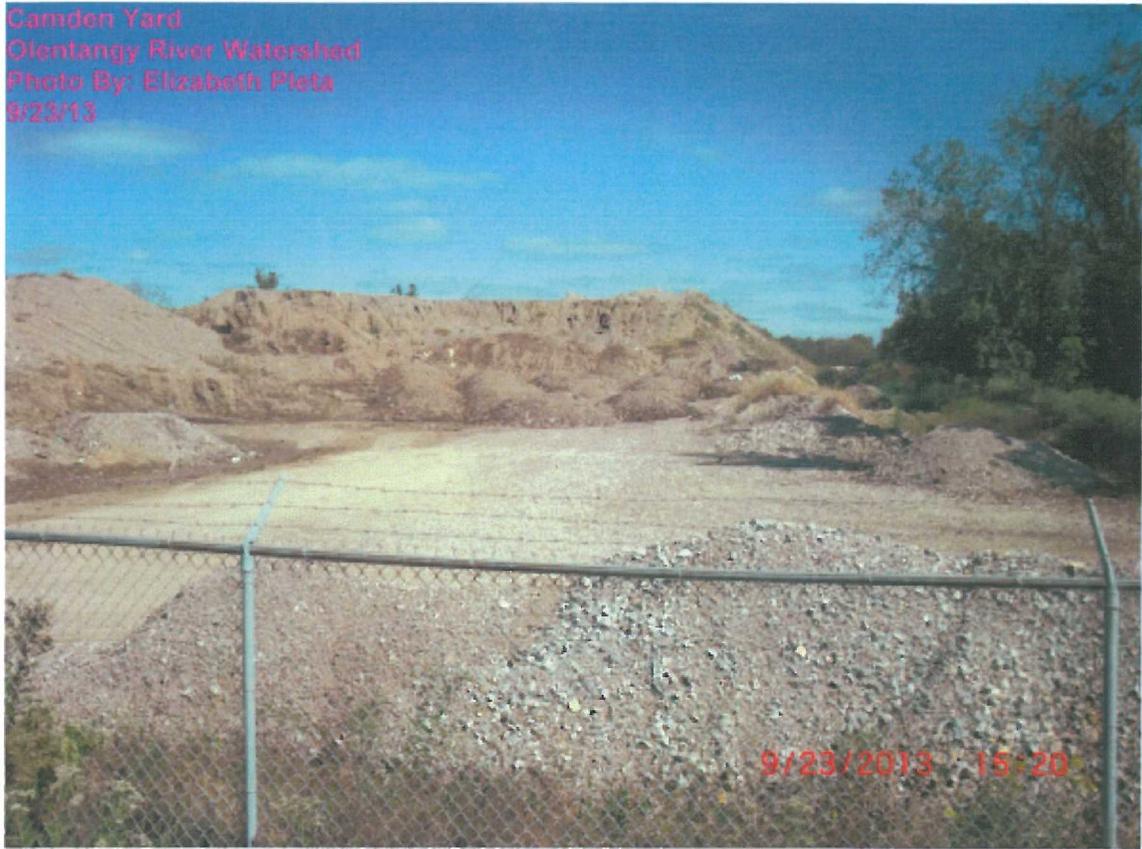
Figure 1: Site largely devoid of silt fence.

- Our staff was unclear of the primary sediment controls for this project. The site was largely absent of required silt fencing (See Figure 1) and inlet protections (See Figure 2). Please submit your Storm Water Pollution Prevention Plan (SWPPP) for review.
- Please be aware measures are expected to ensure all barren areas are properly protected in preparation for the upcoming winter months. In the event earth disturbing activities extend beyond an effective growing season, alternate erosion protection is expected. This would include but not limited to a crimped straw mulch cover. Please submit to my attention the temporary seeding/protection schedule to ensure the erosion protection requirements are not violated.

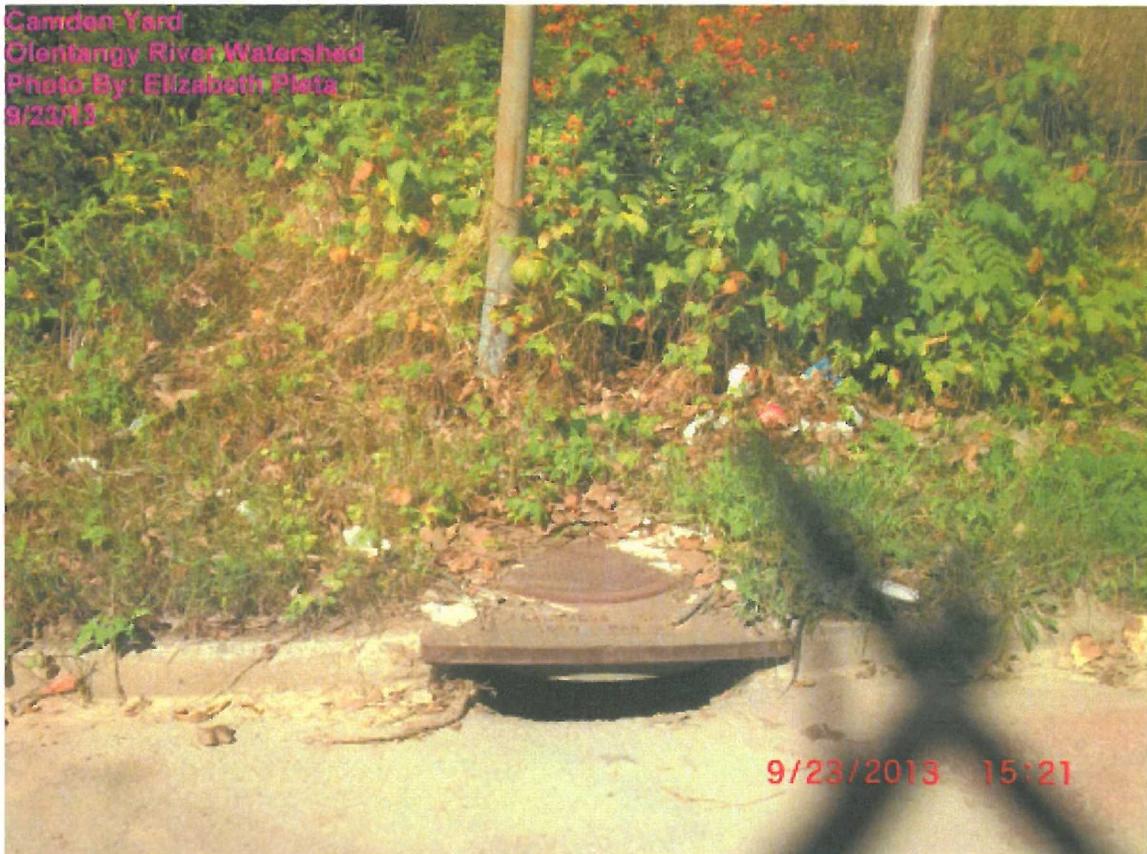
Figure 1: Inlet protections required on site.
