RE: Construction Storm Water Inspection at Harmon Elementary School / Franklin County. Permit Number: 4GC04034*AG

Harmon Elementary School
Scioto River Watershed
Photo By: Elizabeth Pieta
9/23/13

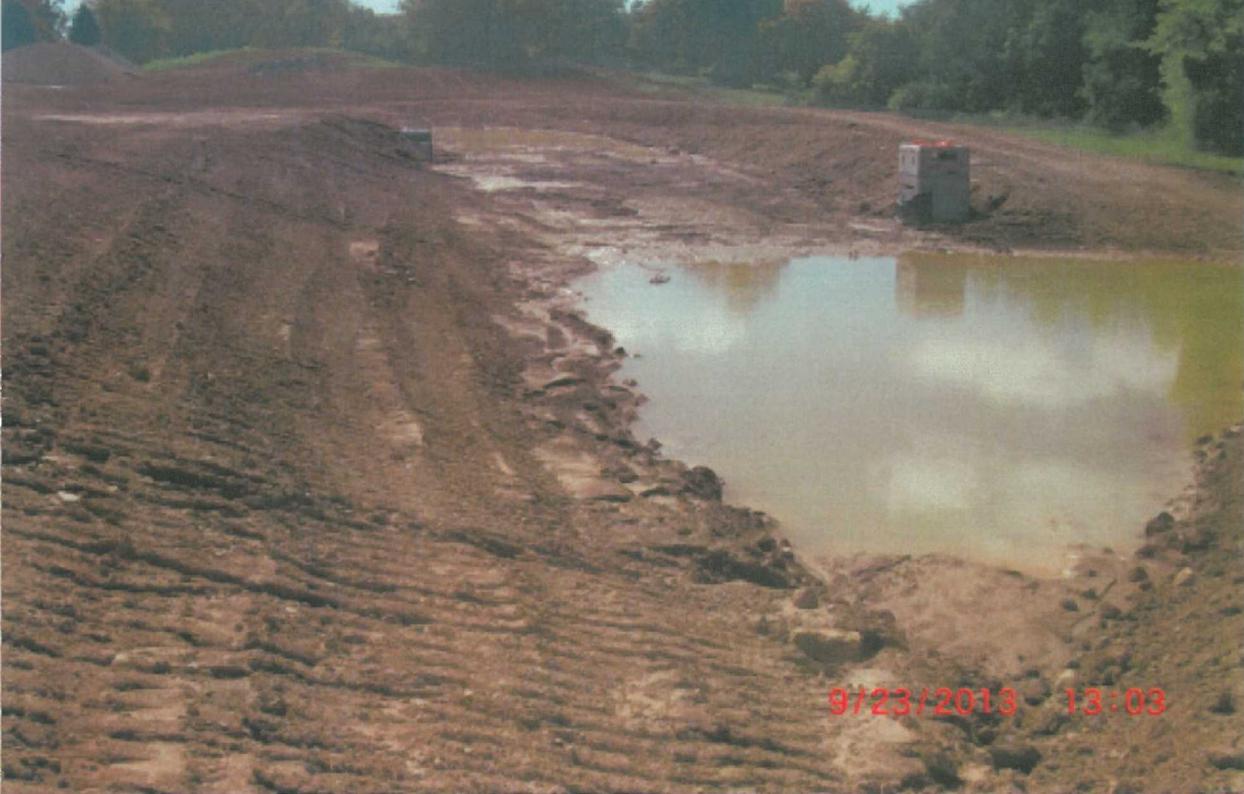
- During the inspection, we noted the sediment pond on the west side of the site still lacked a properly modified outlet structure (See Figure 1). The site superintendent assured us that a skimmer would be installed within the week. Please ensure the skimmer's installation occurs before our next monthly site inspection. Further compliance efforts may be taken on behalf of the Ohio EPA if installation is not complete.
- Please be aware measures are expected to ensure all barren areas are properly protected in preparation for the upcoming winter months. In the event earth disturbing activities extend beyond an effective growing season, alternate erosion protection is expected. This would include but not limited to a crimped straw mulch cover. Please submit to my attention the temporary seeding/protection schedule to ensure the erosion protection requirements are not violated.

Figure 1: Sediment basin requires installation of skimmer.
