October 22, 2012

RE: NOTICE OF VIOLATION
1ST QUARTER FY 2013
COMPREHENSIVE INSPECTION
ELKRUN INDUSTRIES C&DD LANDFILL

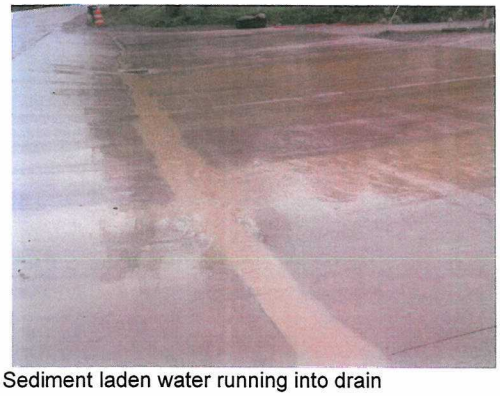
1. **Surface Water.** During this inspection, surface water heavily laden with sediment was observed running uncontrolled along the sides of the access road, over the unpaved access road and behind the office trailer, and into a drain that drains underneath Route 7 and into an unnamed tributary to Turkeyfoot Run. The sediment-laden water appeared to be generated both from general run off from the landfill, and as a result of a worker physically hosing mud off the concrete facility entrance pad and into the drain located near the center of the pad.

Sediment laden water running toward Rt. 7.

Elkrun is in violation because it failed to control surface water at the facility and allowed surface water heavily laden with sediment to flow into waters of the state. Failure to control surface water and allowing water pollution to occur has resulted in violations of the following:

In order to return to compliance with these rules, the owner(s) or operator must immediately cease causing water pollution, and comply with the facility's surface water pollution prevention plan, the facility's current operating license, and all applicable surface water laws and regulations.
