RE: LORAIN
BLACK-ROCKY RIVER WATERSHED
CITY OF OBERLIN
MUNICIPAL STORM WATER PROGRAM
AUDIT FINDINGS

Municipal Storm Water Program Evaluation

MS4 Maintenance Component Worksheet

Date of Evaluation
June 11, 2009
Evaluator Name, Title
Lindsie MacPherson, Ohio EPA Assistant to the District Engineer
MS4 Permittee
City of Oberlin

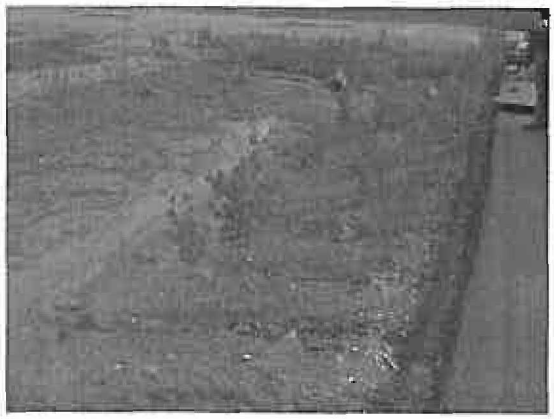
Fig 10 (LEFT): This bioretention cell has become overgrown with weeds and is not properly functioning. The cell needs to be replanted with the proper plants and maintained fittingly.

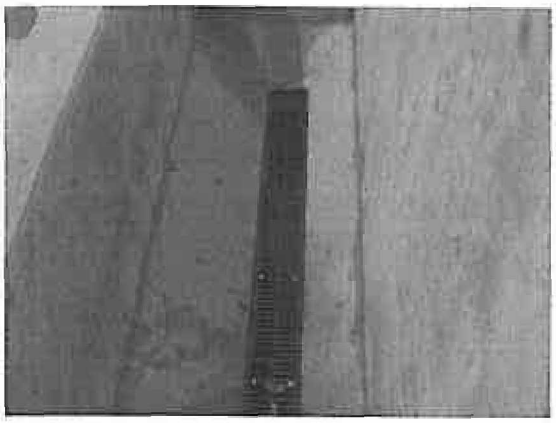
Fig 11 (LEFT)/ 12 (RIGHT): This swale preceding the detention basin needs to be stabilized. Sediment from the stockpile in figure 11 is draining right to the basin along with the rest of the runoff from the swale itself.

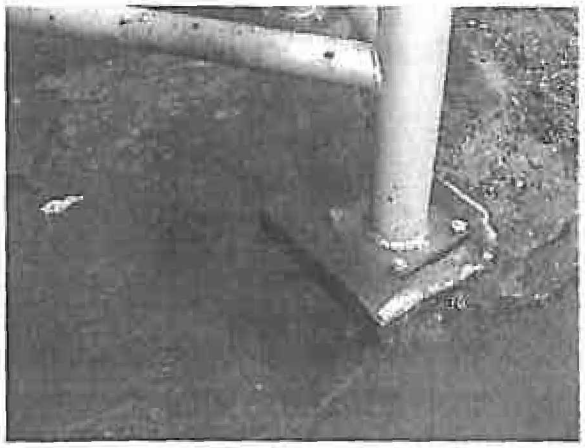
Engine crank case vacuum vent for Engine #5 is not operating and leaking oil. The vacuum vents for the other engines also show evidence of oil staining in and around them. It is believed that the staining occurs when oil vapor condenses in these vents. Attempts are made to collect vapors, but the system must be improved to prevent vapors from condensing onto the building or adjacent pavements where storm water can contact them and convey oil to the MS4.

Fig 3 (LEFT): The oil vapor vent for engine #5 is showing major signs of leakage. Because the engine is no longer in use, it would be a good practice to abandon the vent and clean the surrounding area, avoiding runoff into the storm drains nearby. The system to capture vapors must be improved for vents from operating engines.
