RE: NOTICE OF VIOLATION – Darke County Commissioners WWTPs Compliance Evaluation Inspections (CEIs)
Rolin Acres WWTP, 1PG00090*CD/OH0085561
Stillwater Golf Estates WWTP, 1PX00014*CD/OH0119067
Darke County Home WWTP, 1PG00105*BD/OH0133612
Darke County Jail WWTP, 1PG00104*BD/OH0133621

Darke County Commissioners
Wastewater Treatment Plant Inspections
November 1, 2011

NPDES Compliance Inspection Report
Semi-Public Sewage Disposal Inspection Form

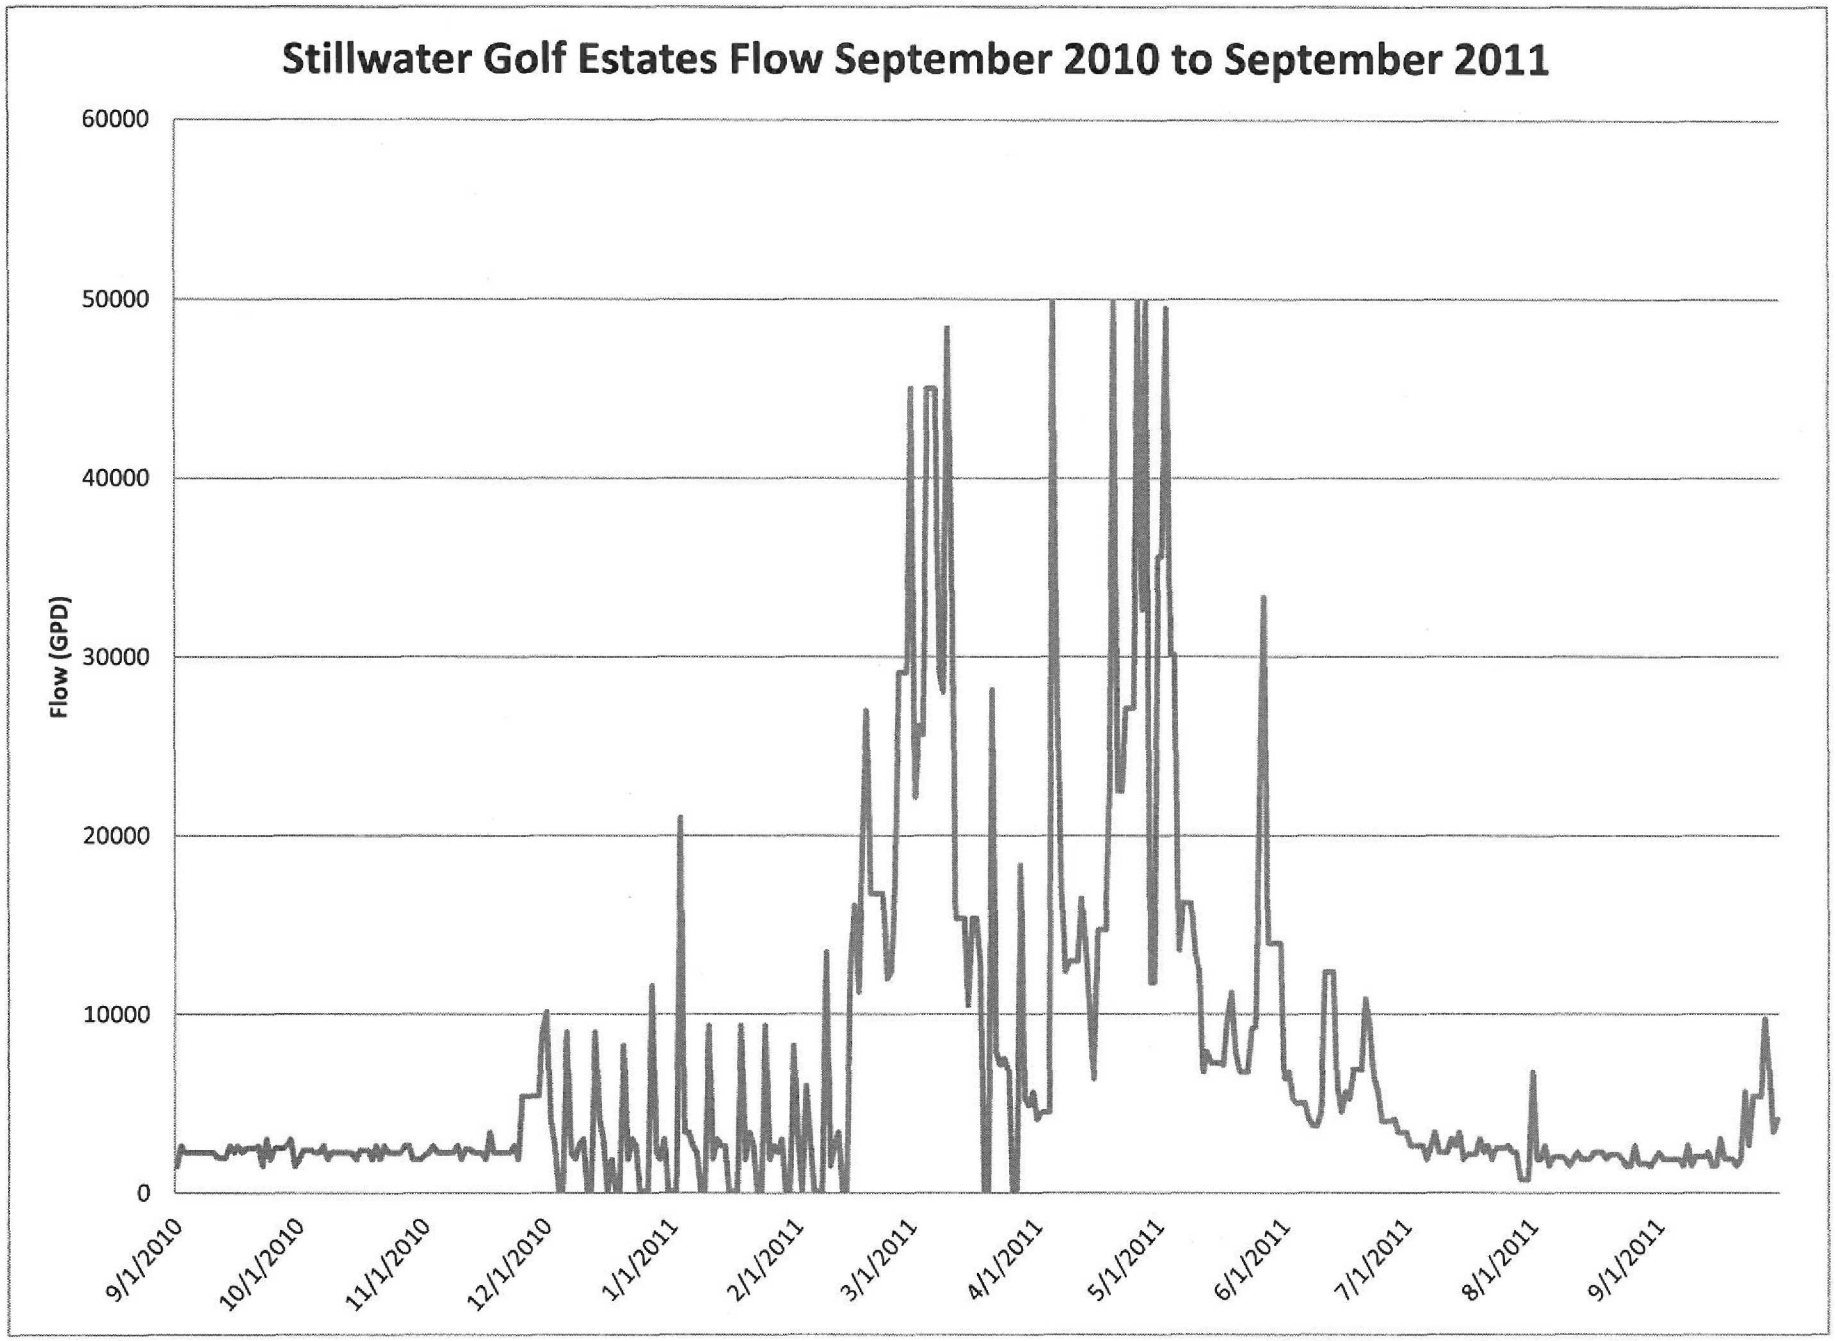
Infiltration and Inflow has been a problem in both the Stillwater Golf Estates and Rolin Acres Subdivision wastewater treatment collection systems. During periods of heavy storm flows, flows to the wastewater treatment exceed plant design resulting in the washout of solids to the sand filters and effluent limitation violations.

Stillwater Golf Estates Flow September 2010 to September 2011
Flow (GPD)
60000
50000
40000
30000
20000
10000
0
9/1/2010
10/1/2010
11/1/2010
12/1/2010
1/1/2011
2/1/2011
3/1/2011
4/1/2011
5/1/2011
6/1/2011
7/1/2011
8/1/2011
9/1/2011
