Ohio Environmental Protection Agency
John R. Kasich, Governor
Mary Taylor, Lt. Governor
Scott J. Nally, Director

RE: LORAIN
CITY OF AMHERST
NOTIFICATION OF MUNICIPAL STORM WATER PROGRAM INSPECTION

Municipal Storm Water Program Evaluation

MS4 Maintenance Component Worksheet

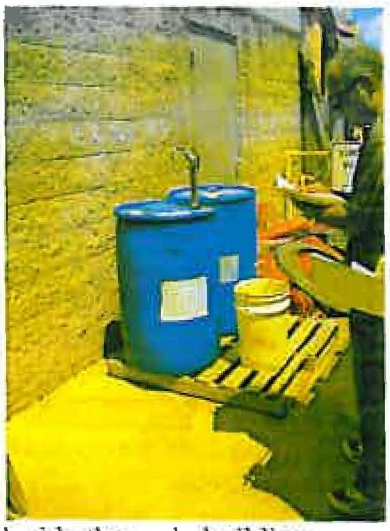
Fig. 1: These materials were stored off the ground and inside the main building as a good storm water pollution prevention practice.
