January 14, 2013

RE: MEDINA COUNTY
CITY OF WADSWORTH
RESTORED CHURCH OF GOD SUBDIVISION
NPDES PERMIT NO: OHC000003
OHIO EPA PERMIT NO: 3GC05928*AG
CONSTRUCTION STORM WATER INSPECTION

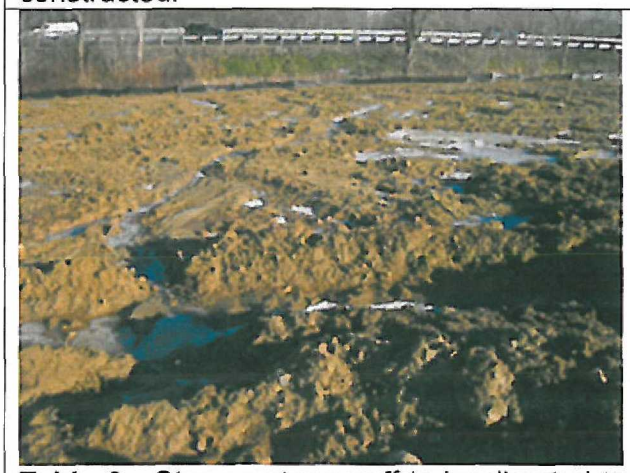
- A diversion channel is depicted on the SWP3 to direct storm water to the large sediment settling pond for treatment prior to discharge. The diversion channel has been partially filled in due to soil stockpiling activities (Figure 2), which has caused storm water runoff to be directed to the silt fence (Figure 3), located north of the site. The silt fence has failed due to concentrated flow events as sediment deposition was documented north of the silt fence. The diversion channel must be repaired to direct storm water runoff to the sediment settling pond for proper treatment.

Table 2 - The diversion channel has been partially filled in due to soil stockpiling activities.
