State of Ohio Environmental Protection Agency

Re: Seneca County  
Fostoria Mobile Estates  
Sewerage

July 13, 2009

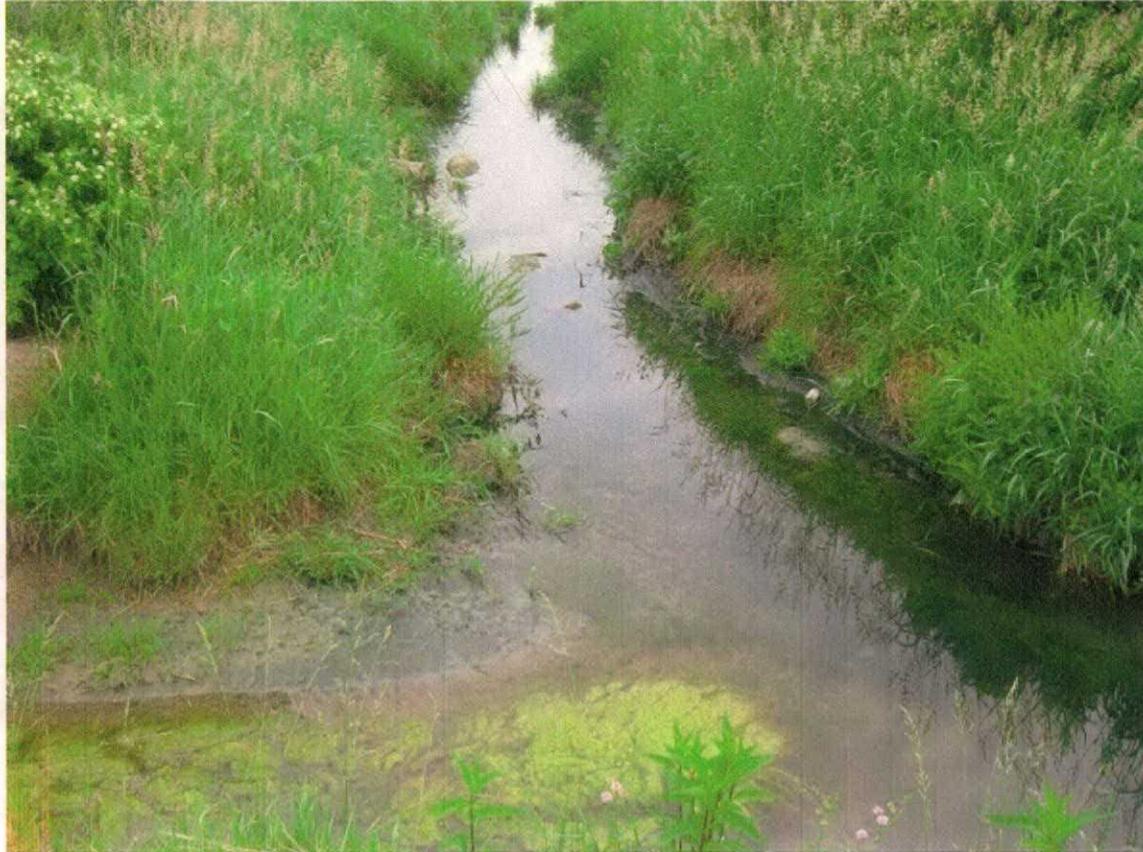
Fostoria Mobile Estates MHP, Seneca Co.

Looking south at ditch on east side of plant where it joins the ditch running to the west

taken by M.B.Cohen, 06/10/09

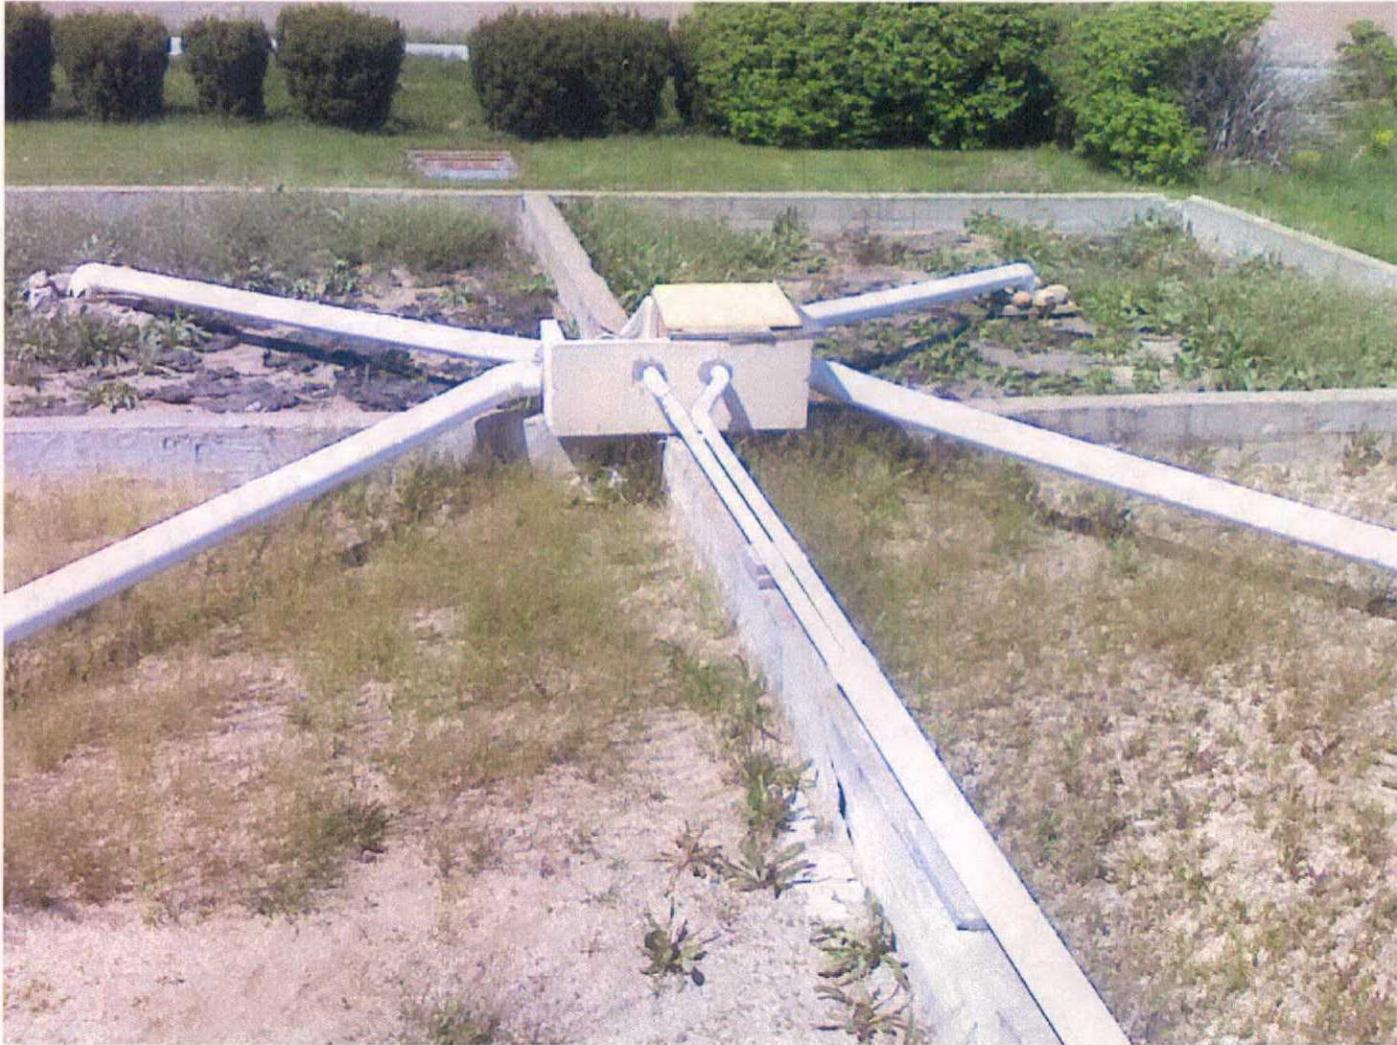
Fostoria Mobile Estates MHP, Seneca Co.  
Sand filters (looking North)  
taken by M.B.Cohen, 5/12/09
