State of Ohio Environmental Protection Agency

**RE: YMCA Camp Wilson Reconnaissance Inspection, NPDES Permit No.
1PR00052*CD/OH0046451, Logan County**

NPDES Compliance Inspection Report

Inspection Findings

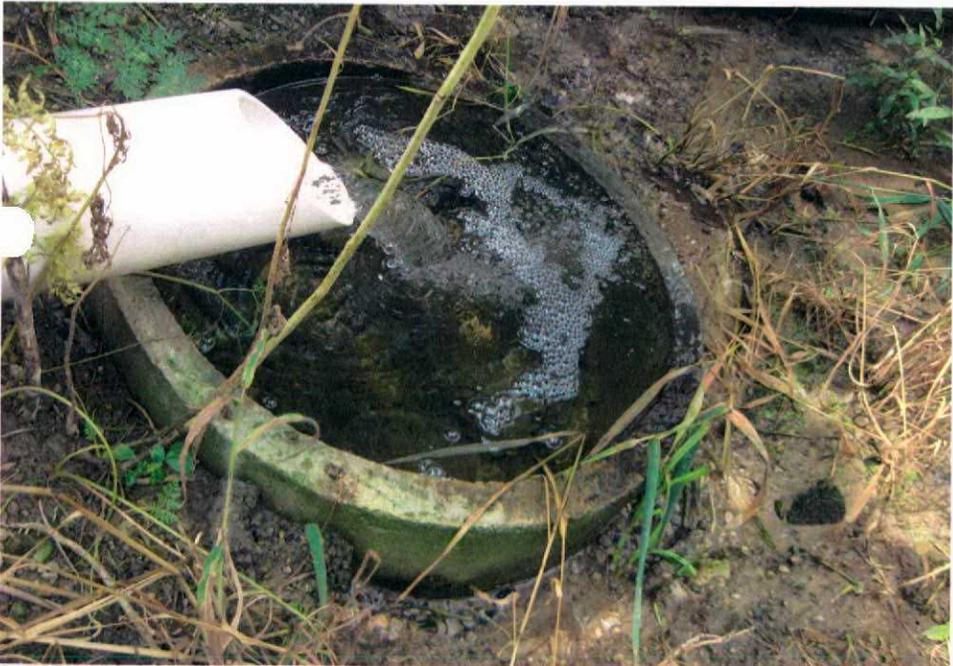
YMCA Camp Wilson 7/21/10
Final effluent

The final effluent to Silver Lake was clear. No foam, solids, or sewage fungus was noted at the final outfall.

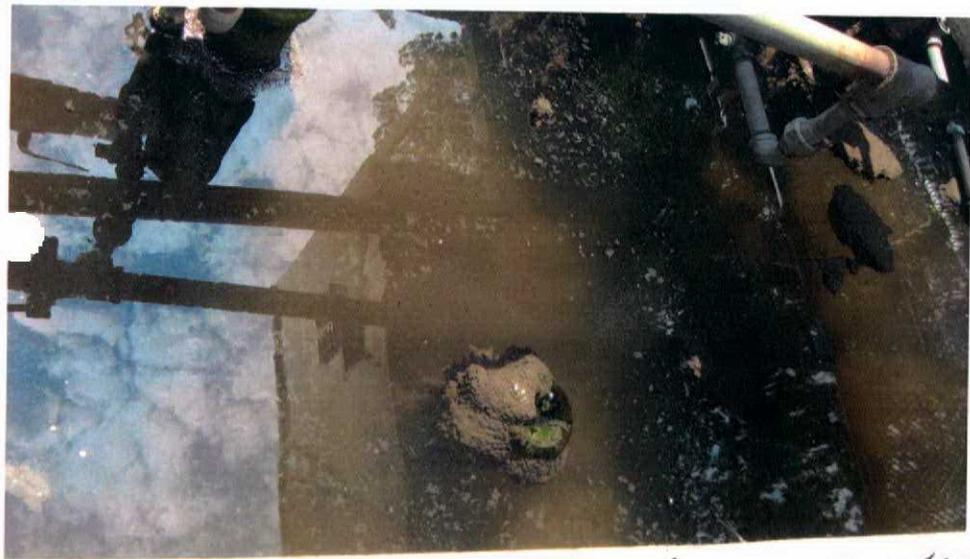
YMCA Camp Wilson 7/21/10
final clarifier

The clarifier had clumps of solids on the surface. Some pin floc solids were rising in the tank. The sludge blanket was within two feet of the surface. The effluent was clear. Solids were noted behind the weir and in the effluent trough.

1. The flow equalization electrical control system needs to be repaired in order to allow the system to work properly.
2. Solids need to be removed from the system in order to control solids carry over to the tertiary system.
3. Weeds located in both tertiary sand filters need to be removed (weed killers should not be used). Additionally, all solids that have carried over from the secondary system need to be removed. Filter wall leaks need to be repaired.
