**Environmental
Protection Agency**

March 14, 2012

**RE: Notice of Violation
Rumpke Sanitary Landfill, Hamilton County**

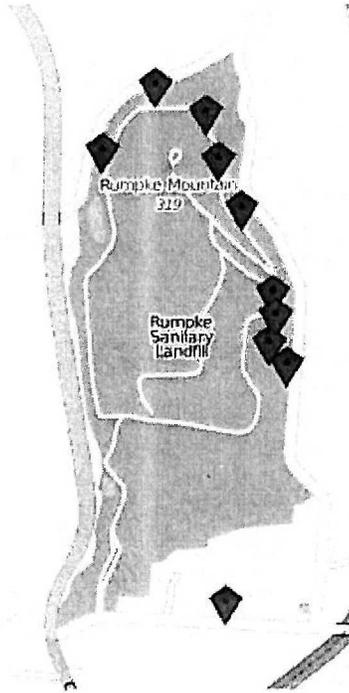
Below is a cursory inventory of north end odors observed on-site during the 2-8-12 follow-up inspection. The locations where odors were observed are indicated on the map and results of handheld instrument readings measured using a ppb Rae are contained in the following table. Results appear clockwise beginning in the northwest corner of the site.

Type of Odor	Odor Intensity	Total VOC (ppb)	Noteworthy Observations
Phase 5 Odor Leachate	3	38,500	NW lift station Odor Control in pit continuous, steam with high VOC's still escaping tarp- 38.5 ppm VOC read at edge of tarp.
	0	111	Phase 6 valve pit full of black liquid no strong odor, low VOC read, doors to pit open.
Phase 5 Odor	1	6,140	Reading from under rain flap east side phase 5/6, Brian H. had marked with orange paint to be addressed. Possible OCB anchor trench blow by.
Phase 5 Odor Leachate	3	1500	Phase 5 valve pit VOC read from pit 1500 ppb.
Phase 5 Odor Leachate	3	3,400	Lift Station 2 (east Lift Station) Up to 10ppm in valve pit door, steam and odor present at 8" line during pump run.
Leachate	2	846	At leachate load-out station, VOC reading from open port on frac tank.
Landfill Gas Gas Plant	2	300	Intermittent odor by gas plant.
Landfill Gas Gas Plant Leachate	2	350	Intermittent odor by service shop/gas plant.

Landfill Gas Gas Plant	1	40	In parking lot of Landfill Office.
Garbage Working Face	1	28	Slight garbage odor noted on Struble, south of phases 8 - 11.
