Air Pollution Control Division

Canton City Health Department

December 3, 2007

Re: Notice of Violation: OAC Rule 3745-20-02 (A)
OAC Rule 3745-20-03 (A) (1)
OAC Rule 3745-20-03 (A) (3)
OAC Rule 3745-20-04 (A) (2) (b)
OAC Rule 3745-20-04 (A) (6) (a)
OAC Rule 3745-20-04 (C)
OAC Rule 3745-20-05 (A)
OAC Rule 3745-20-05 (C)
Violations involving demolition at 12777 Mogadore Ave., NW, Lake
Township, Stark County, Ohio

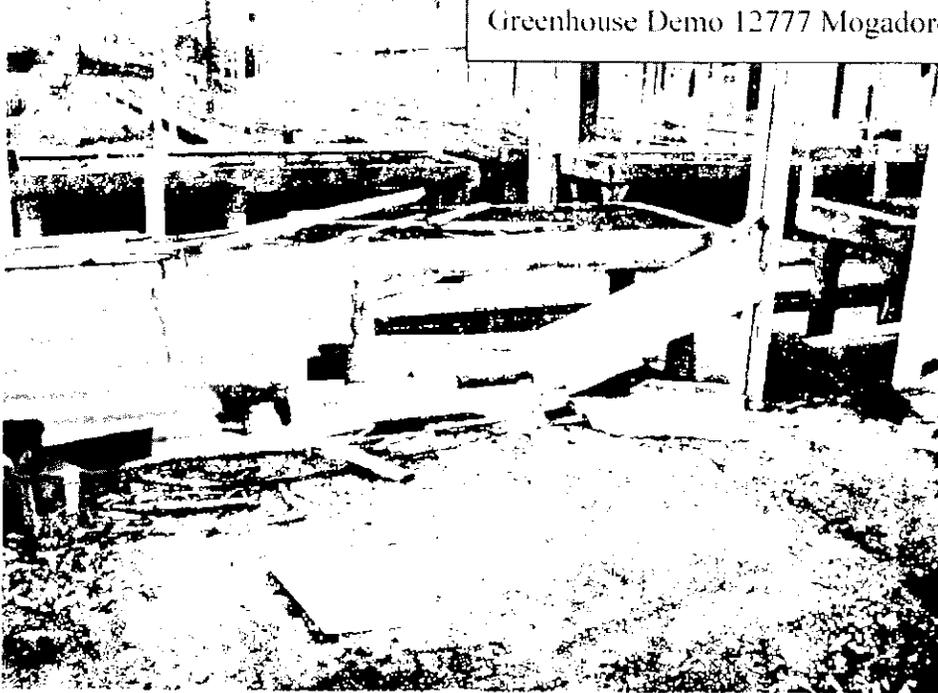
Greenhouse Demo 12777 Mogadore Rd. Photos 5/19/06 by G.A. Clark

Transite on ground.

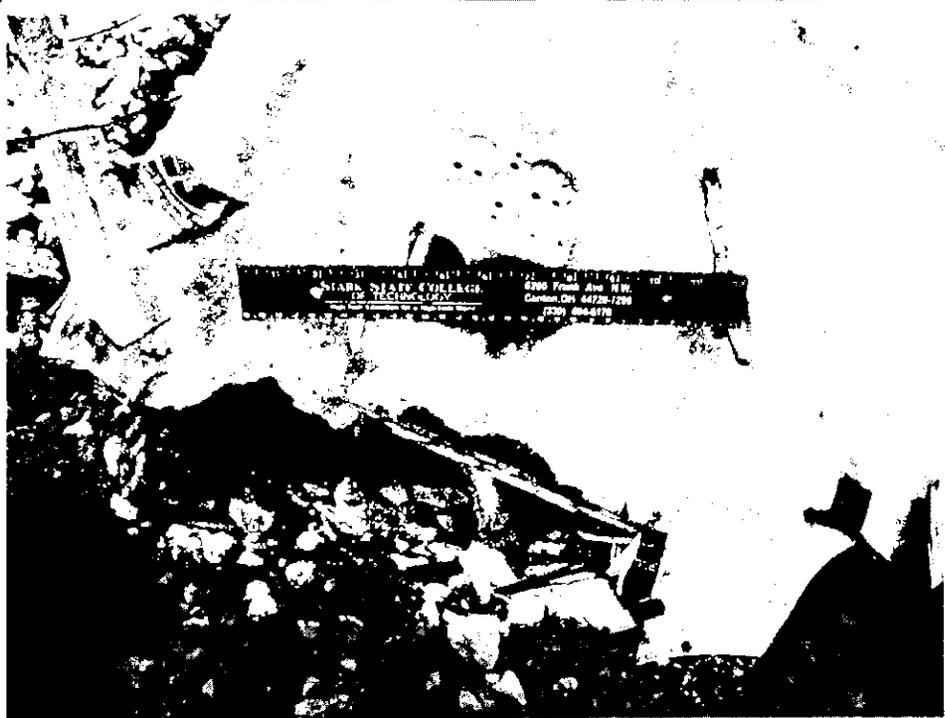
Pipe insulation

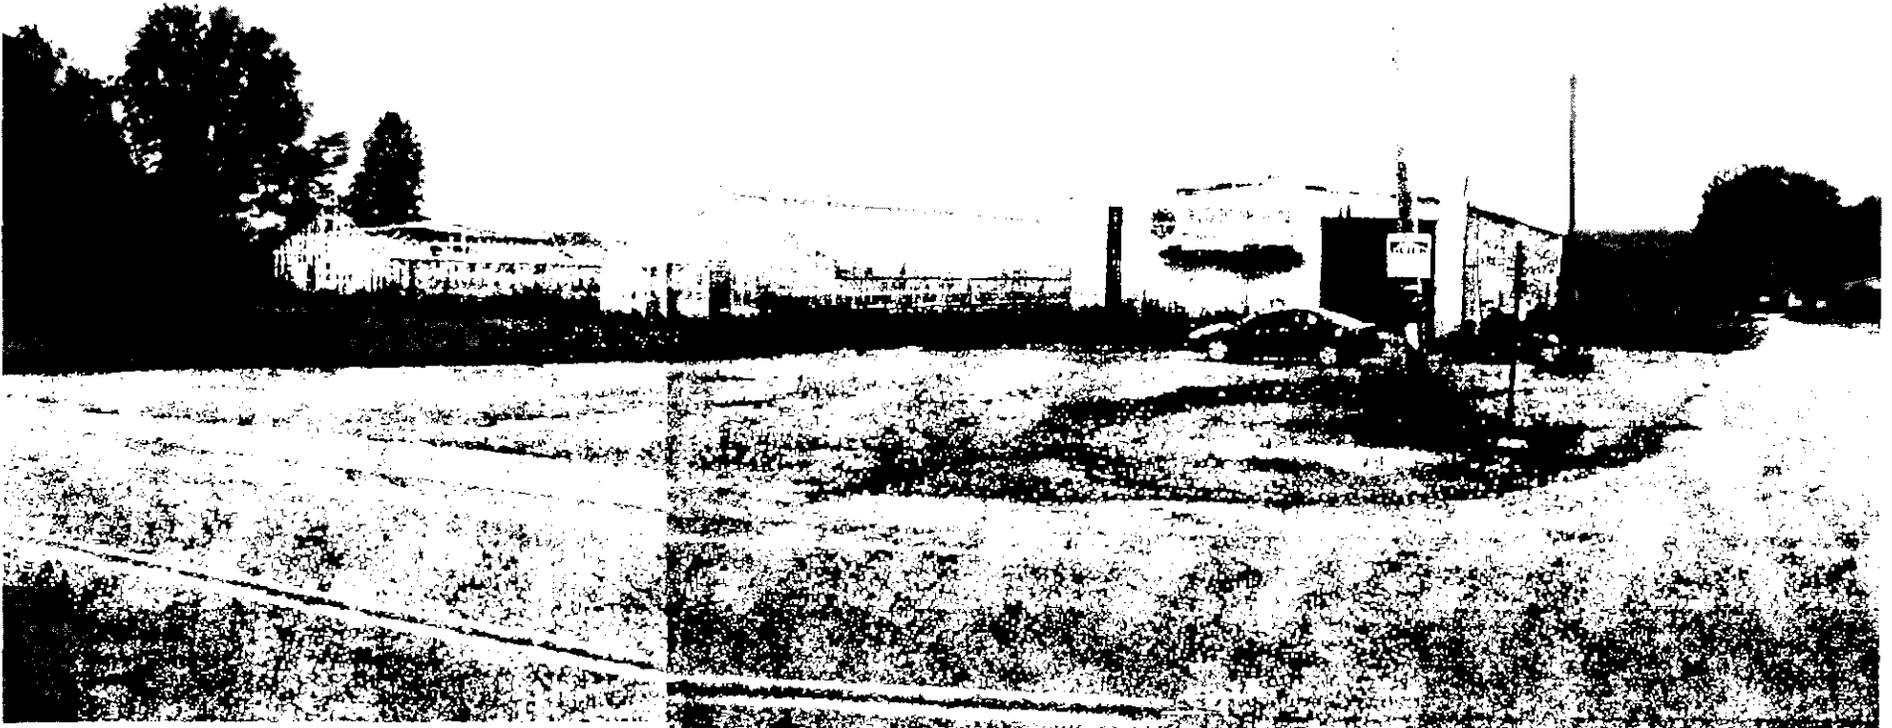
Greenhouse, 12777 Mogadore NW. All photos by G.A. Clark Aug. 30, 2007 Page 1 of 4

3. Facility Description (Setup and Conditions Observed): Partially demolished buildings with broken transite on walls and on ground and in roll offs. Drywall and surfacing debris. Damaged TSI. Describe facility and outside indications of demolition, renovation or asbestos removal activity.

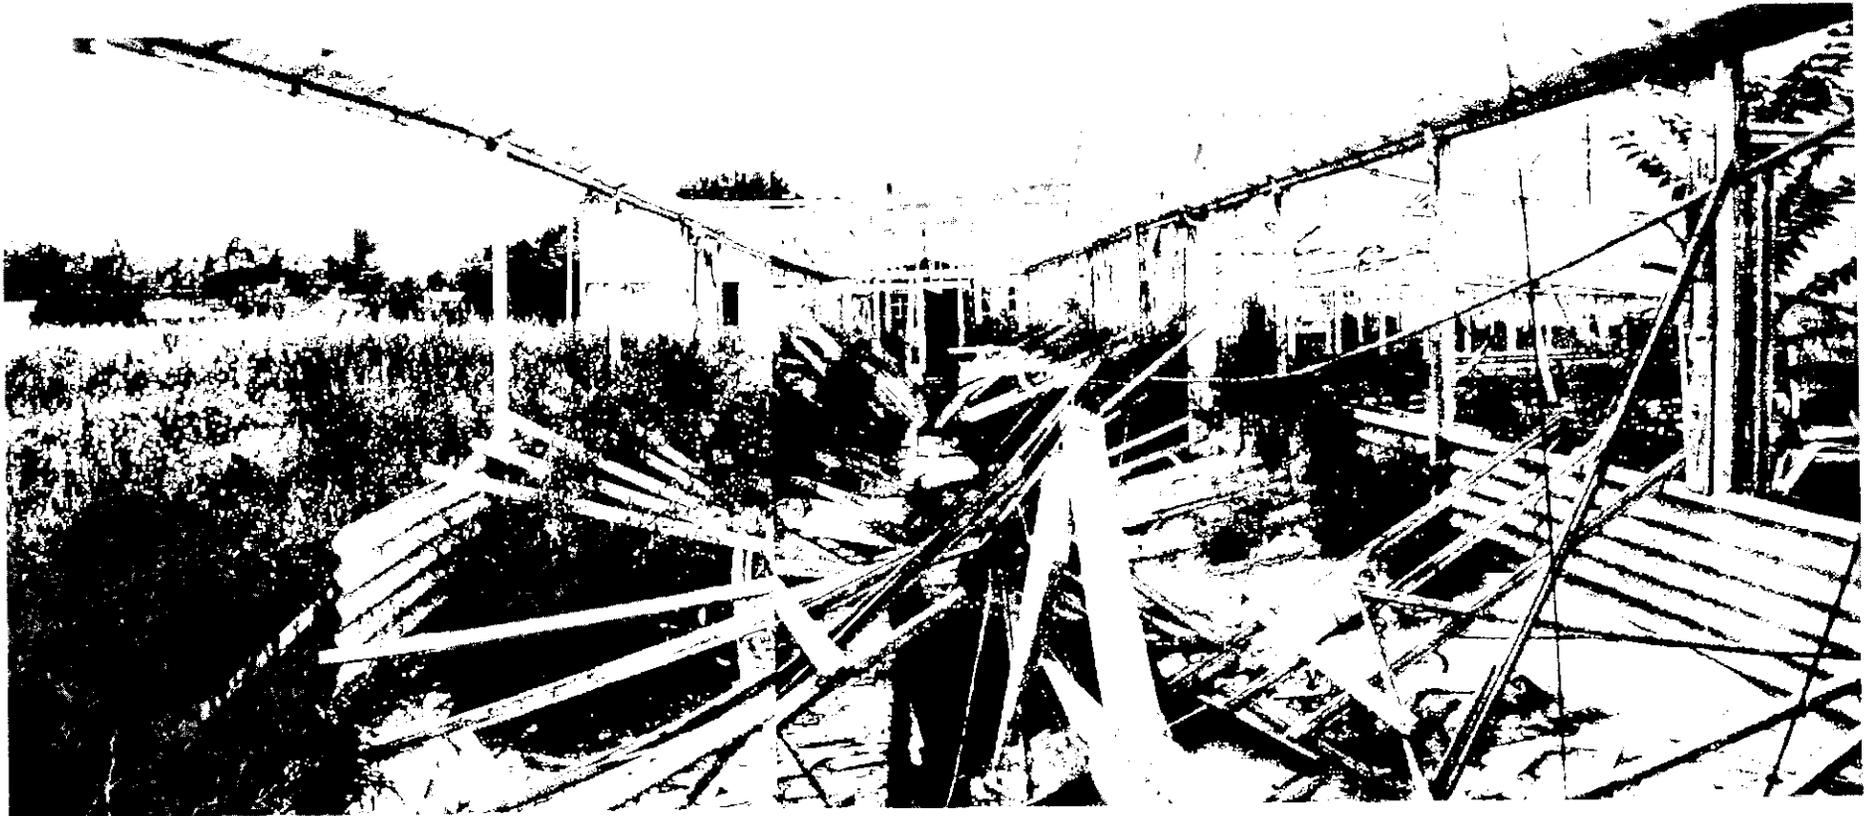
Greenhouse, 12777 Mogadore NW. All photos by G.A. Clark Aug. 30, 2007 Page 2 of 4

Examples of broken transite in field at rear of property.
