July 5, 2013

**RE: Catholic Central School; NPDES Permit # 1GC04654*AG;
Compliance Inspection Findings and Notice of Violation**

Ohio EPA DSW Storm Water Section, Construction Site Visit Information Form

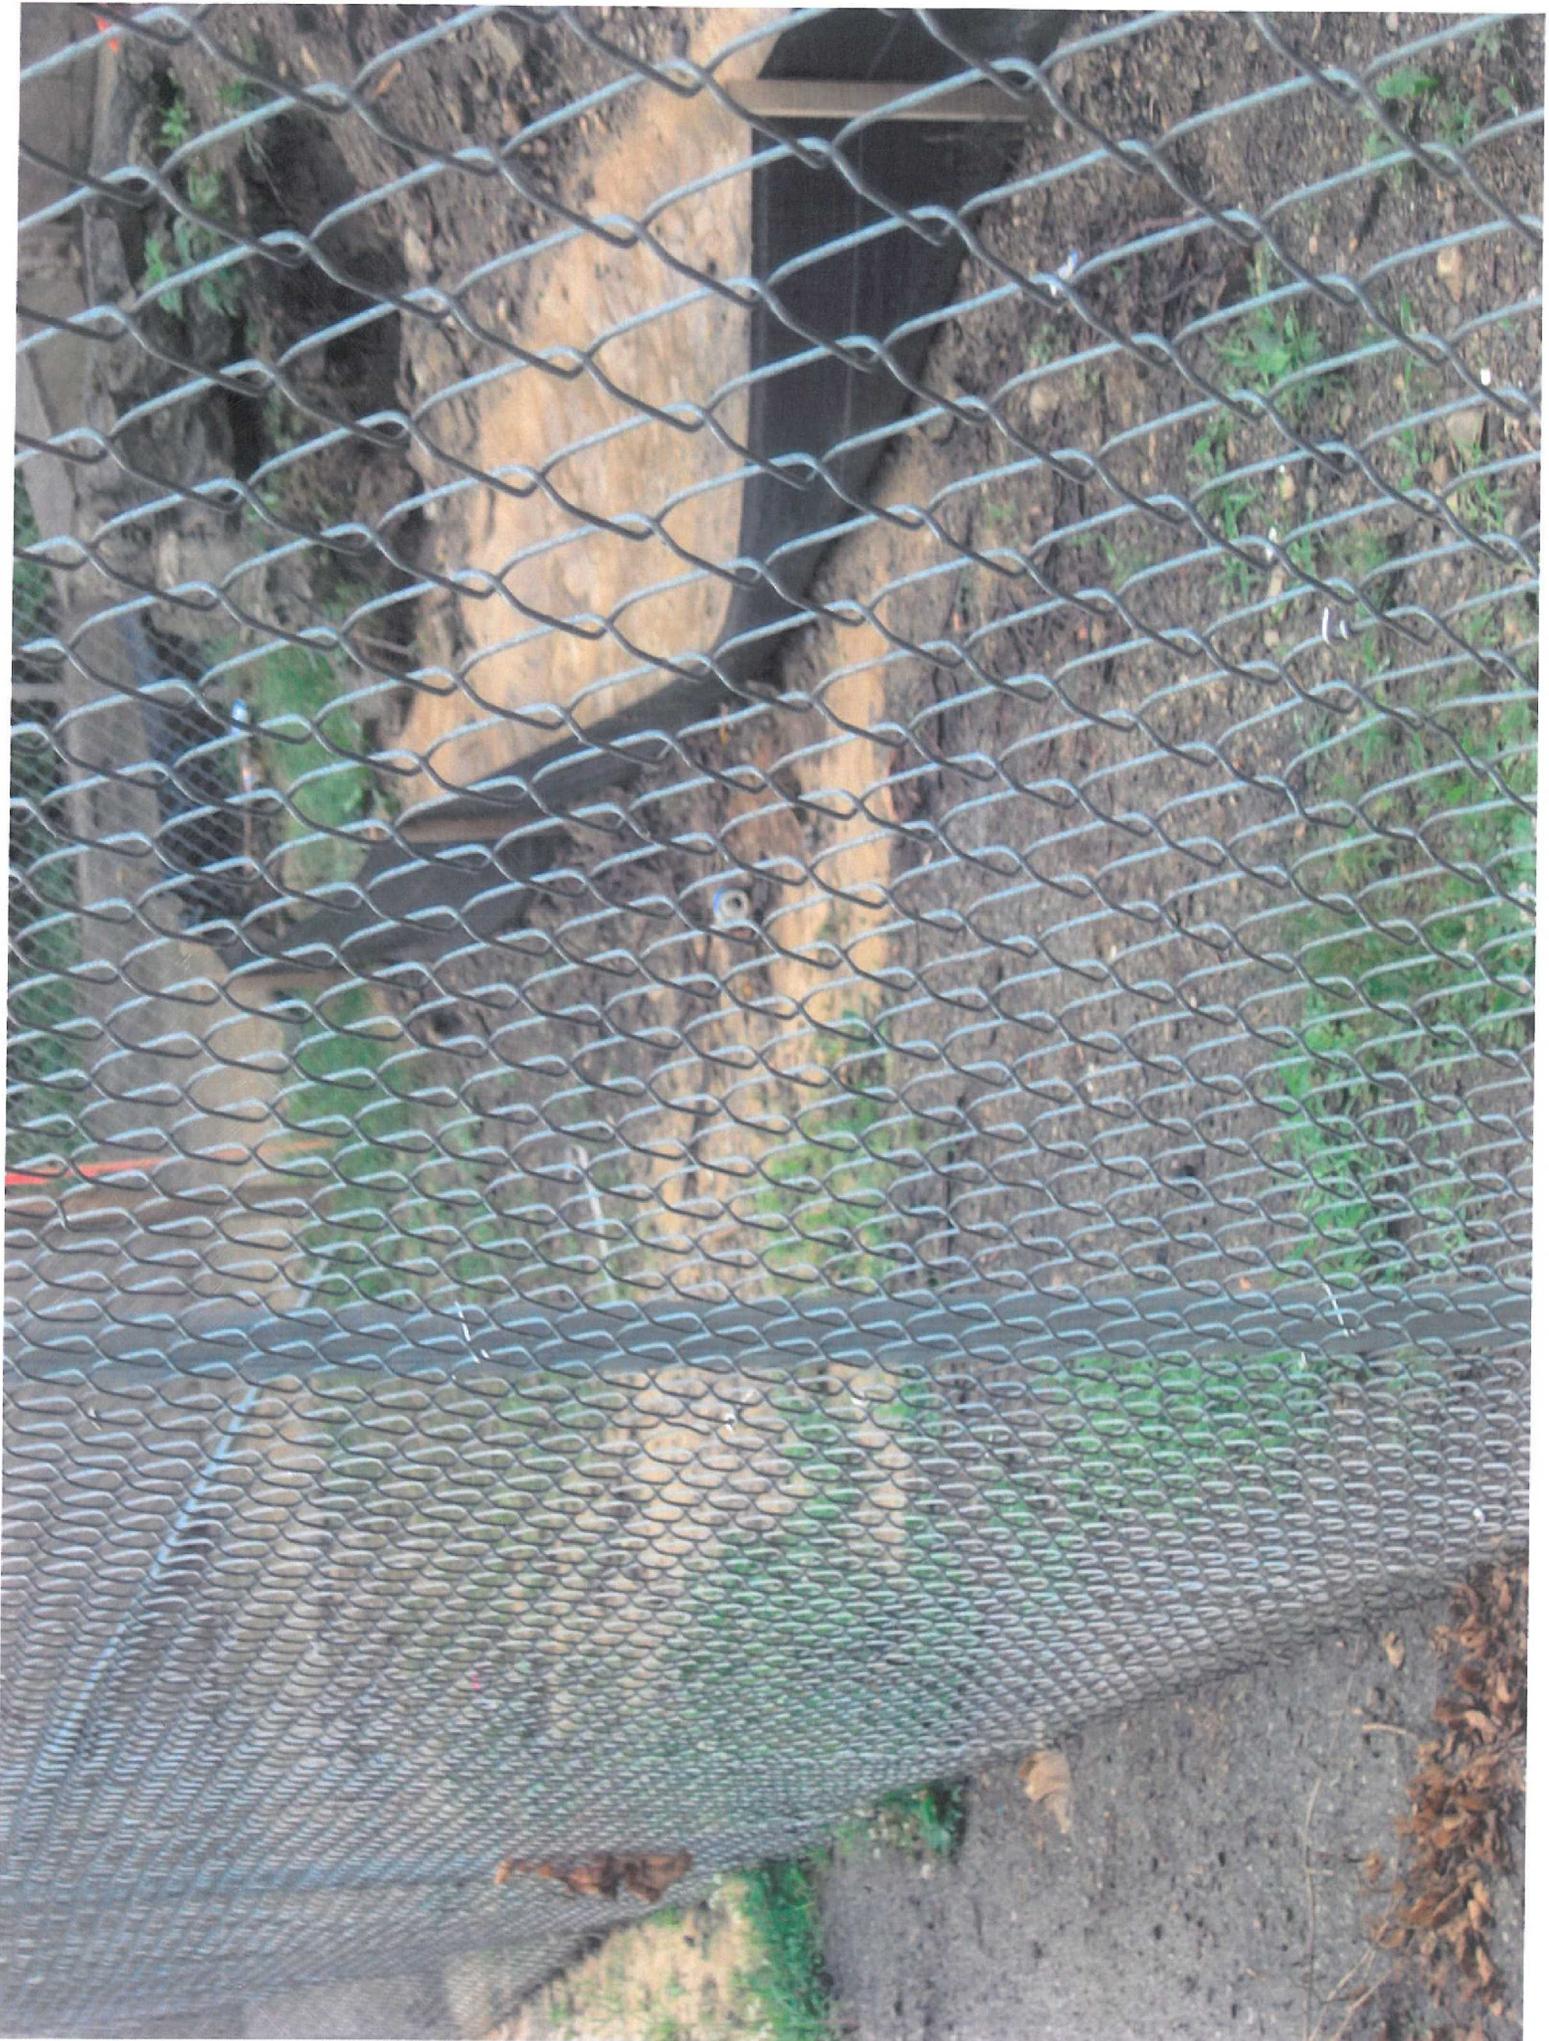
The silt fence located along McKinley Avenue, in the northwest corner of the property, is incapable of minimizing the loss of sediment in the event of a rainstorm. The photographs included, with this letter, document the violation. Sediment laden water is flowing over the damaged fence into the street and storm sewer system.

Located on McKinley Avenue there is an unprotected storm drain inlet. Sediment laden water is running from the site into this inlet. The dandy bag that was installed has been destroyed and is no longer protecting the storm drain. The photo included with this letter documents the violation. A dandy bag will minimize sediment laden water entering the city of Springfield's storm drain systems until construction activities have ceased.

Explain: Silt Fence needs maintenance, Northwest corner (low spot) Ripped Dandy Bag, Need containment for everything drains into that corner

It is evident that this area is the low spot for the entire site. Silt fence is generally not recommended for use in areas where concentrated flows of runoff will occur. A better option might be to create a storm water detention basin to collect run off. Refer to Ohio's Rainwater Land Development Manual, Chapter 6 section 1 for more details. Another option is a Temporary Sediment Trap which would only be utilized until the site is stabilized. Refer to Ohio's Rainwater Land Development Manual, Chapter 6 section 2 for more details.
