September 10, 2013

RE: ROUND UP LAKE
FORMERLY JELLYSTONE PARK
PERMIT NO. 3PR00090*ED
PORTAGE COUNTY
MANTUA TOWNSHIP

On August 29, 2013, an inspection of the above referenced facility's wastewater treatment system was conducted. The facility was represented by Mr. Mark Rhoades, Class "A" Waste Water Treatment Plant Operator. The purpose of the inspection was to: (1) evaluate the performance of the wastewater treatment system along with the facility's compliance status with respect to the terms and conditions of the above-referenced National Pollutant Discharge Elimination System (NPDES) permit and (2) determine required additional actions to be undertaken as part of the permit renewal process.

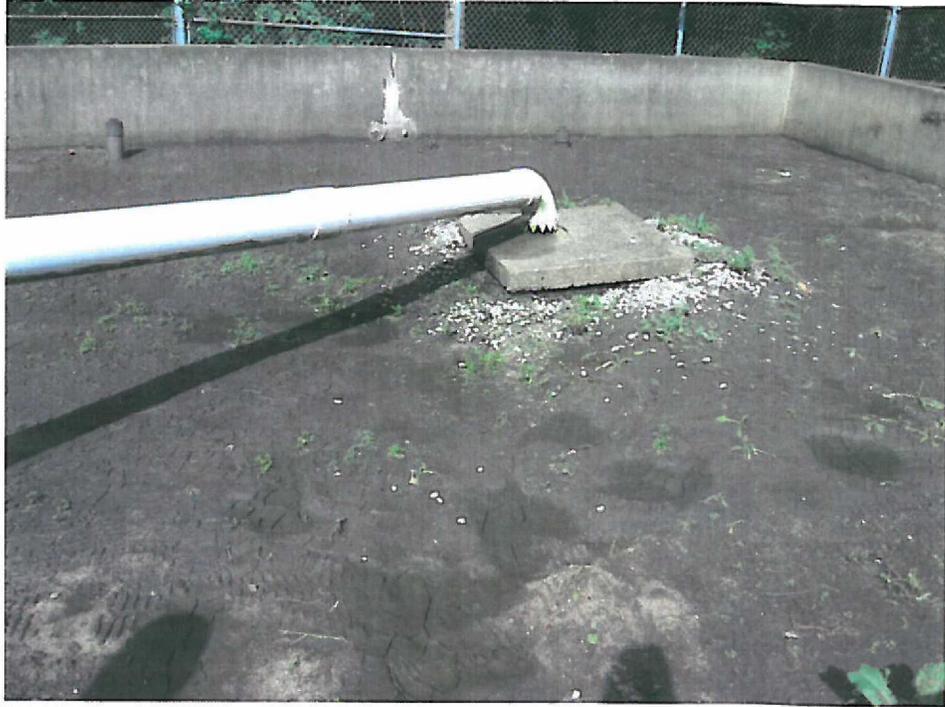
Figure 2

26. The weir is leaking between the plates near the outlet. See Figure 2. Also, it appears that the weir needs to be leveled. The water is only flowing over the weir on the west side near the outlet. This needs to be corrected immediately.
