Re: Sandusky County
Sycamore Hills Golf Course
Sewerage

On July 20, 2011, and September 8, 2011, inspections were conducted of the wastewater treatment plant (WWTP) which serves the Sycamore Hills Golf Course. The golf course is located on the north side of U.S. Route 6, approximately one mile west of State Route 53, Washington Township. Observations and recommendations noted during the inspection are as follows:

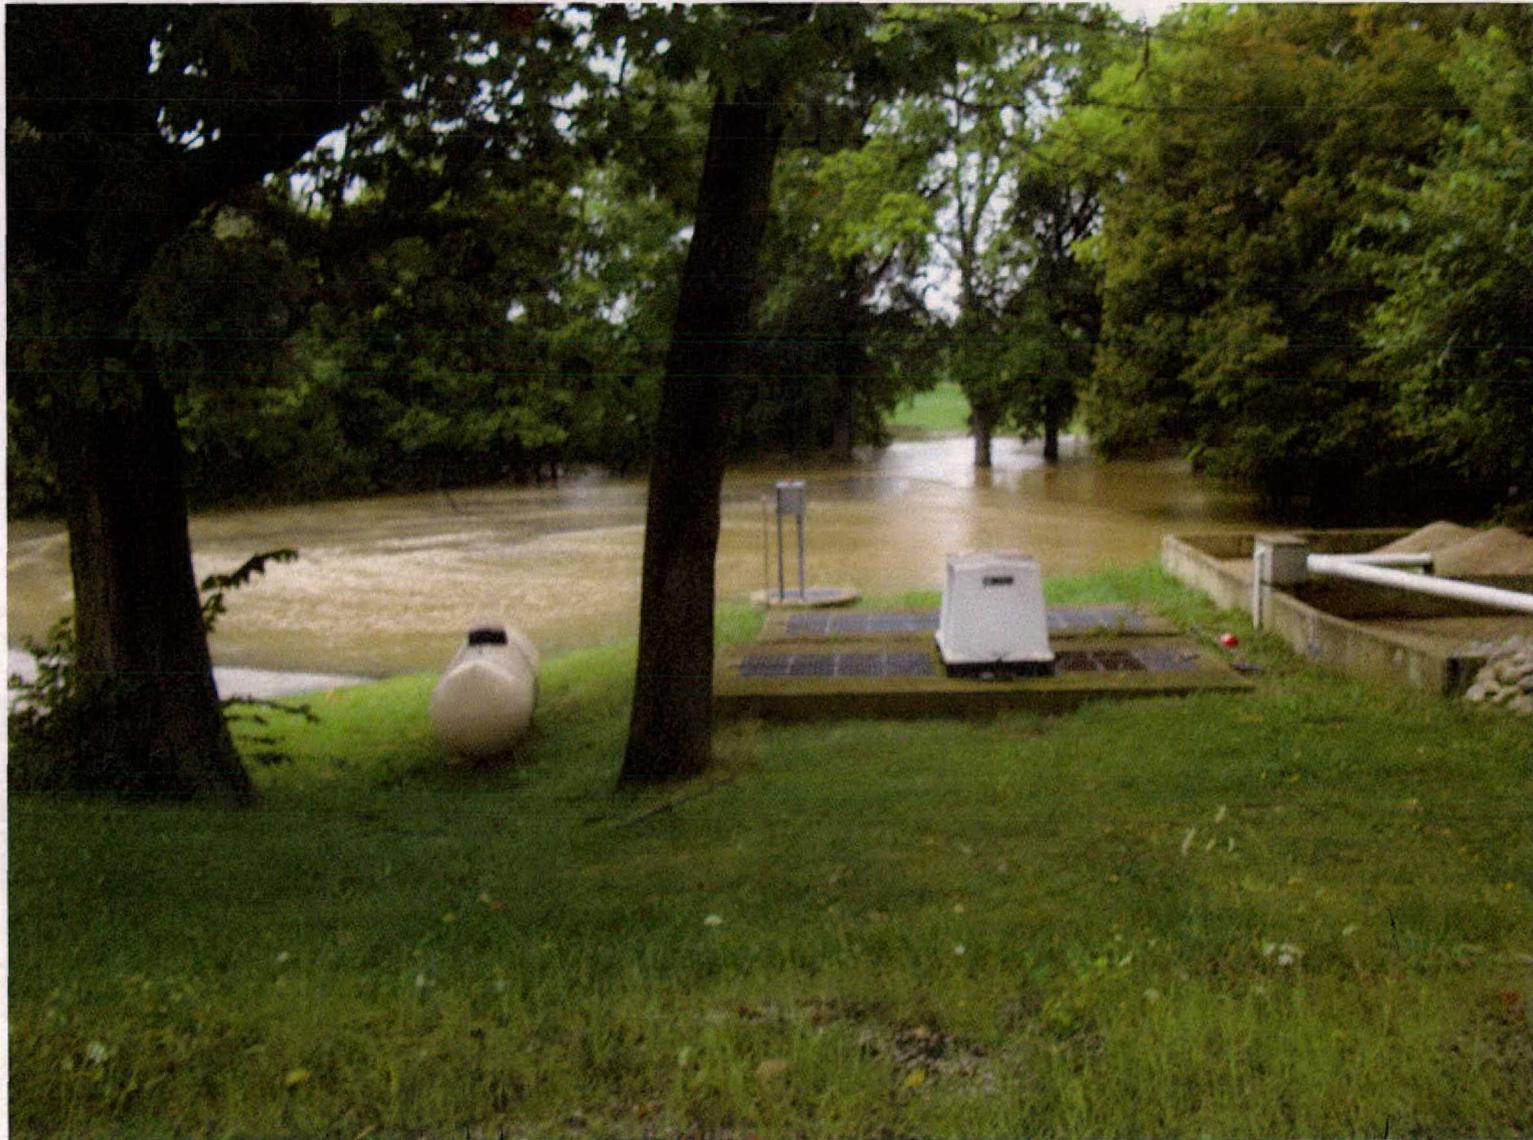
page 6 of 7

Sycamore Hills Golf Course WWTP, Sandusky Co.
taken by M.B. Cohen, 09/08/2011

1. The plant was operating, but the tanks had very little aeration. The aeration lines should be inspected and repaired as needed.
2. Two sludge returns were operating with a slightly turbid return flow. The clarifier hopper walls should be scraped down once per day to increase the solids returned.
3. The skimmer was operational.
4. The sand filter walls have been damaged (due to flooding) and only a portion of each filter was in use. The filters need to be repaired and/or replaced.
5. The sand filters also need to be kept clean, level and free of weed growth at all times.
6. Chlorination / de-chlorination must be provided from May through October.
7. Pictures taken at the time of the two inspections are enclosed. Muskellunge Creek was overflowing it's banks and the lower parking lot was flooded at the time of the 09/08/11 inspection as a result of heavy rains.

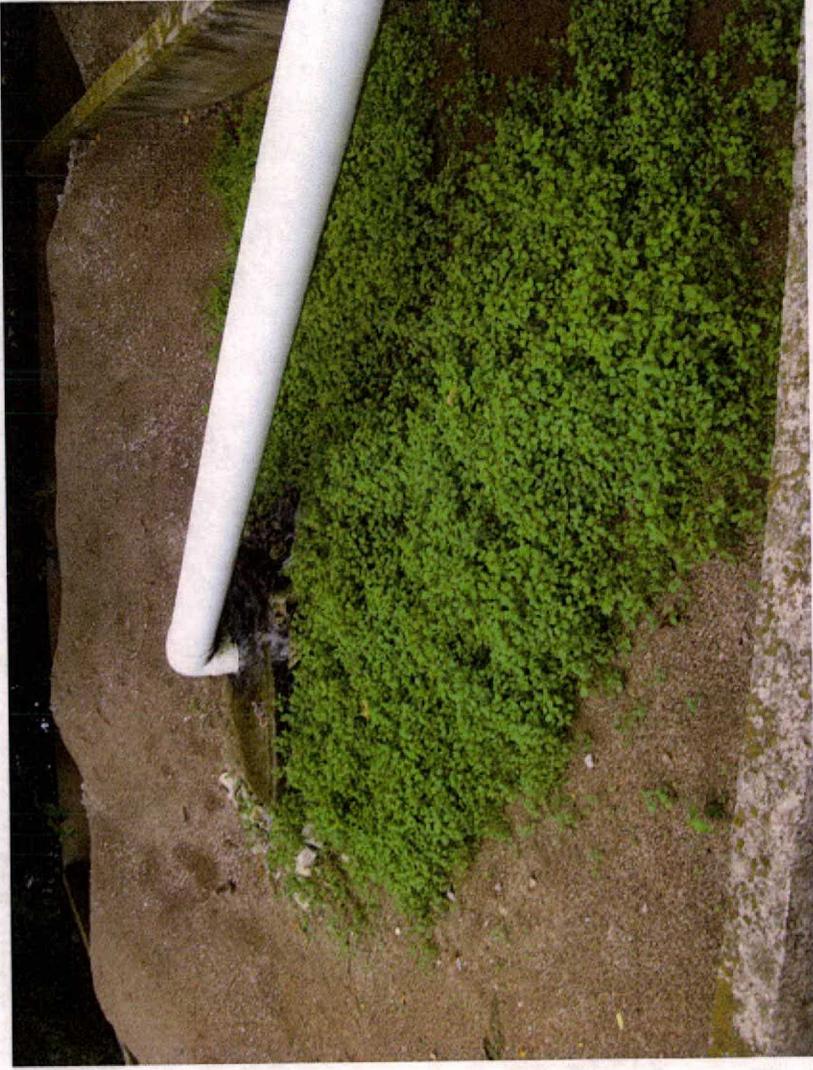
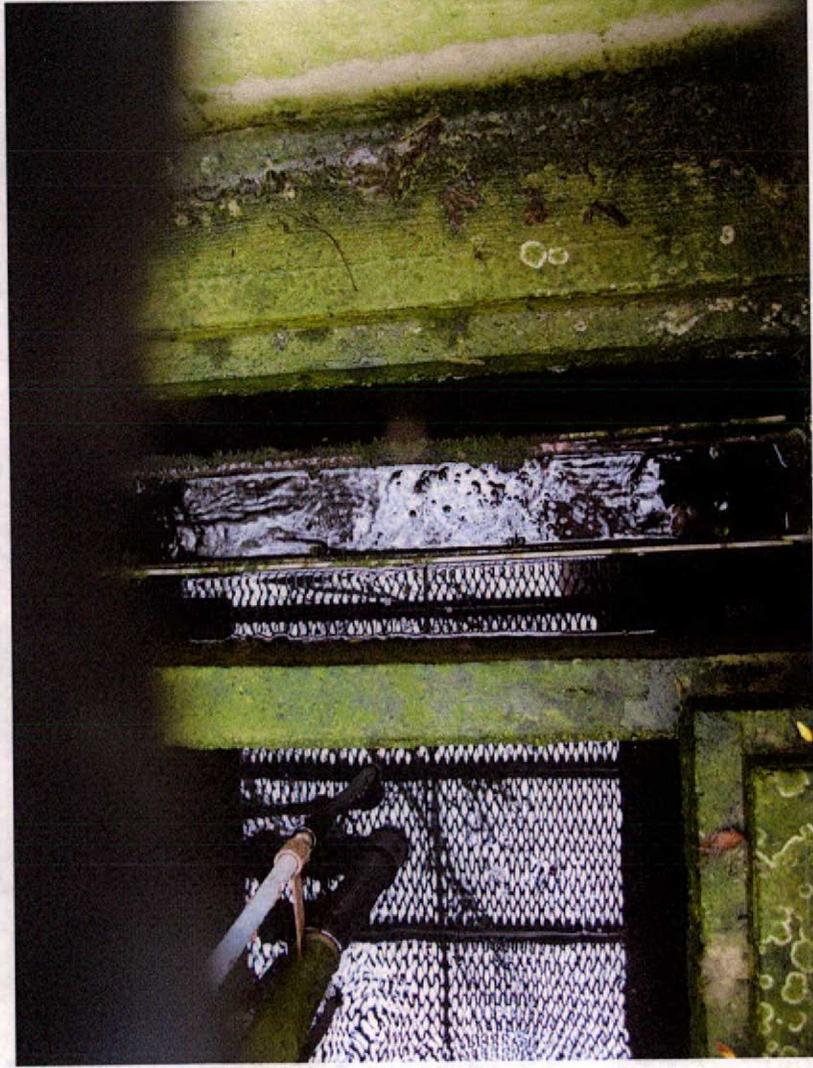
page 1 of 6

Fremont Baptist Temple WWTP, Sandusky Co.
taken by M.B.Cohen, 09/08/2011
