August 29, 2013

RE: MEDINA COUNTY
GRANGER TOWNSHIP
GRANGER UNITED METHODIST CHURCH
(PERMIT NO. 3PR00594)

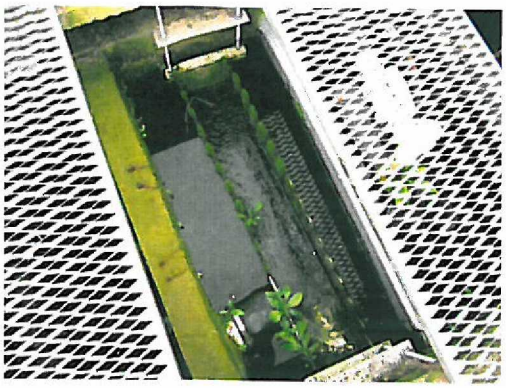
5) Contents of the settling tank were clear down to a depth of approximately 6", but did contain some floating scum and duckweed on the water surface. The settling tank effluent trough contained a deposition of solids; and there was a mossy

growth on the weirs of the trough and a few plants (see photo).

The effluent trough should be kept clean at all times, and the skimmer operational.
